Moosehead Hydroelectric Project Condition Assessment

for the Town of Dover-Foxcroft

Dam Inspection - Findings

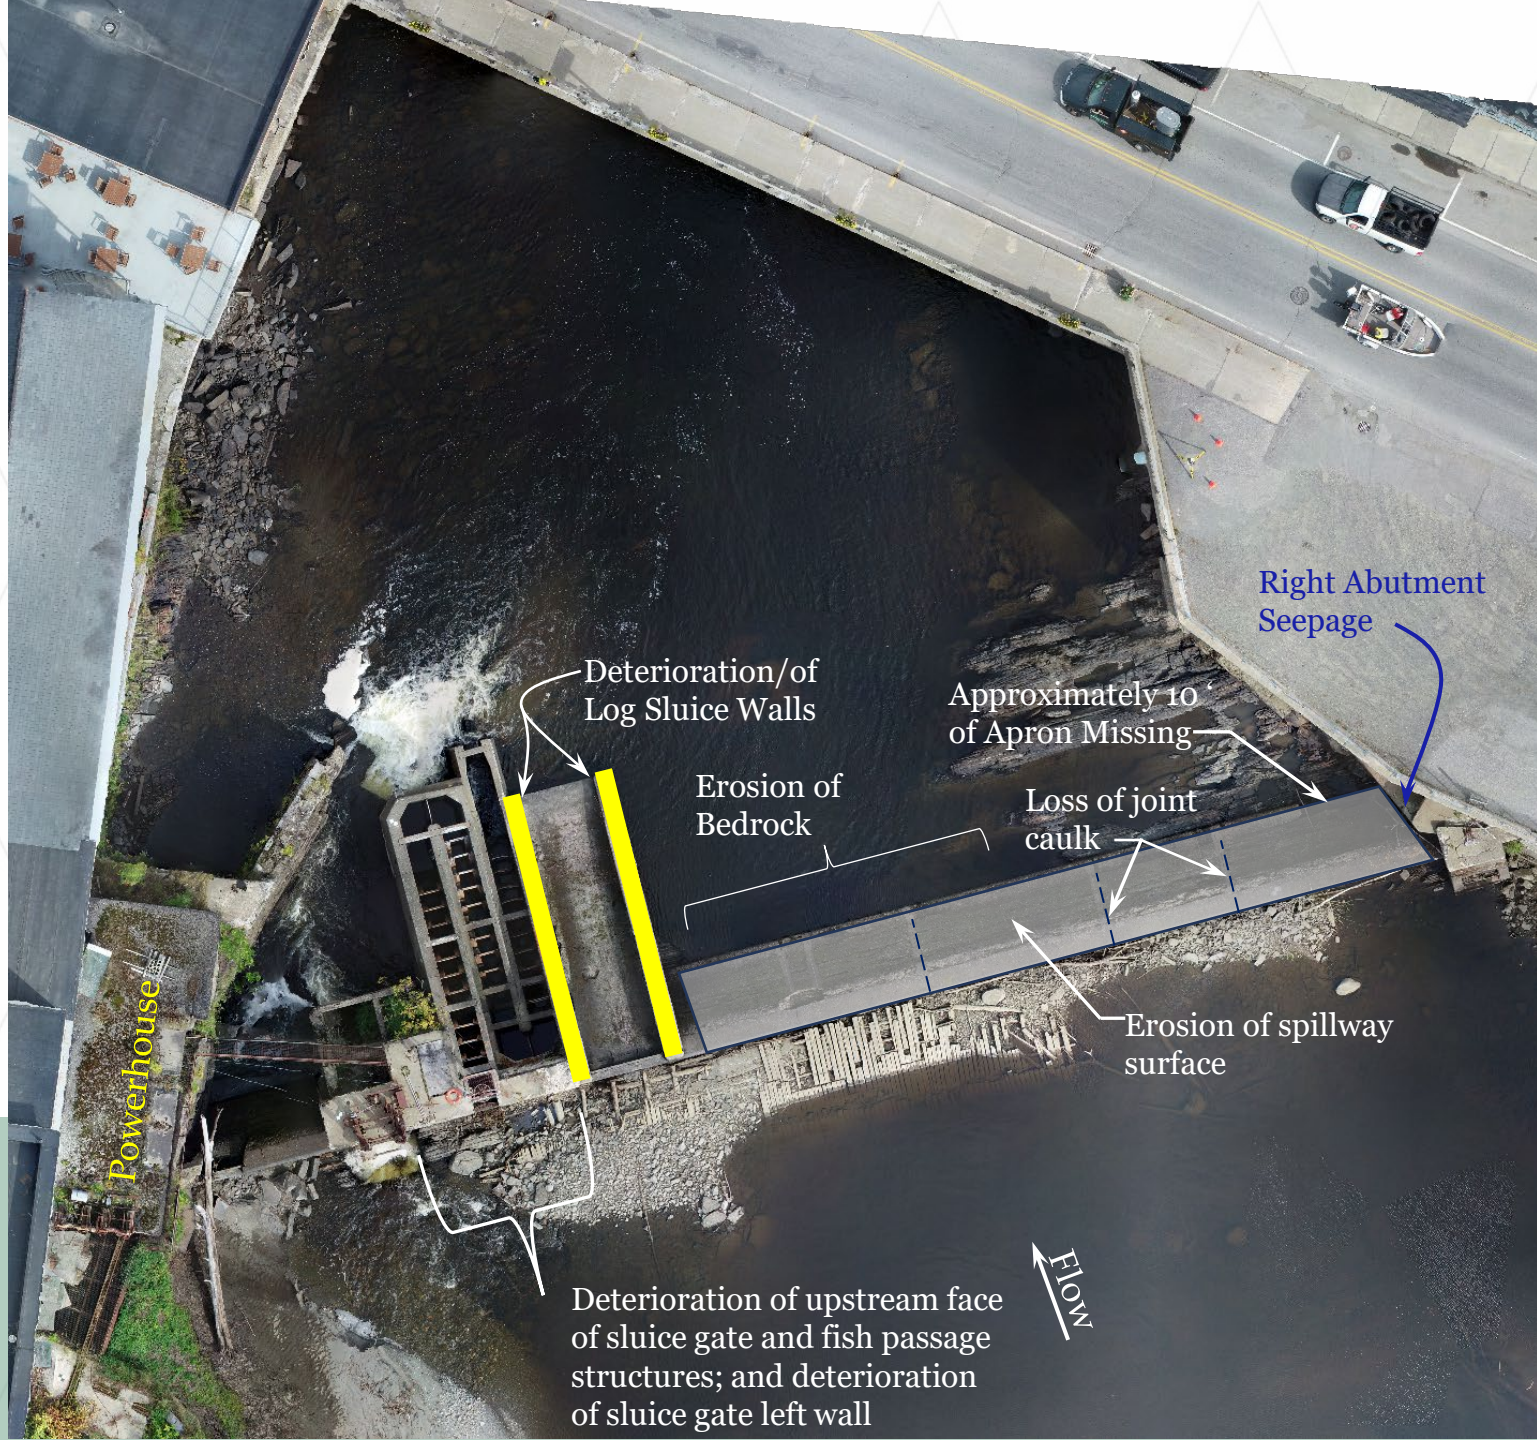
Deterioration of Log Sluice Walls

Approximately 10 of Apron Missing

Erosion of Bedrock

Loss of joint caulk

Right Abutment Seepage

Erosion of spillway surface

Deterioration of upstream face of sluice gate and fish passage structures; and deterioration of sluice gate left wall

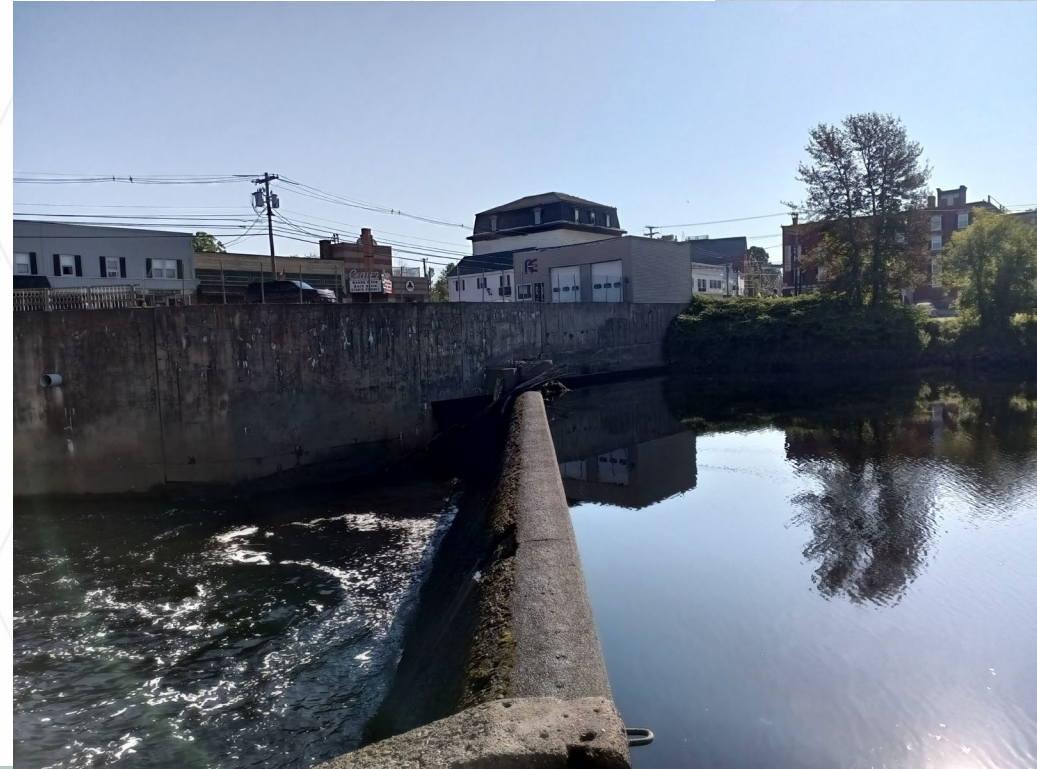
- Horizontal & vertical alignment is good.
- Seepage through right abutment (less than 5 gpm).
- Loss of about 10 feet of concrete apron at right side of dam.
- Concrete surface erosion (crest and downstream face), concrete surface is generally sound.
- Erosion of bedrock along toe of dam, to depths up to 9 feet (no significant undercutting).

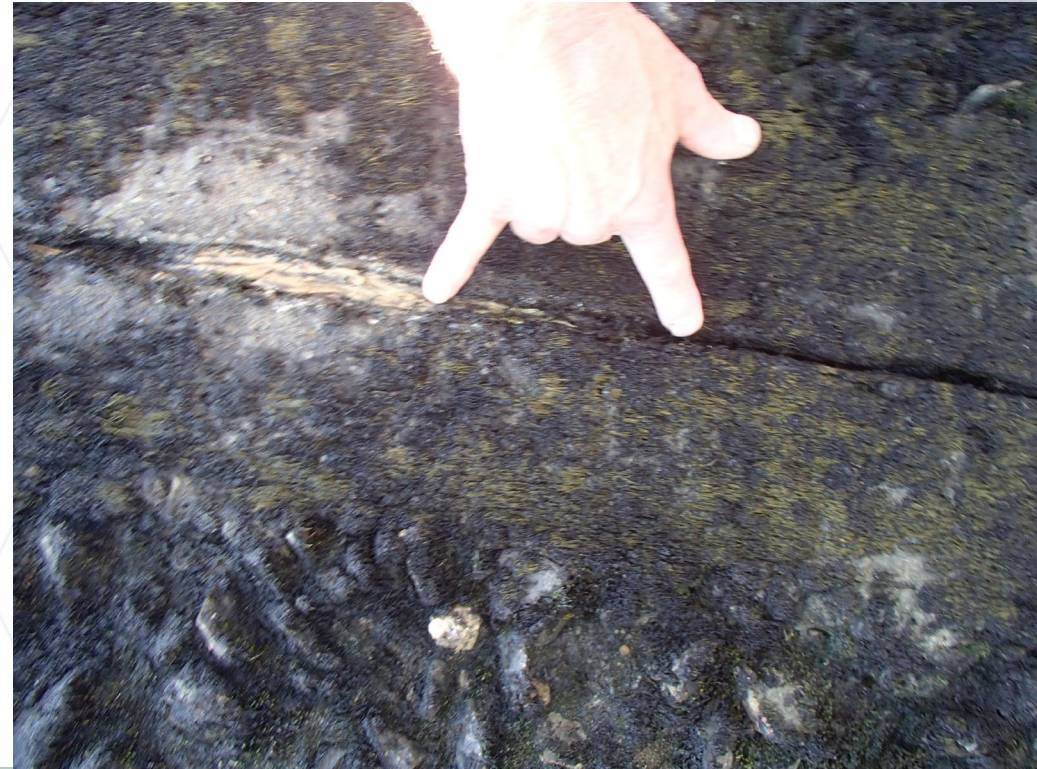
- Loss of caulking/sealant in joints between concrete monoliths.
- Concrete deterioration at the upstream face and left wall of the sluiceway structure and the upstream face of the fish passage structure.
- Concrete deterioration of the left and right walls of the log sluice, and seepage through the walls.

- ✓ Erosion of Bedrock Downstream
 - Place concrete and/or heavy riprap to fill void
- ✓ Concrete Deterioration of Log Sluice Left & Right Walls
 - Remove all soft and deteriorated concrete
 - Drill & grout rebars into existing concrete; place new concrete to original lines
- ✓ Upstream face of dam and Left Sluiceway Structure Wall
 - Remove all soft and deteriorated concrete
 - Drill & grout rebars into existing concrete; place new concrete to original lines

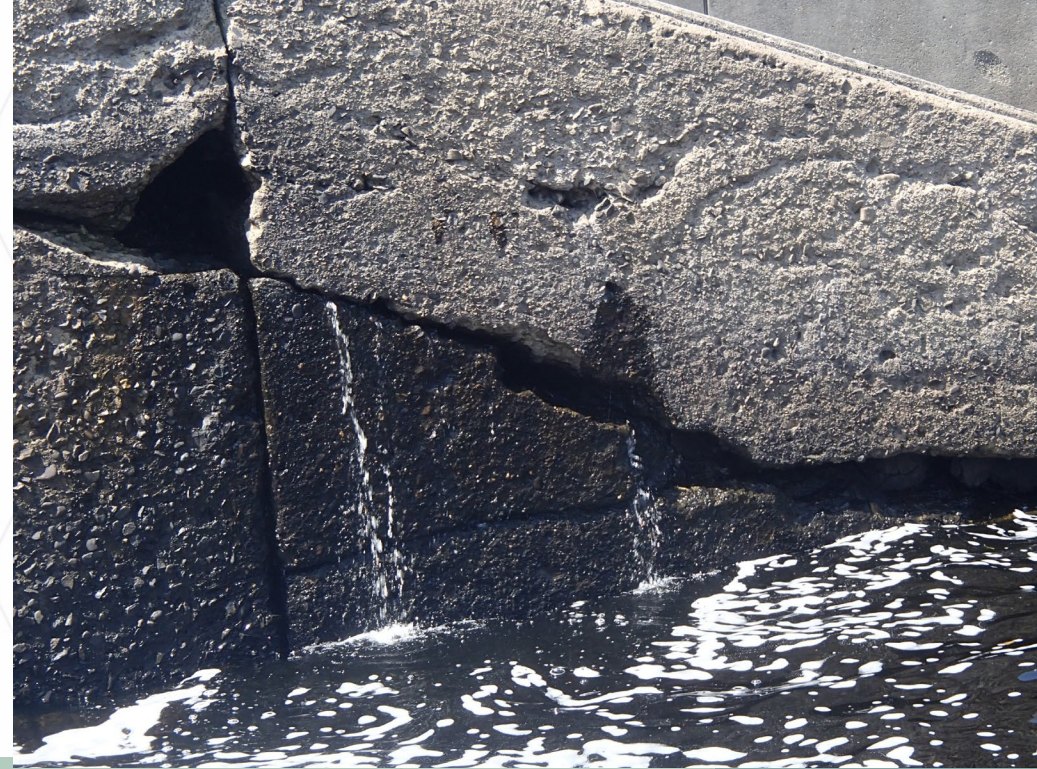
- Left abutment wall, also serving as powerhouse foundation wall, missing individual stones

- In Next 1-Year
 - ✓ Left Abutment Wall
 - Shore existing building structure from building interior as necessary
- In Next 1-to-3-Years
 - ✓ Left Abutment Wall
 - Fill voids with reinforced concrete
- In the Next 3-to-5 Years
 - ✓ Seepage Through Right Abutment
 - Place new concrete to fill voids, and
 - Pressure grout as required
 - ✓ Loss of Concrete Apron
 - Drill & grout rebars into existing concrete; place new concrete to original lines

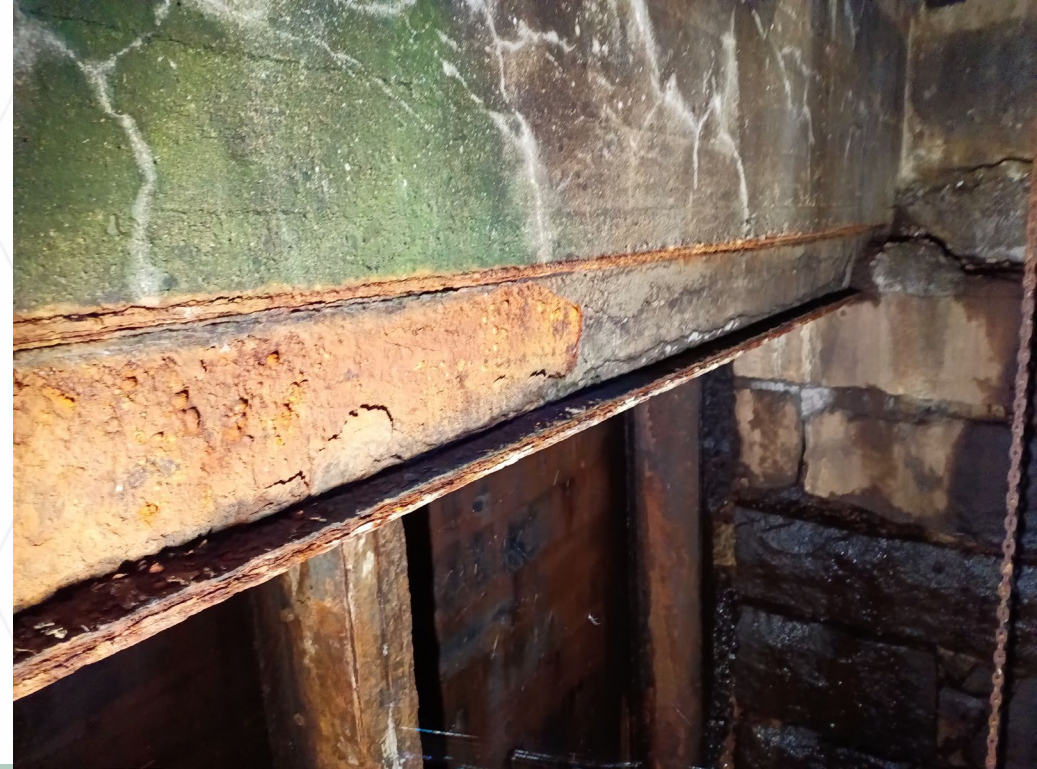
- A section of the powerhouse roof has collapsed.
- Roof slab and beams are spalling in several areas exposing corroded rebar.
- Steel I-Beams supporting the generator floor have varying degrees of web and flange corrosion.
- Generator floor timber beam with marginal end support.

- In Next 1-Year
 - ✓ Roof
 - Shore structure as required
 - Make roof watertight with tarps or similar to prevent additional damage
 - ✓ Generator Floor
 - Provide positive support for timber floor beam on upstream end of Powerhouse
 - ✓ Turbine Floor Deck
 - Replace missing and damaged floor planks, or
 - Close-off area to prevent access
- In Next 1-to-3-Years
 - ✓ Roof
 - Repair roof structure and install new roofing system

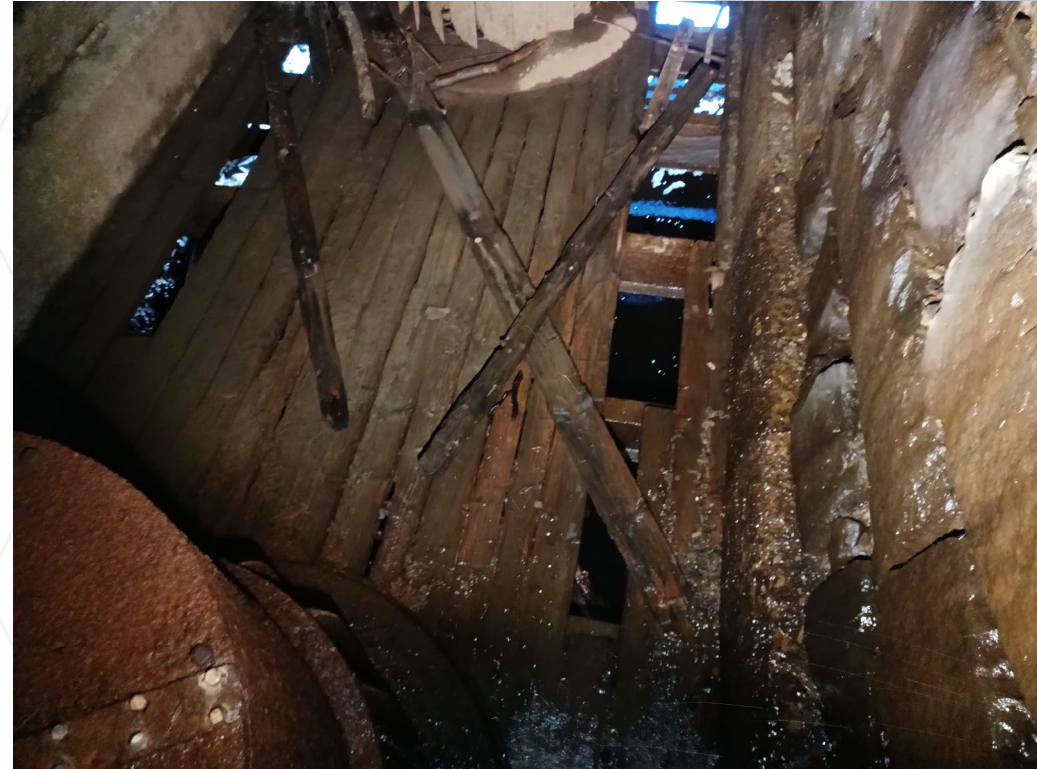
- Individual wood planks are missing from the turbine floor and some planks show signs of rot.
- Vertical guides (I-Beams) for upstream bulkhead have significant corrosion of the web and flanges.
- Joints in the stone foundation wall show signs of deterioration and mortar loss.

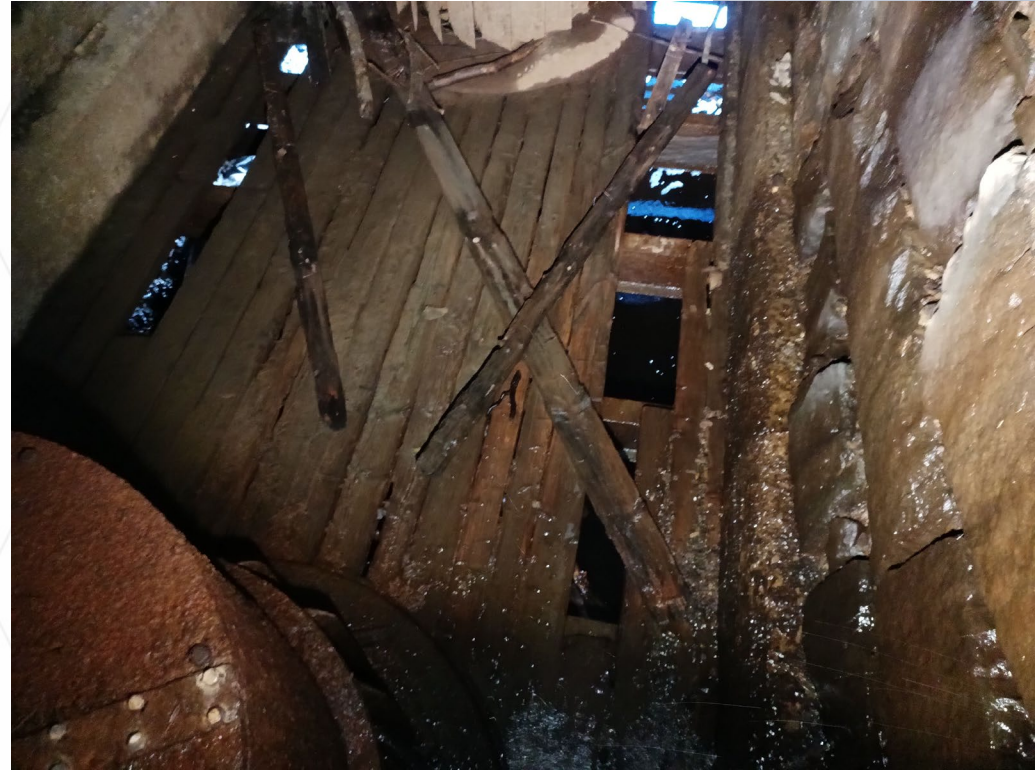
- Joint seepage observed through the left and right stone masonry foundation walls, at the upstream end powerhouse.

- ✓ Stone Foundation Walls
 - Pressure grout areas of walls with seepage, or
 - Place concrete on exterior face of walls
 - Repoint walls
- In Next 3-to-5 Years
 - ✓ Corroded Structural Steel Framing
 - Reinforce existing framing if possible, or
 - Replace individual members
 - ✓ Spalled concrete roof deck and beams
 - Remove deteriorated concrete
 - Splice-in new reinforcing to make up lost area of steel due to corrosion
 - Patch with structural epoxy with minimum compressive strength of 4,500 psi
