Mayo Mill Dam Feasibility Study Baseline Conditions Report Piscataquis River Dover-Foxcroft, ME

October 2023

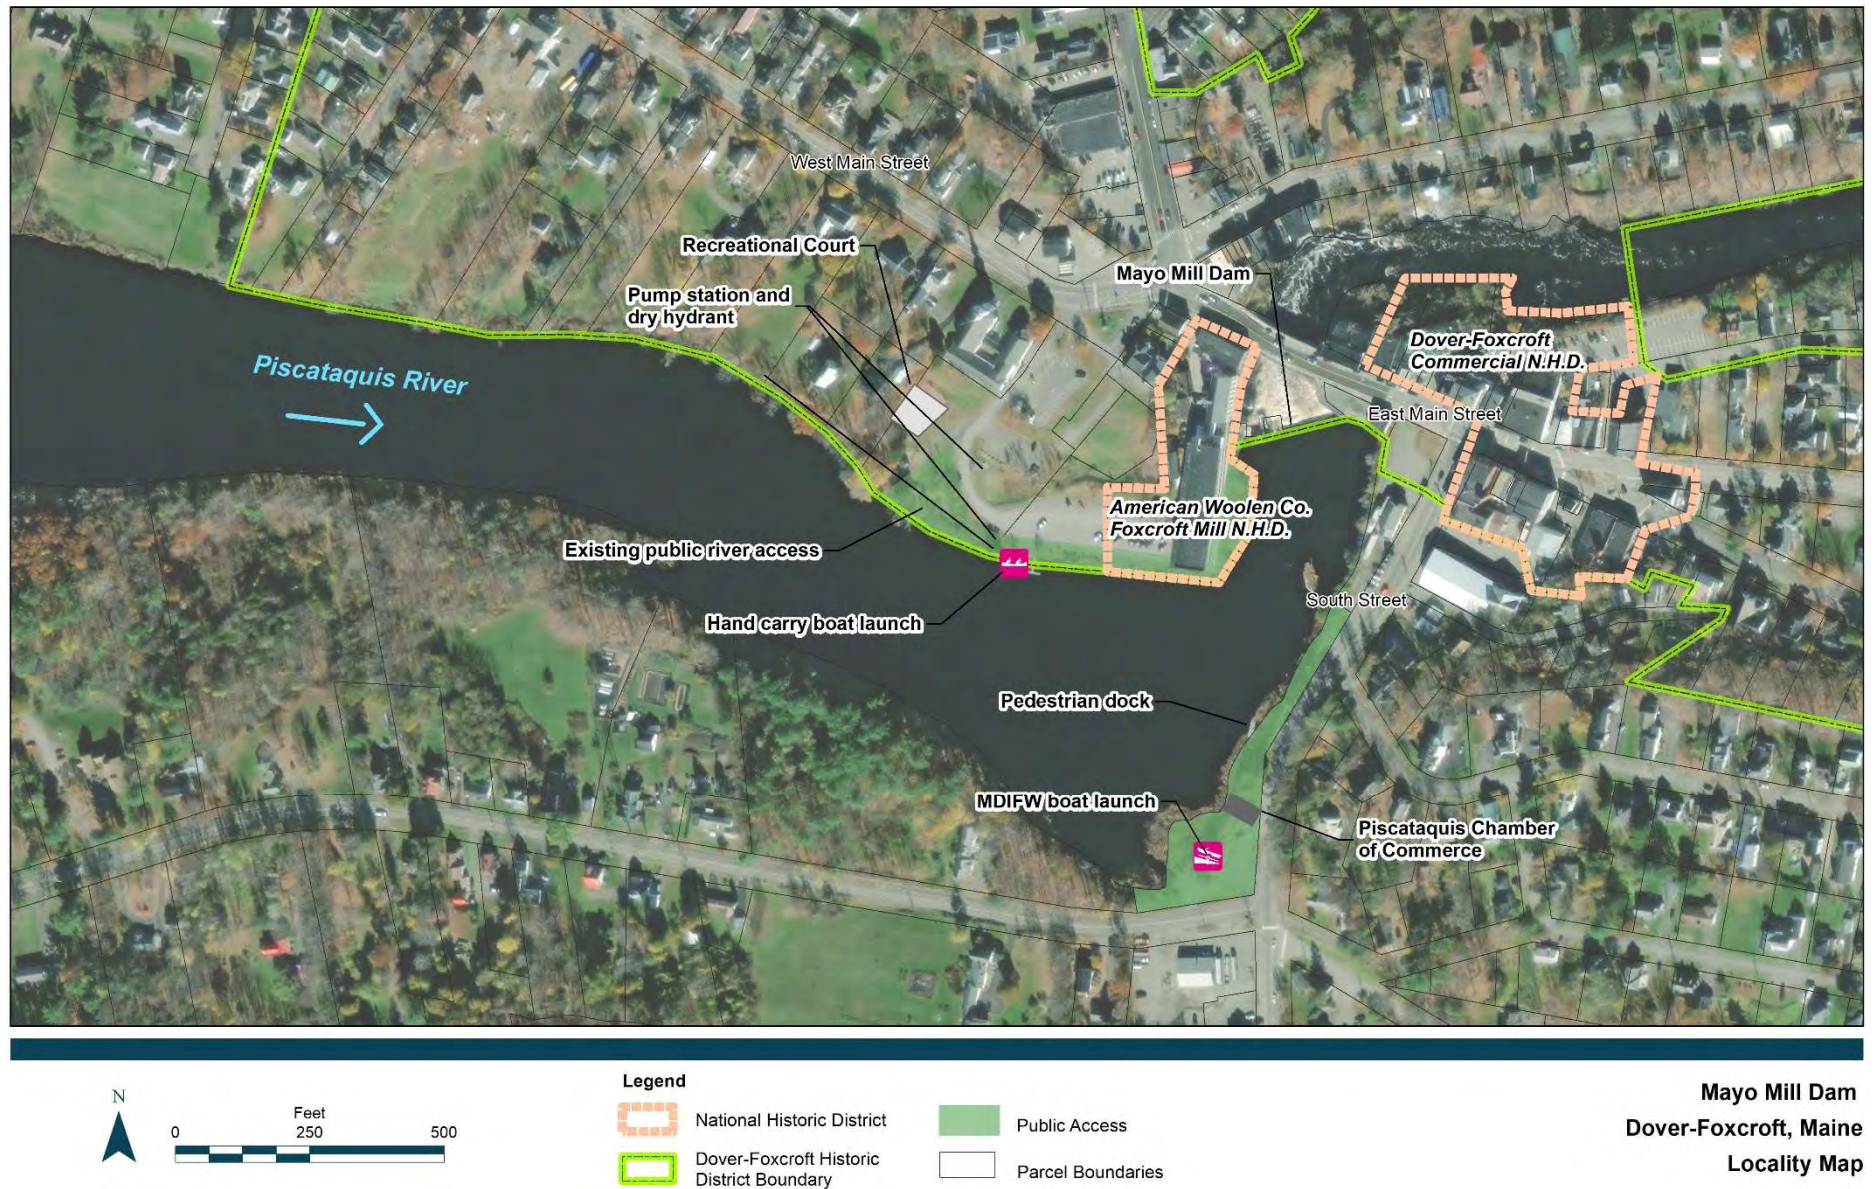
Figure 1. Overview map of Mayo Mill Dam and vicinity.

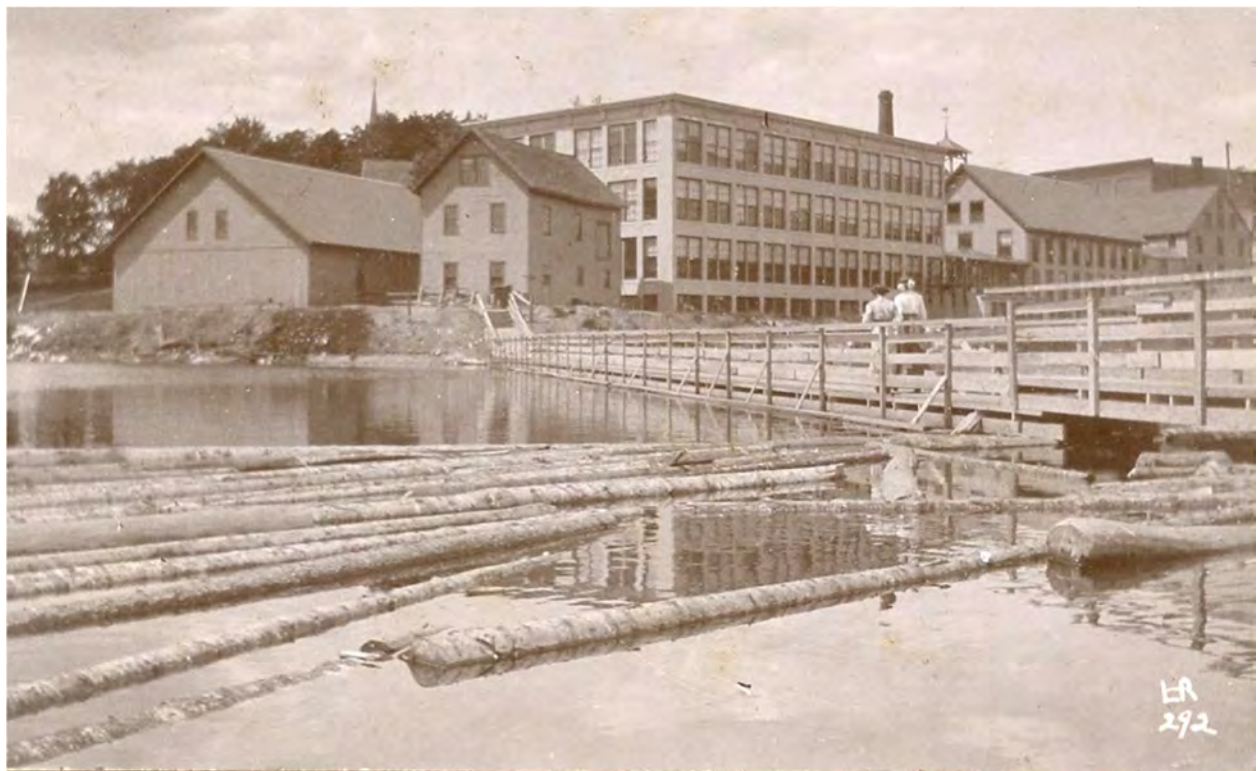
Figure 7. 1911 image showing the floating bridge that was constructed for pedestrians while the Main Street bridge was being replaced. Source: Dover-Foxcroft Historical Society.

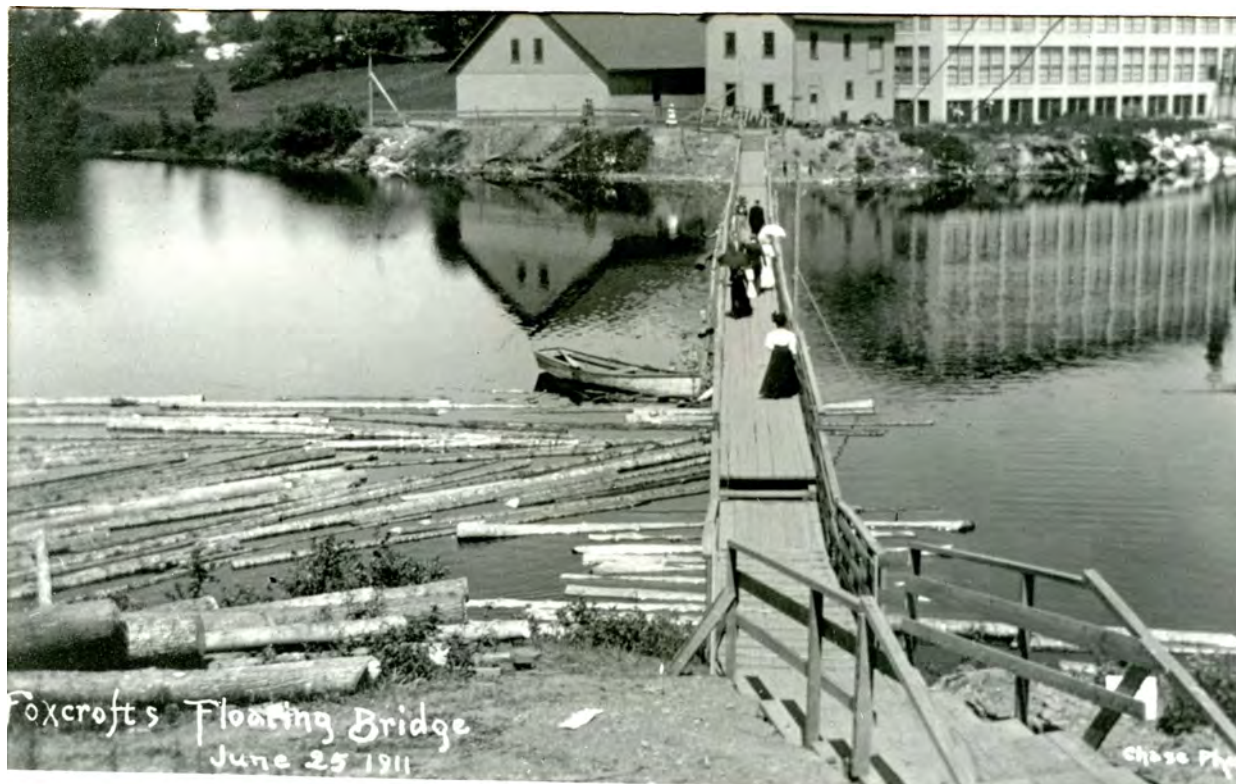
Figure 8. 1911 image showing the floating bridge that was constructed for pedestrians while the Main Street bridge was being replaced. Source: Dover-Foxcroft Historical Society.

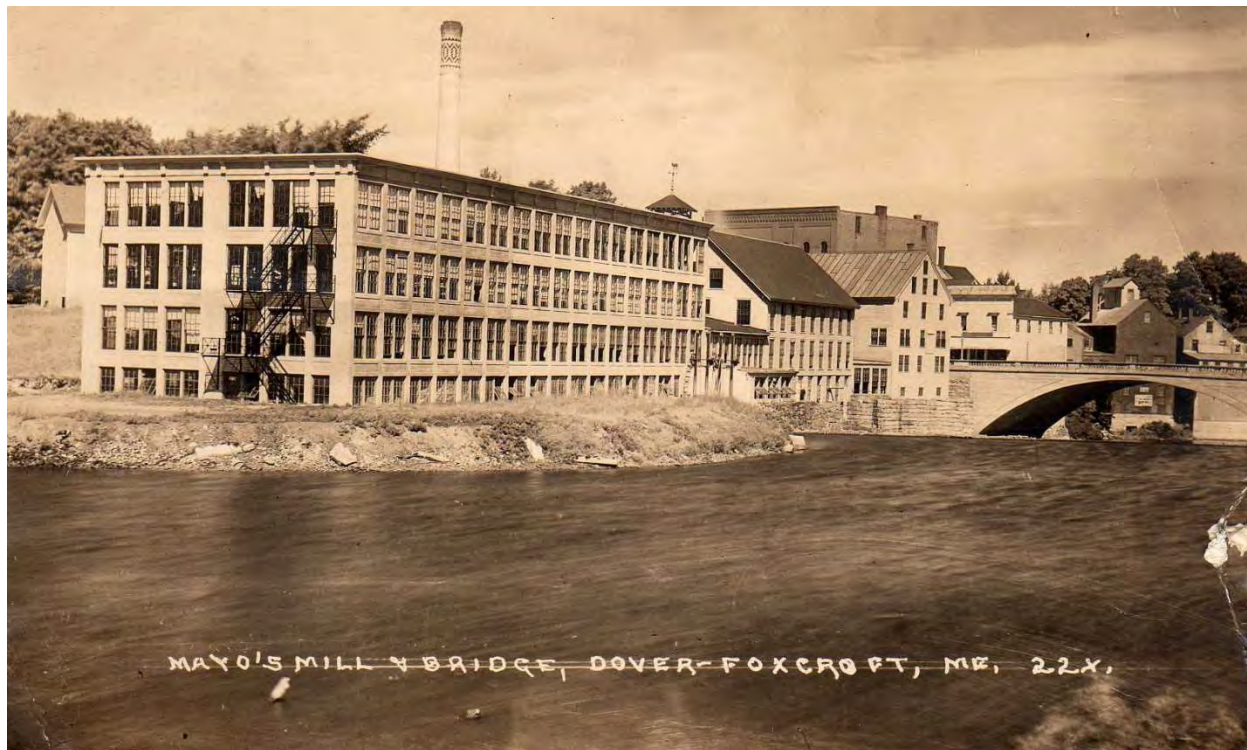
Figure 9. 1918/19-era image showing the 1916 addition to the concrete mill building. The concrete dam had not yet been constructed in this photo. Source: Dover-Foxcroft Historical Society.

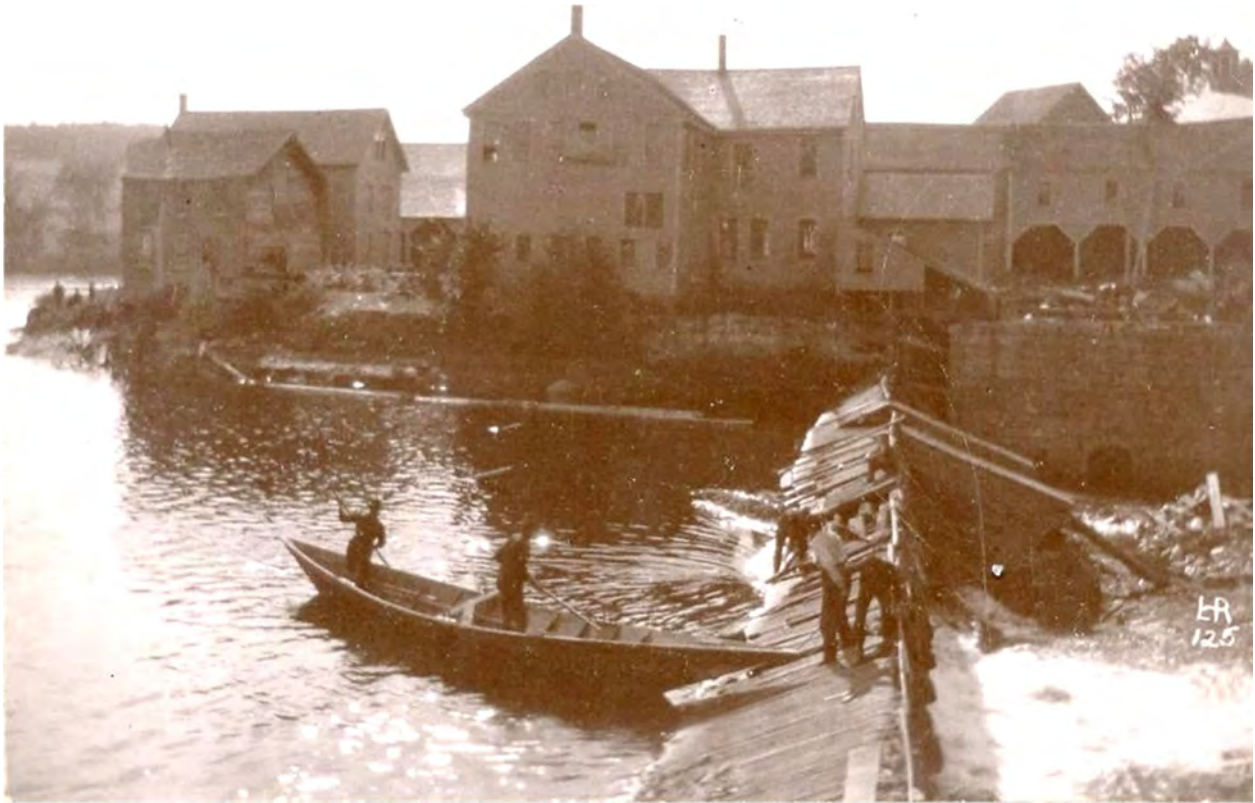
Figure 14. Pre-1883 photo showing the wood planking being replaced on the upstream face of the dam. Source: Dover-Foxcroft Historical Society.

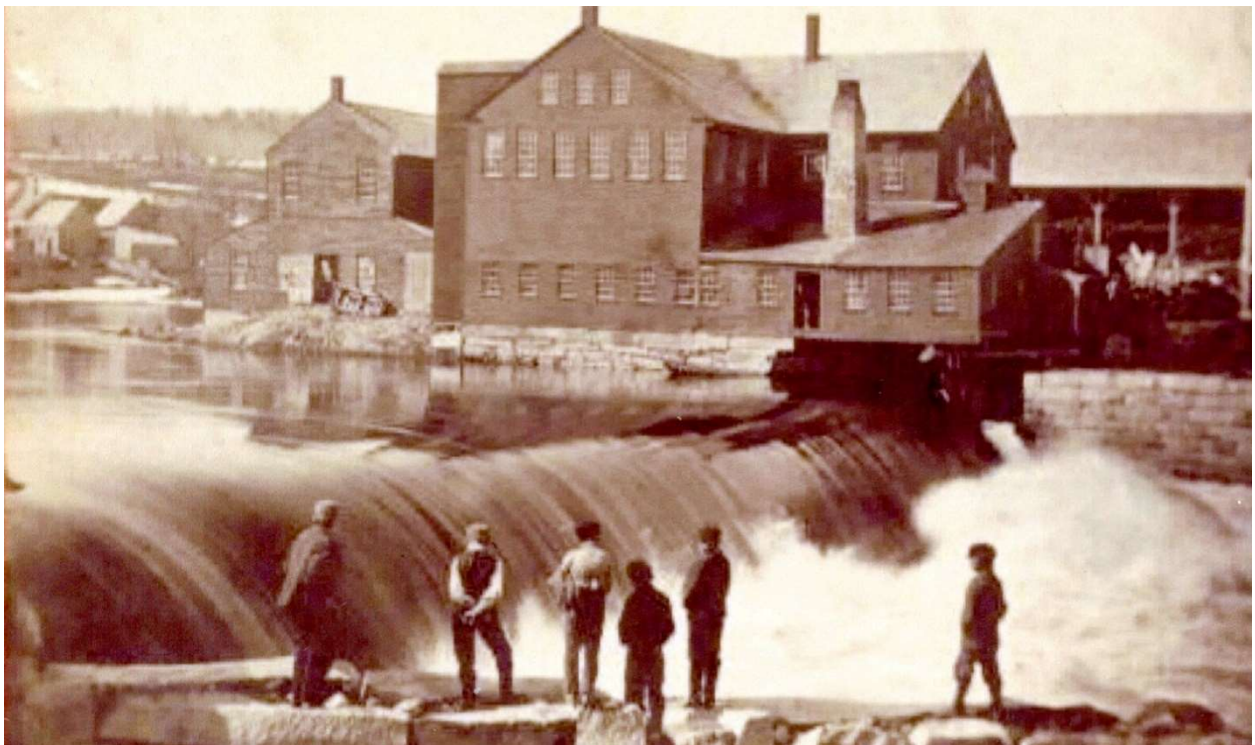
Figure 15. 1870s photo showing high flow over the dam and the foundry which was an early user of the dam. Source: Dover-Foxcroft Historical Society.

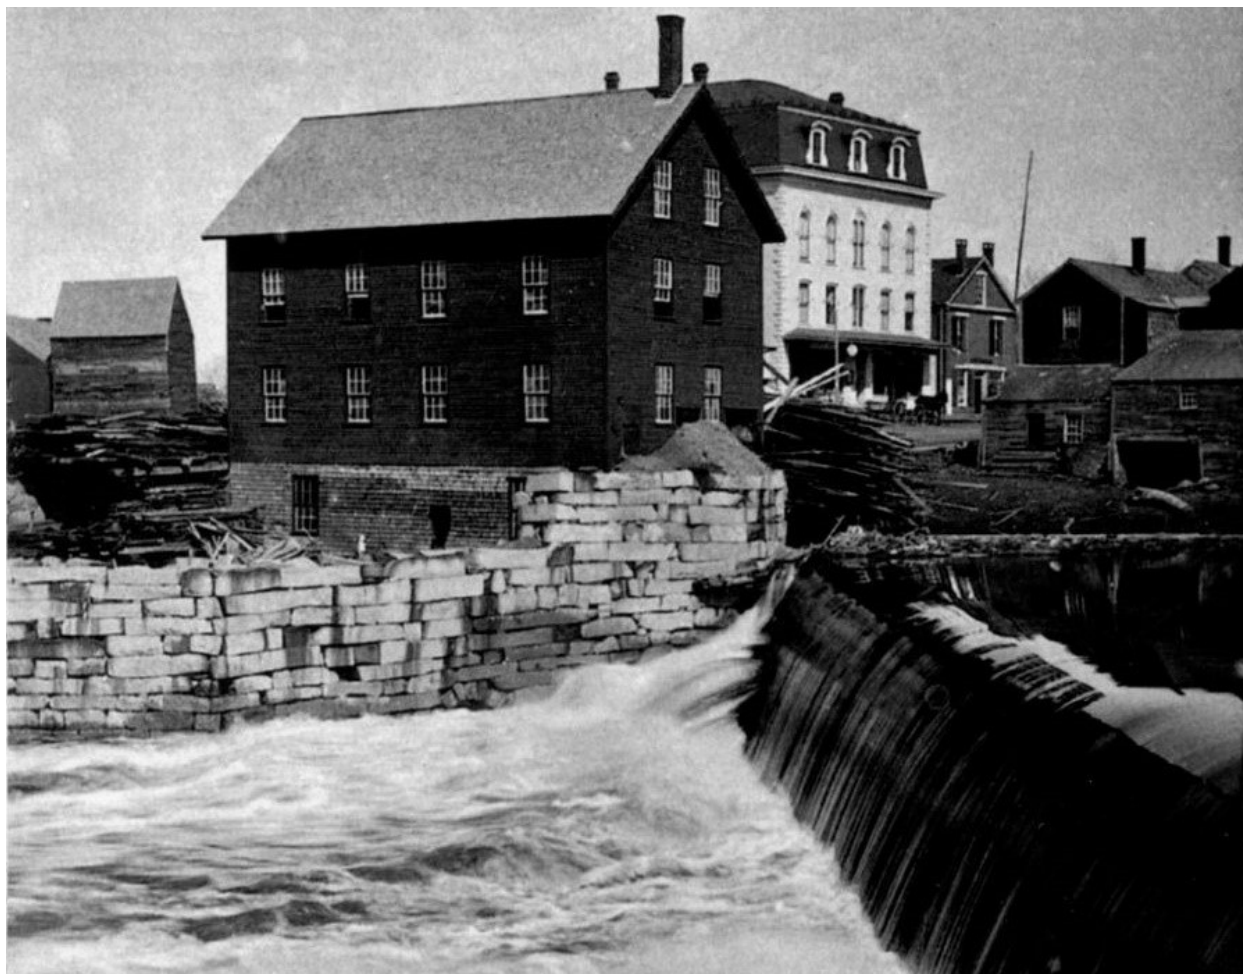
Figure 16. 1800s view of the Dover side of the dam, with the Masonic Hall in the background. Source: Dover-Foxcroft Historical Society.

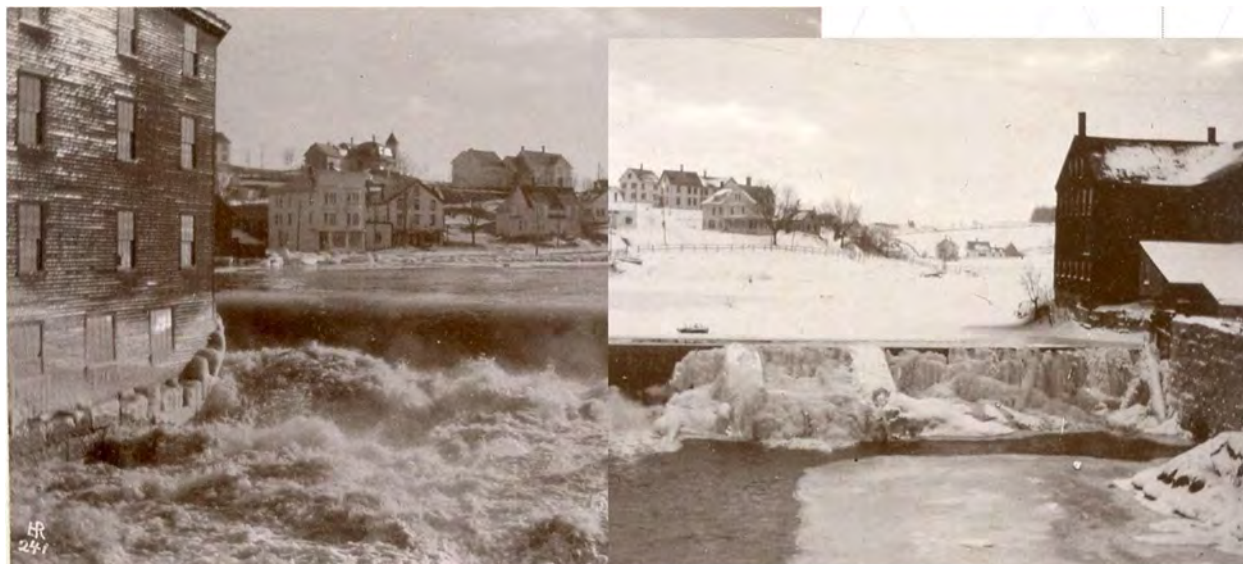
Figure 17. Collage of late 1800s photos showing the dam, mill, foundry and South Street under differing conditions. Source: Dover-Foxcroft Historical Society.

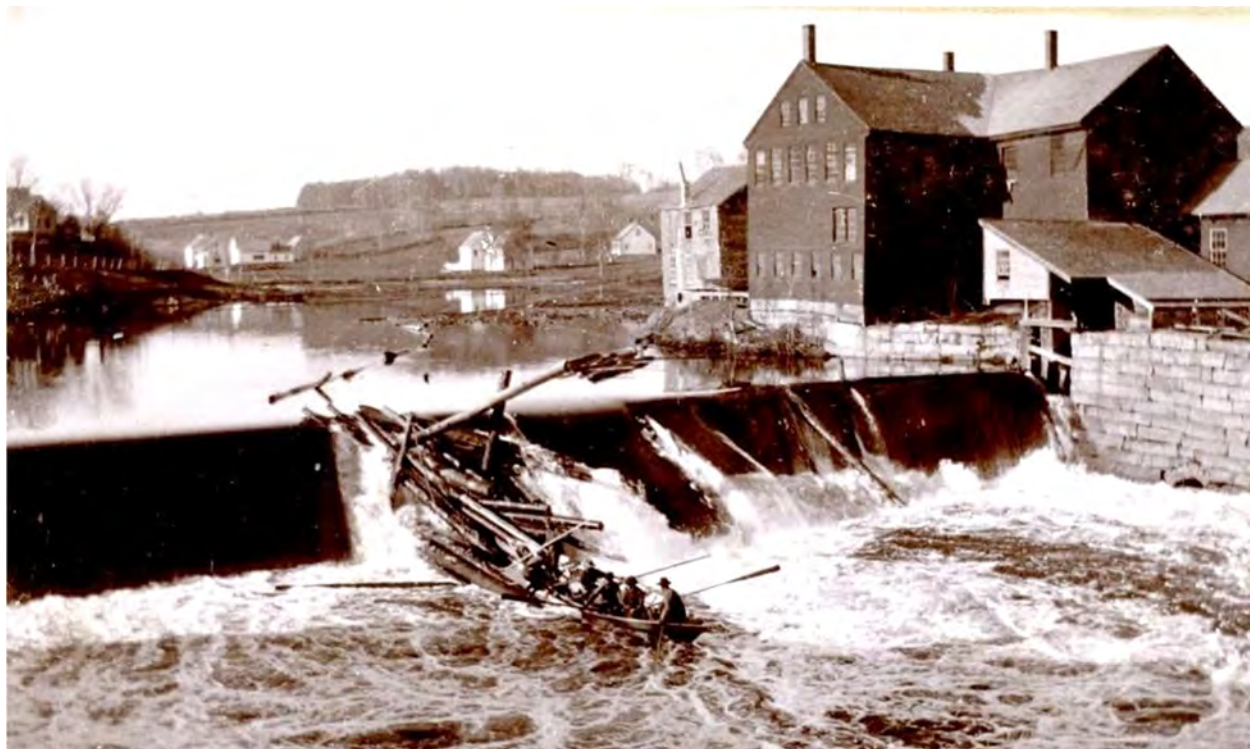
Figure 18. Late 1800s photo showing tangled logs being extracted from the log sluice. Source: Dover-Foxcroft Historical Society.

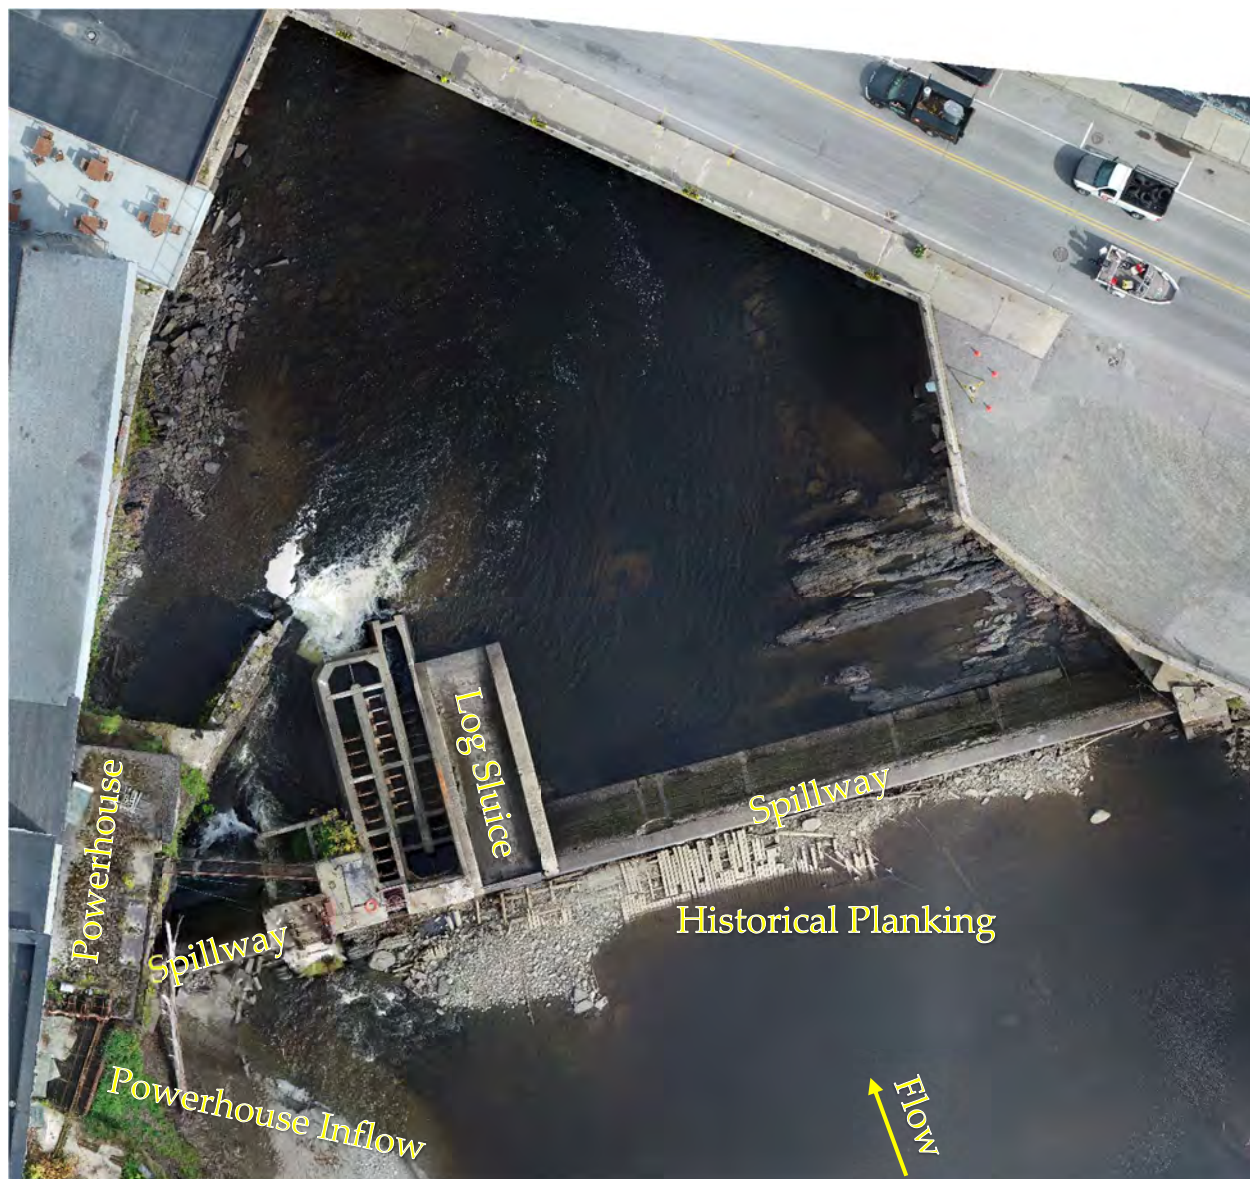
Figure 26. September 2019 aerial photo during drawdown showing features of the dam. Source: Webber Surveying.

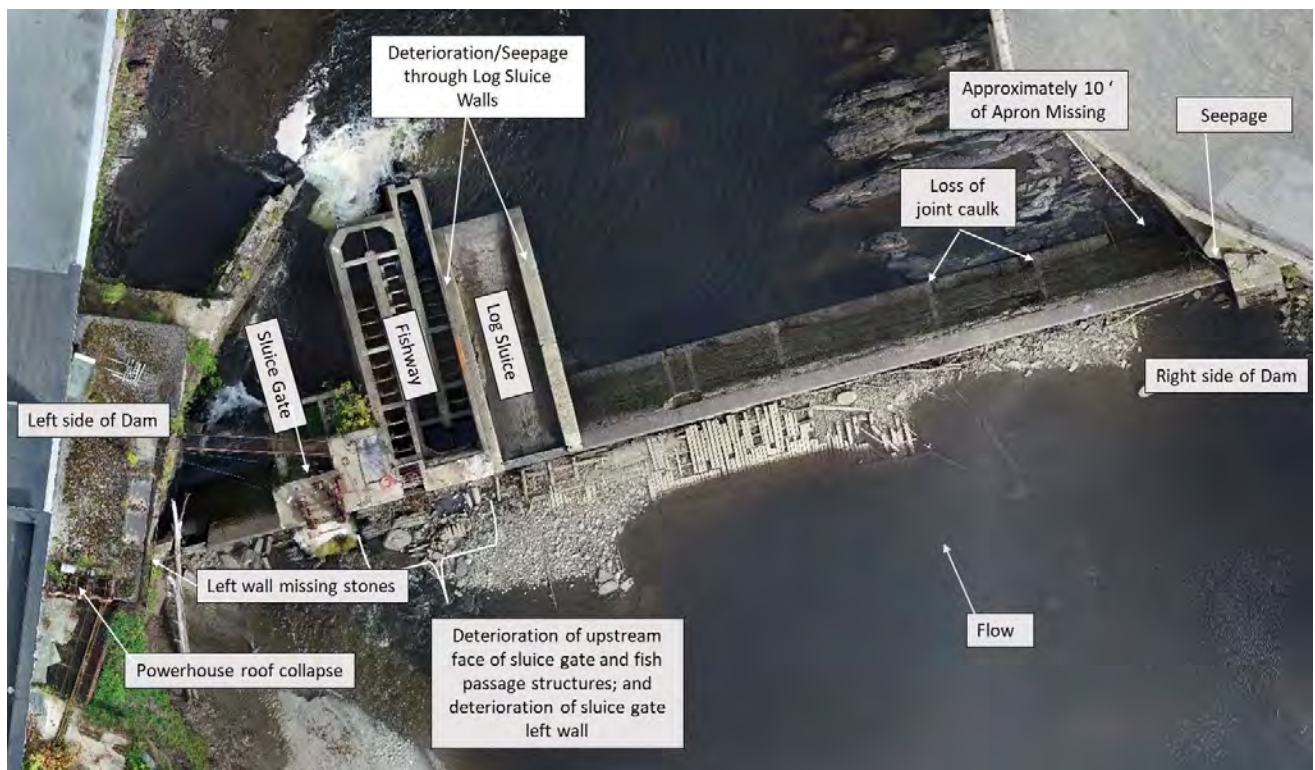
Figure 27. Aerial Image of Dam with Deficiencies Labeled (from Gomez and Sullivan, 2023).

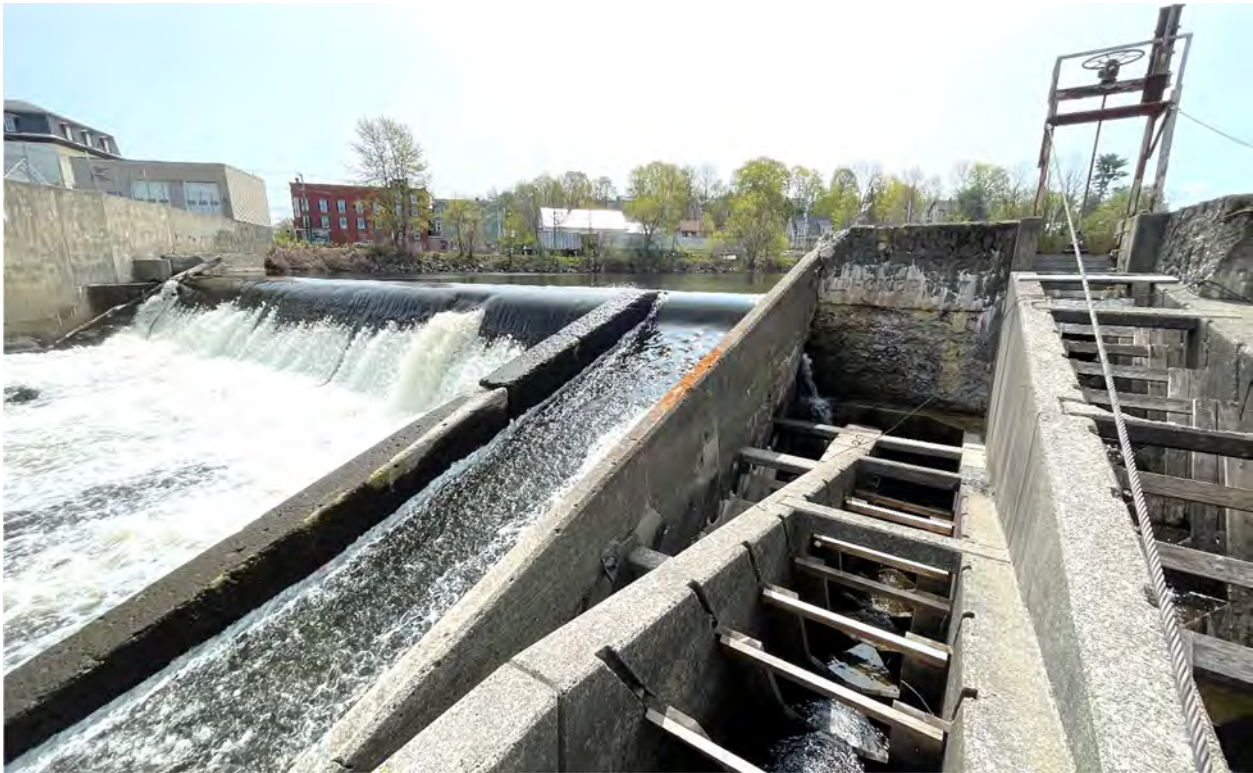
Figure 28. May 2023 photo showing condition of spillways and fishway prior to being opened for the year, including leakage at the base of the log sluice into the fishway.

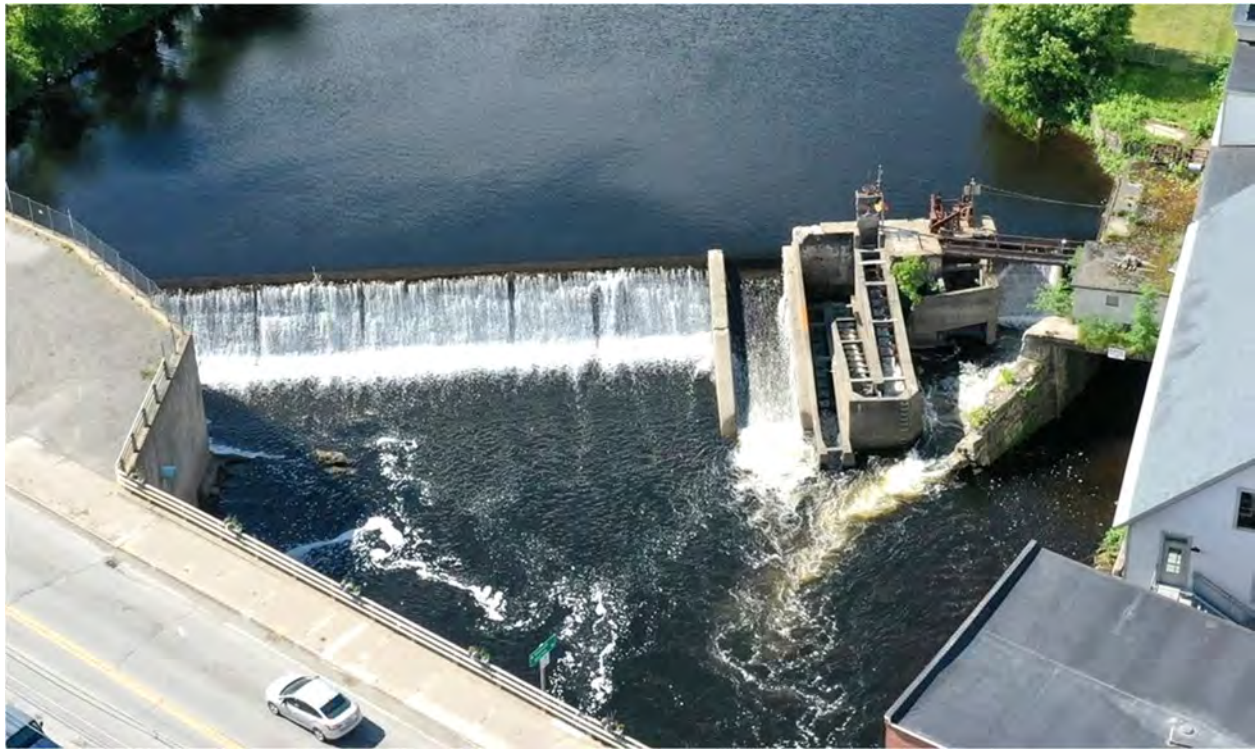
Figure 29. June 2022 aerial photo showing flow patterns over spillways and log sluice, in relation to fishway entrance.

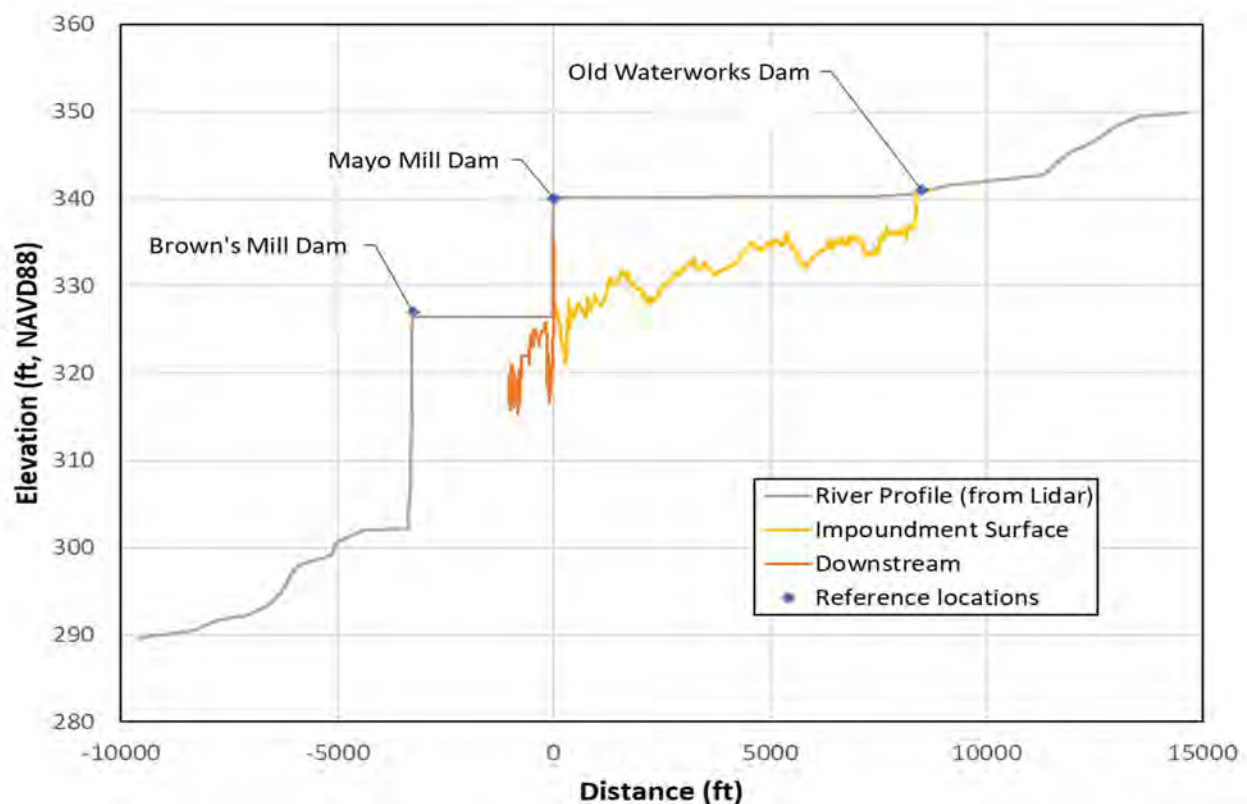
Figure 30. Lidar elevation profile of the Piscataquis River through the project area, with bathymetry surface shown where surveyed. Selected points and their elevations are noted.

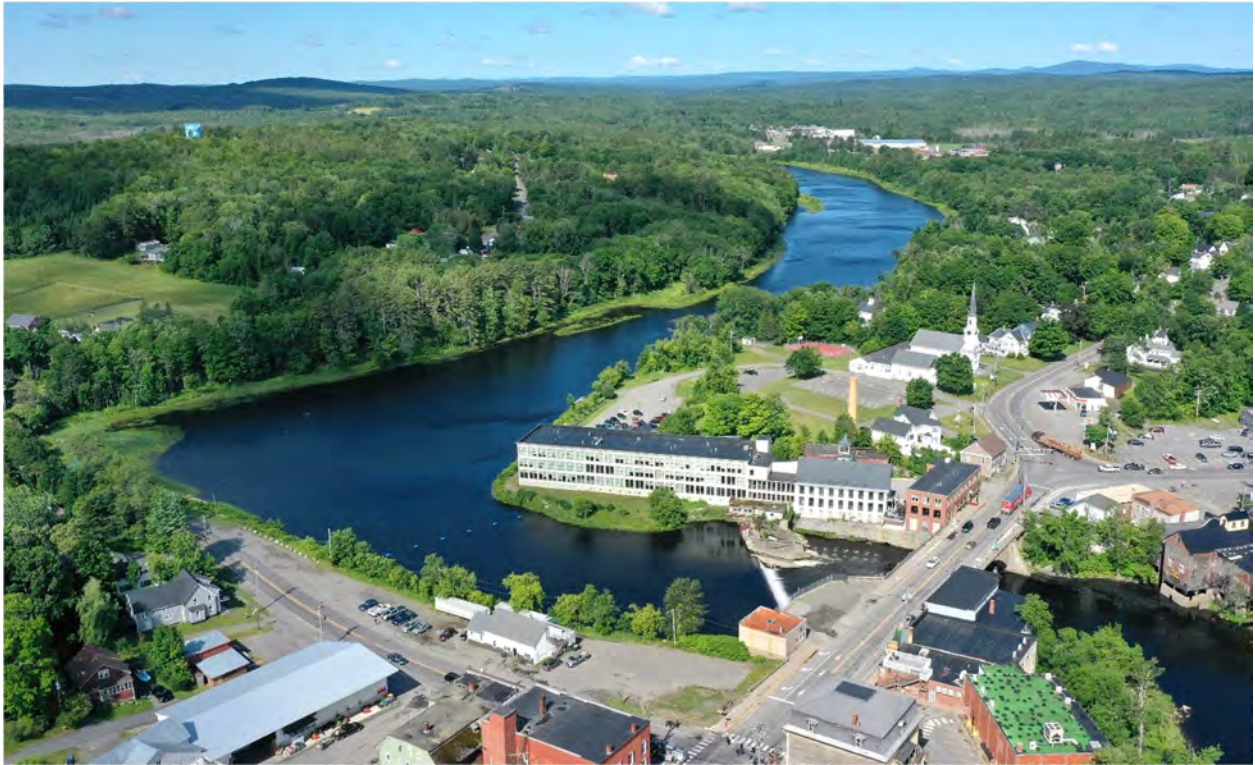
Figure 31. June 2022 view looking upstream at Mayo Mill Dam and impoundment.

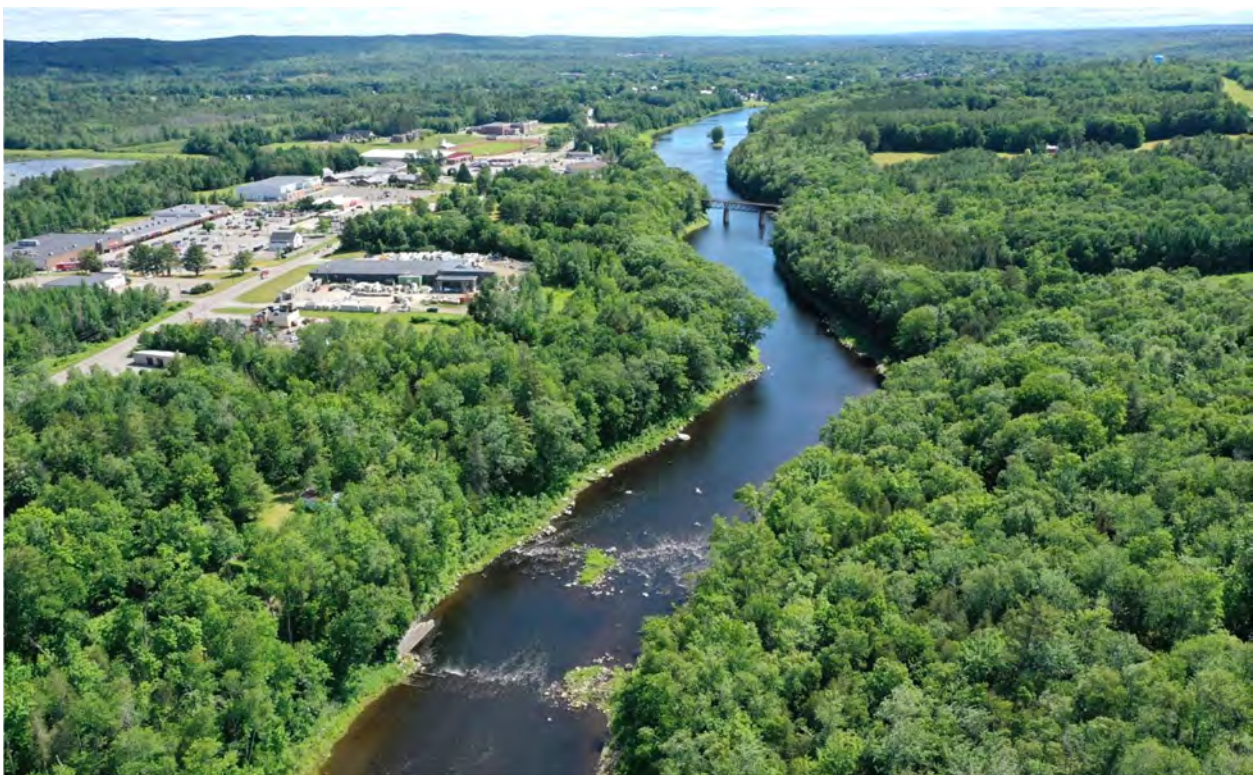
Figure 32. June 2022 view looking downstream at Waterworks Dam location and the upper Mayo Mill Dam impoundment.

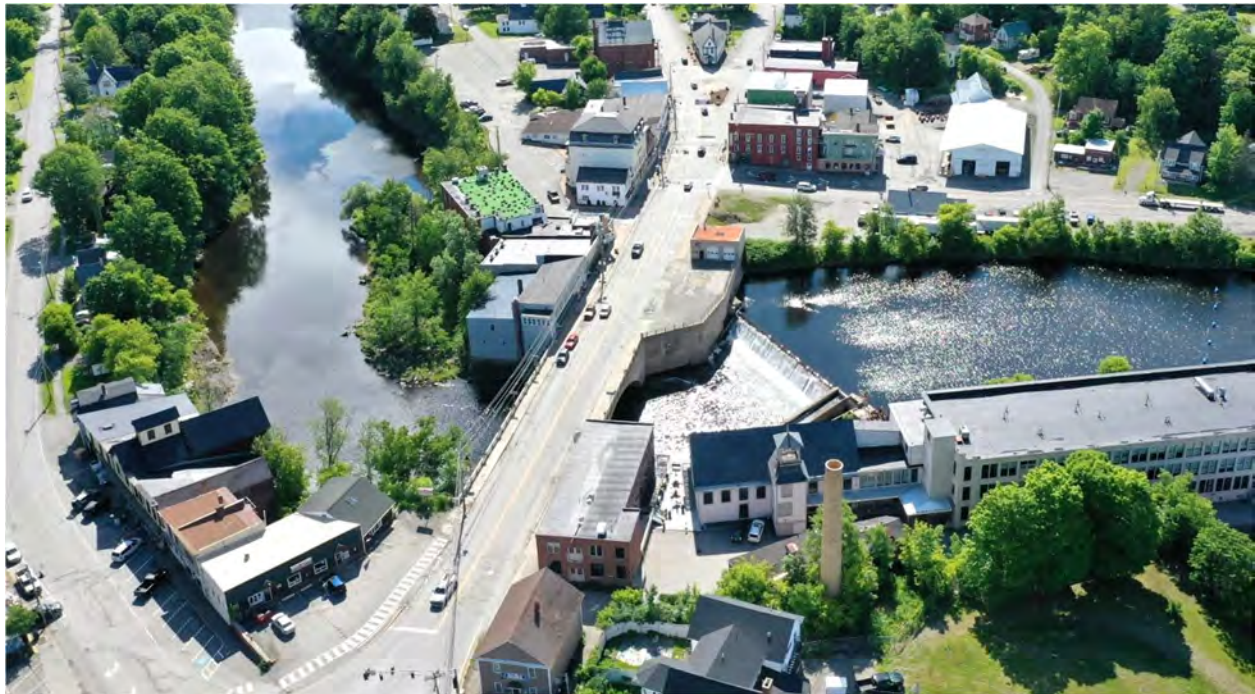
Figure 33. June 2022 view looking downstream at short segment of free-flowing river downstream of Mayo Mill Dam before flowing into Brown’s Mill Dam impoundment.

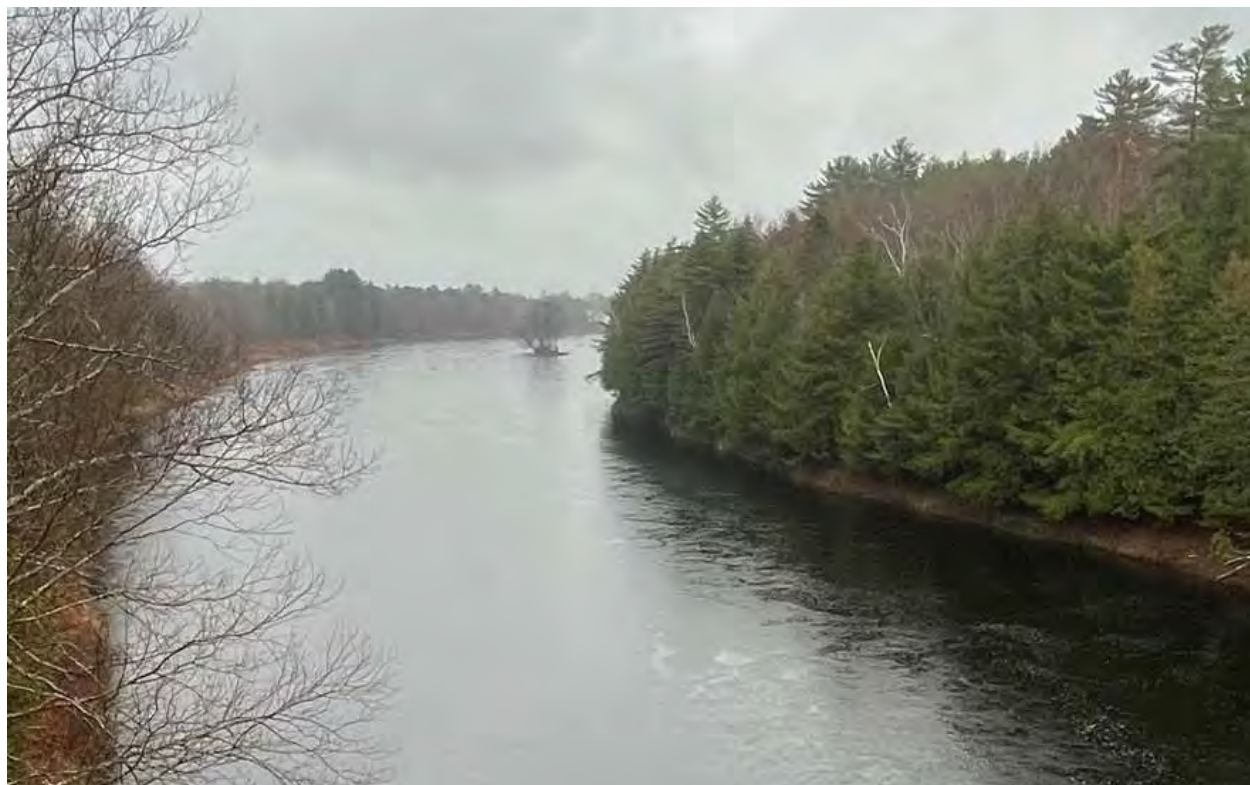
Figure 36. April 2023 view looking downstream towards Foxcroft Academy from the former railroad bridge (now the Four Seasons Adventure Trail). Academy Island is seen in the center of the frame.

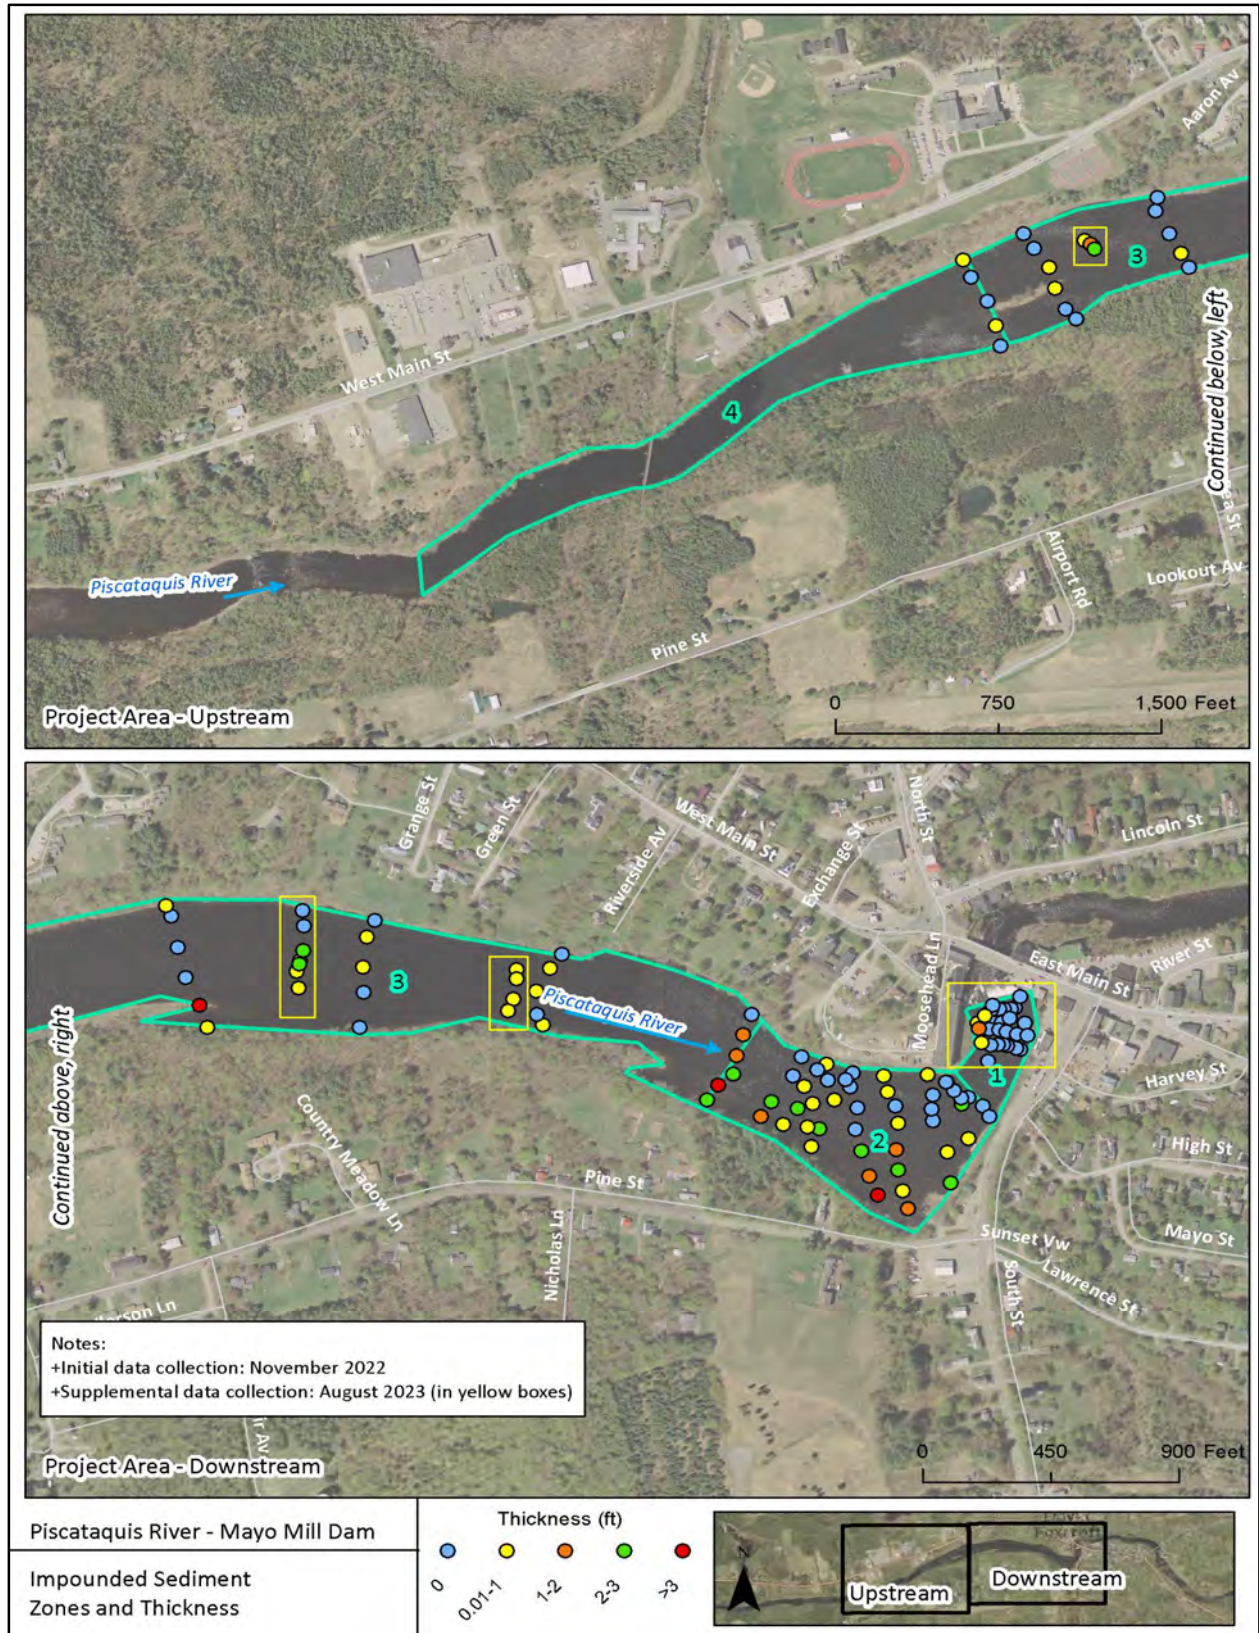
Figure 46. Sediment zones in the impoundment, with accumulated sediment thickness measurements indicated.

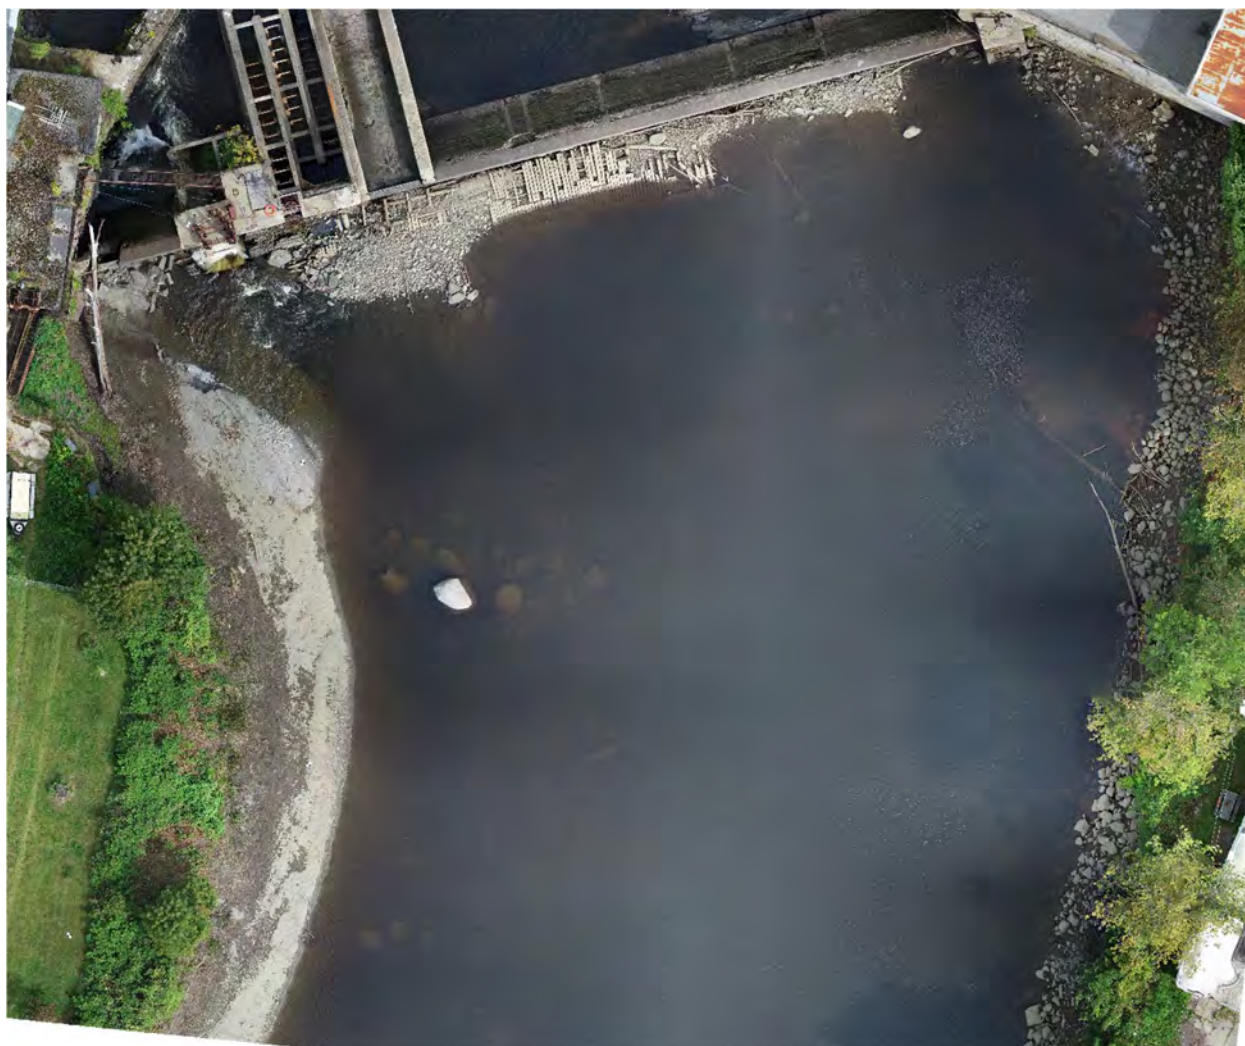
Figure 47. September 2019 aerial photo during drawdown showing sediment conditions in Zone 1. Source: Webber Surveying.
