Mayo Mill Dam Feasibility Study Baseline Conditions Report Piscataquis River Dover-Foxcroft, ME

October 2023

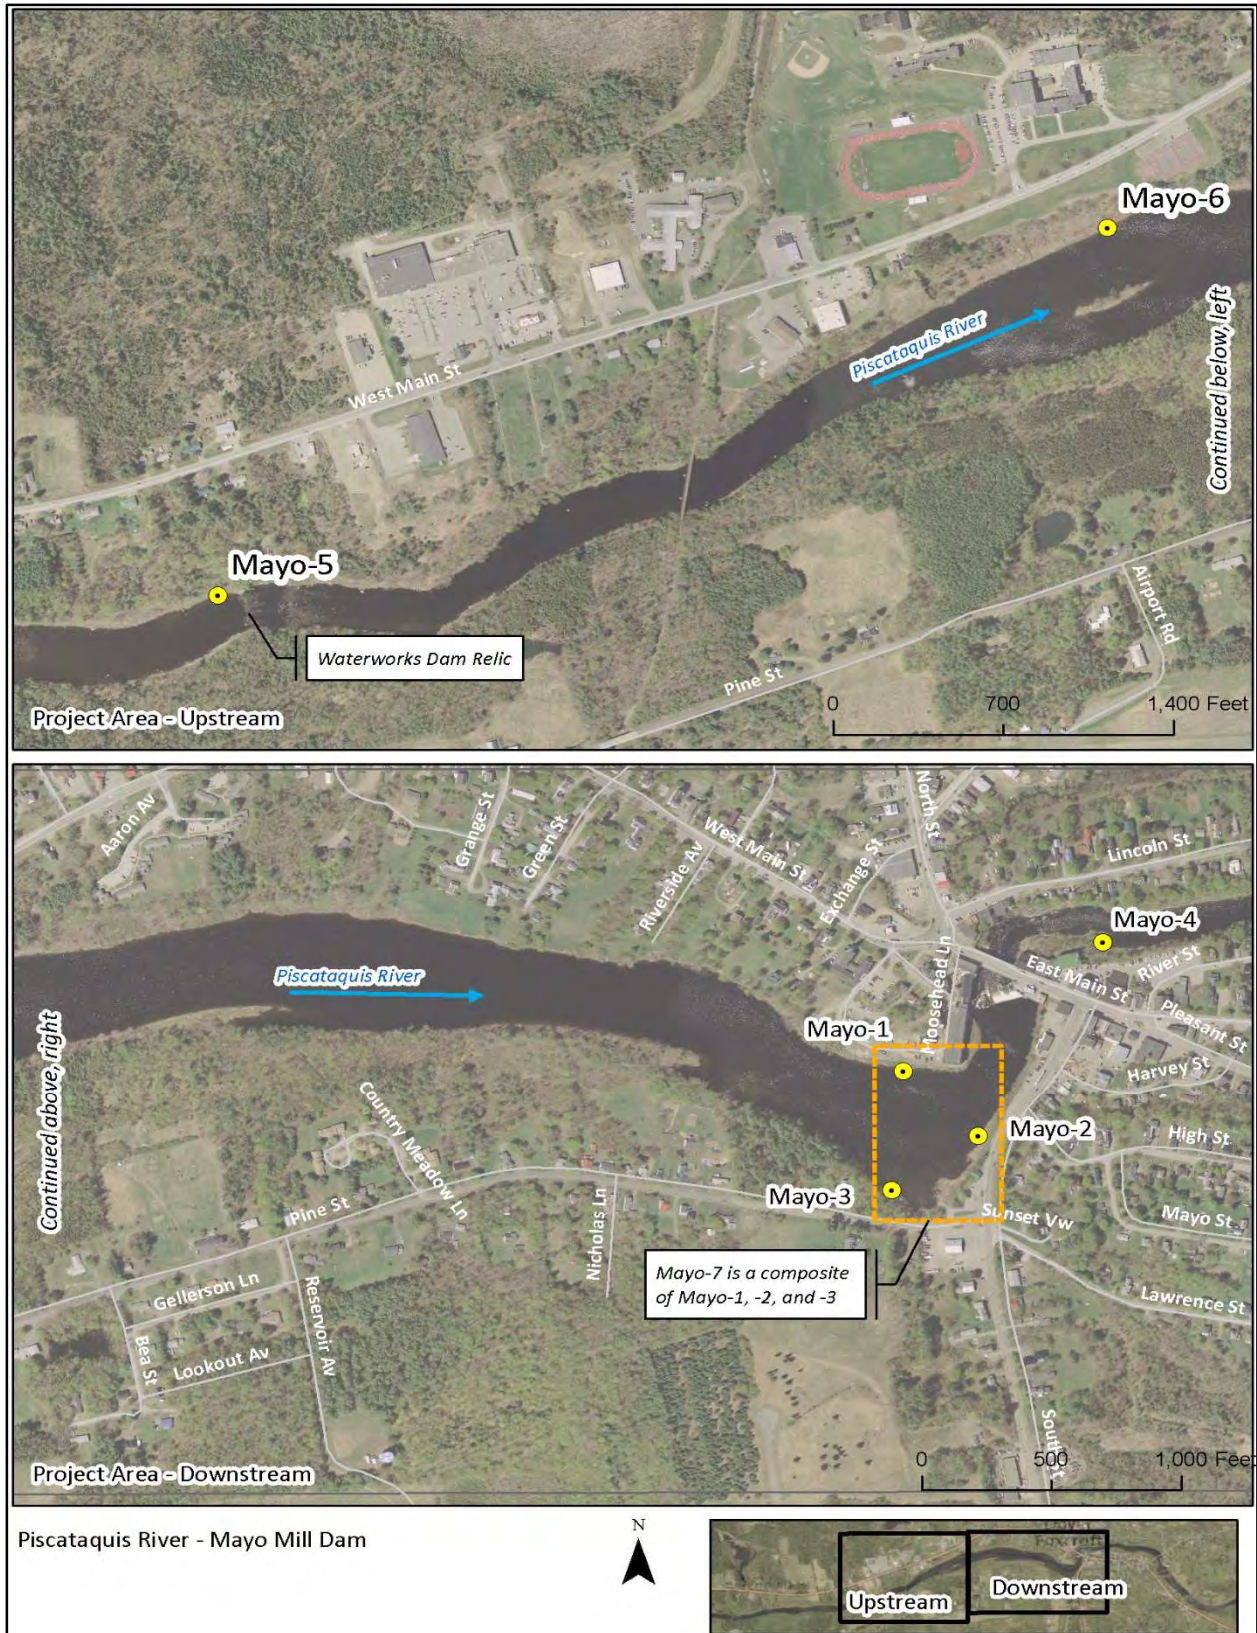
Figure 48. Overview of sediment sample locations. Mayo-4 is a background sample from the free-flowing reach downstream of the dam. Mayo-5 is a background sample from the free-flowing reach upstream of the impoundment.

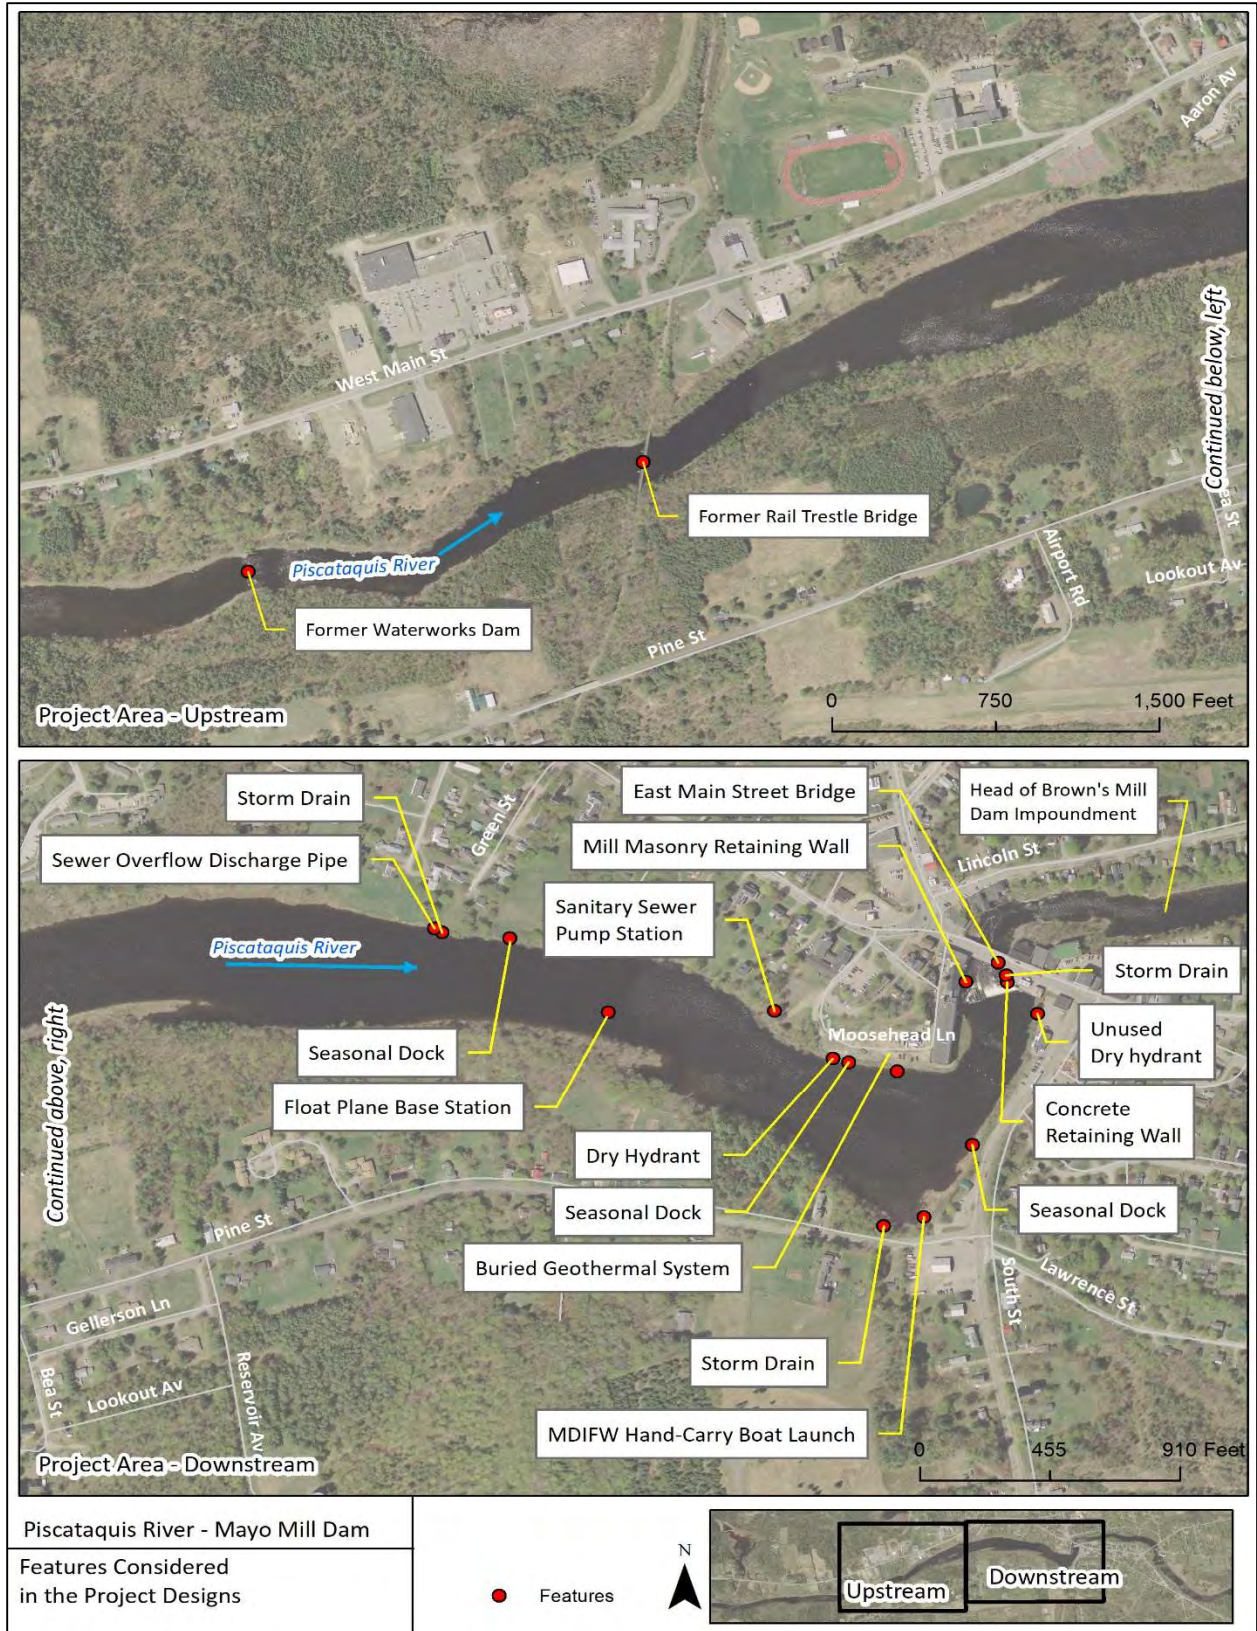
Figure 49. Locations of adjacent features and low-lying infrastructure.

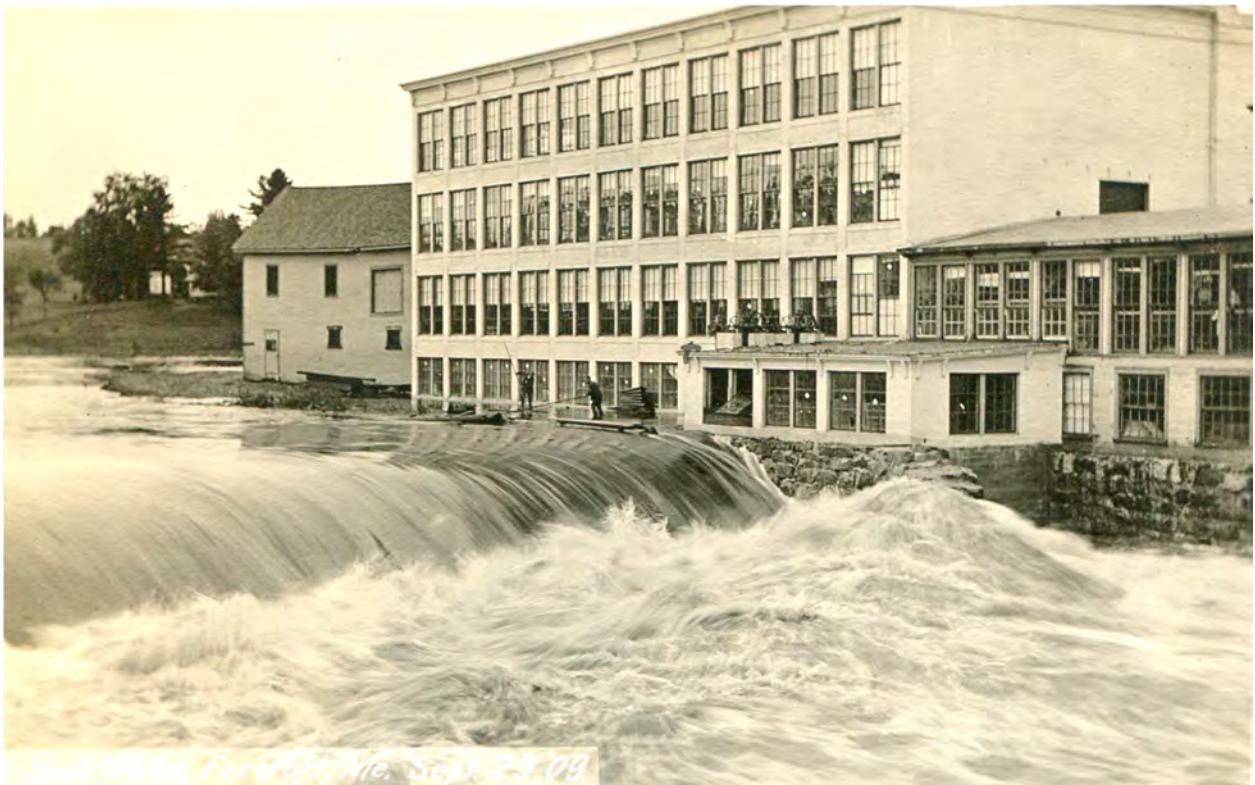
Figure 53. Flood conditions during the 1909 flood, estimated at between a 5- and 10-year peak flood event. Photo courtesy of Dover-Foxcroft Historical Society.

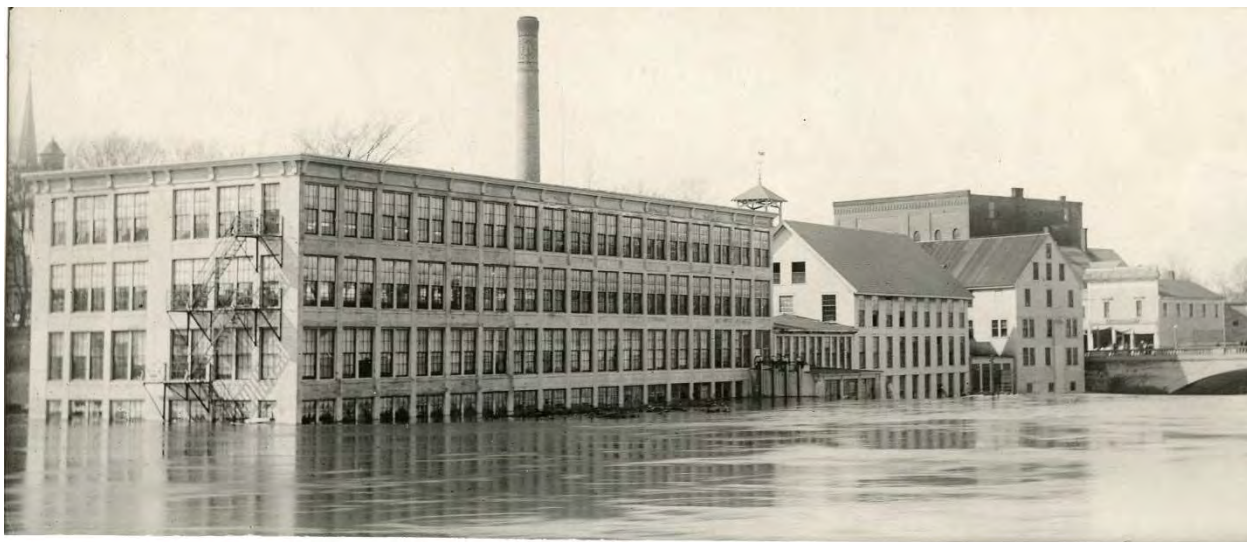
Figure 54. Flood conditions during the 1936 flood, estimated as an approximate 10-year peak flood event. Photo courtesy of Dover-Foxcroft Historical Society.

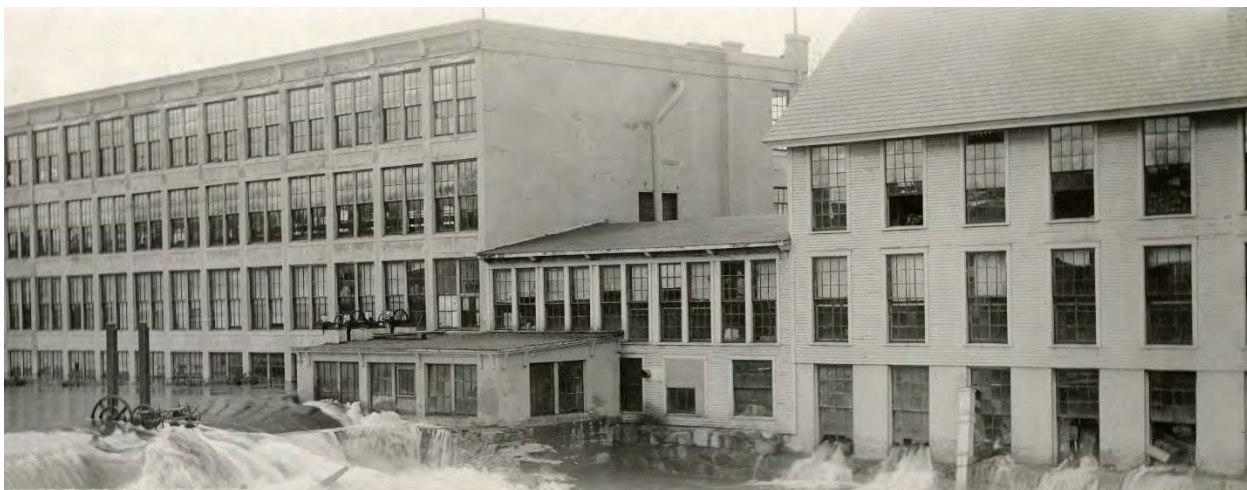
Figure 55. Flood conditions during the 1936 flood, estimated as an approximate 10-year peak flood event. Photo courtesy of Dover-Foxcroft Historical Society.

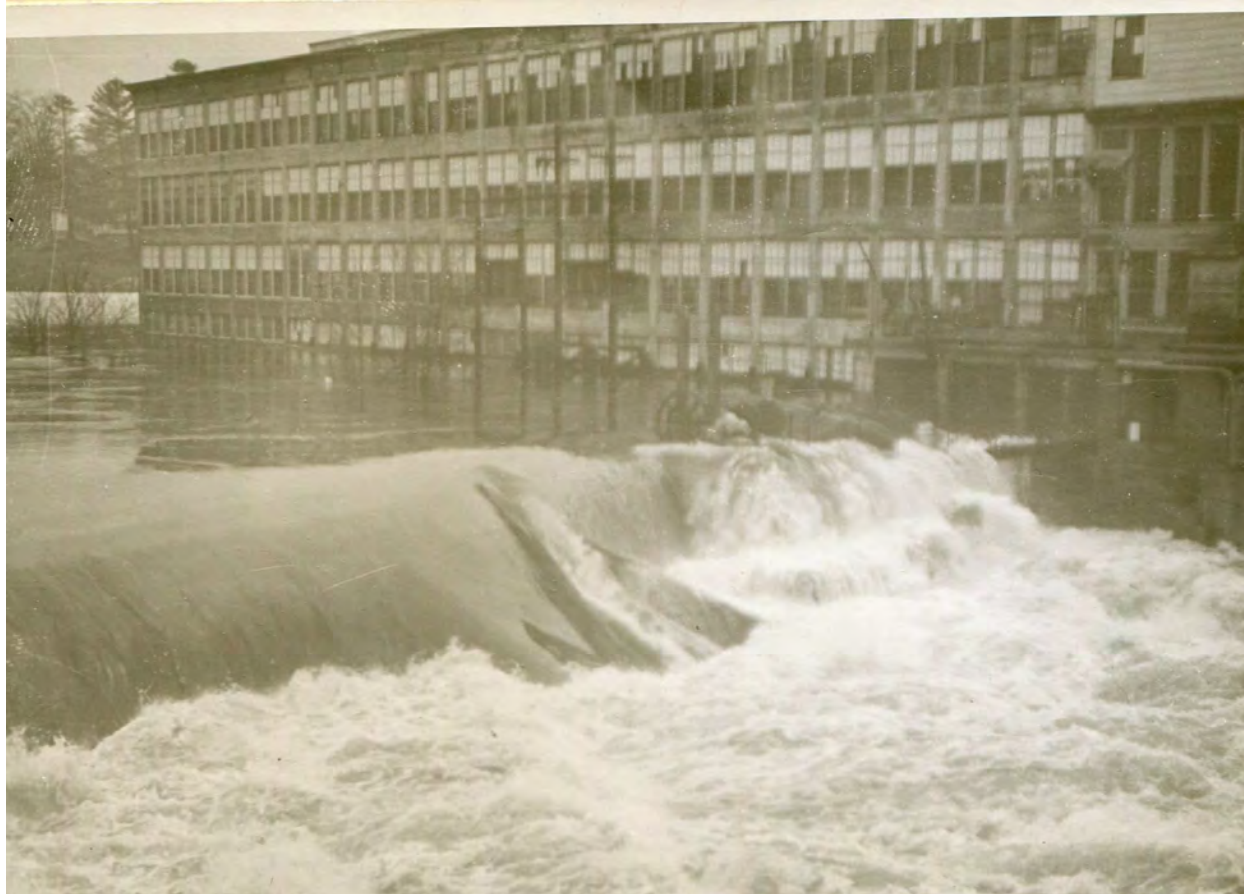
Figure 56. Flood conditions during the 1950 flood, estimated at between a 5- and 10-year peak flood event. Photo courtesy of Dover-Foxcroft Historical Society.

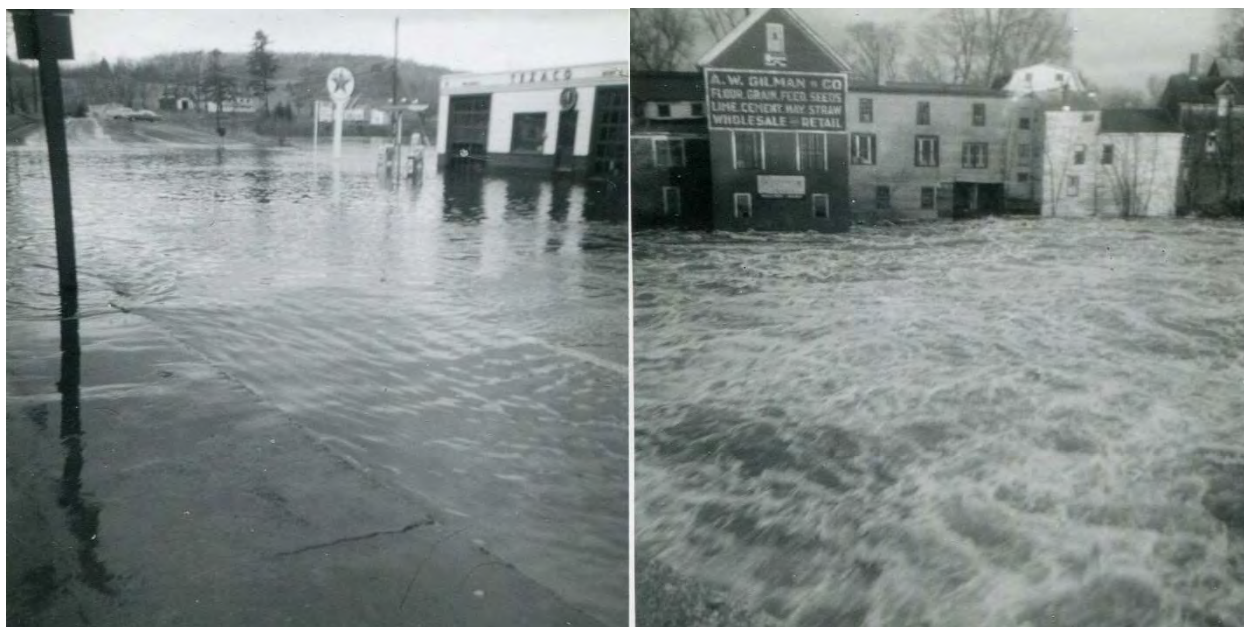
Figure 57. Flood conditions along South Street (left) and downstream of the Main Street bridge (right) during the 1966 flood, an approximate 20-year peak flood event. Photos courtesy of Dover-Foxcroft Historical Society.

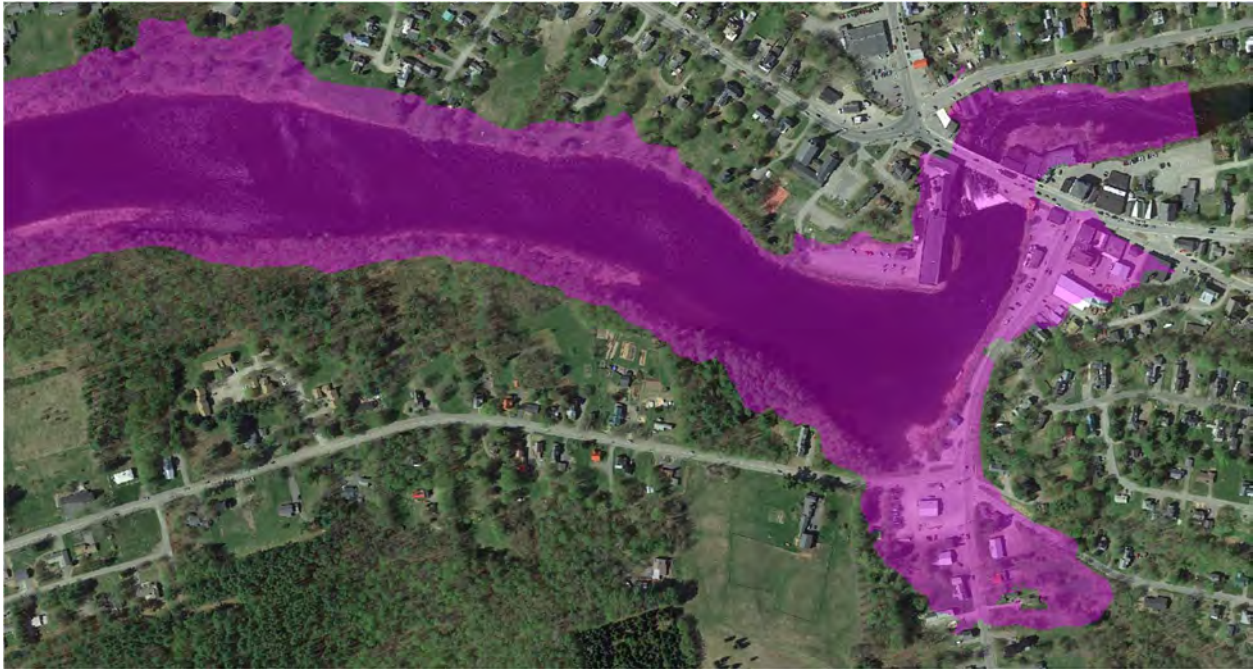
Figure 58. Simulated flood extent during the 1987 flood, estimated as an approximate 200-year peak flood event.

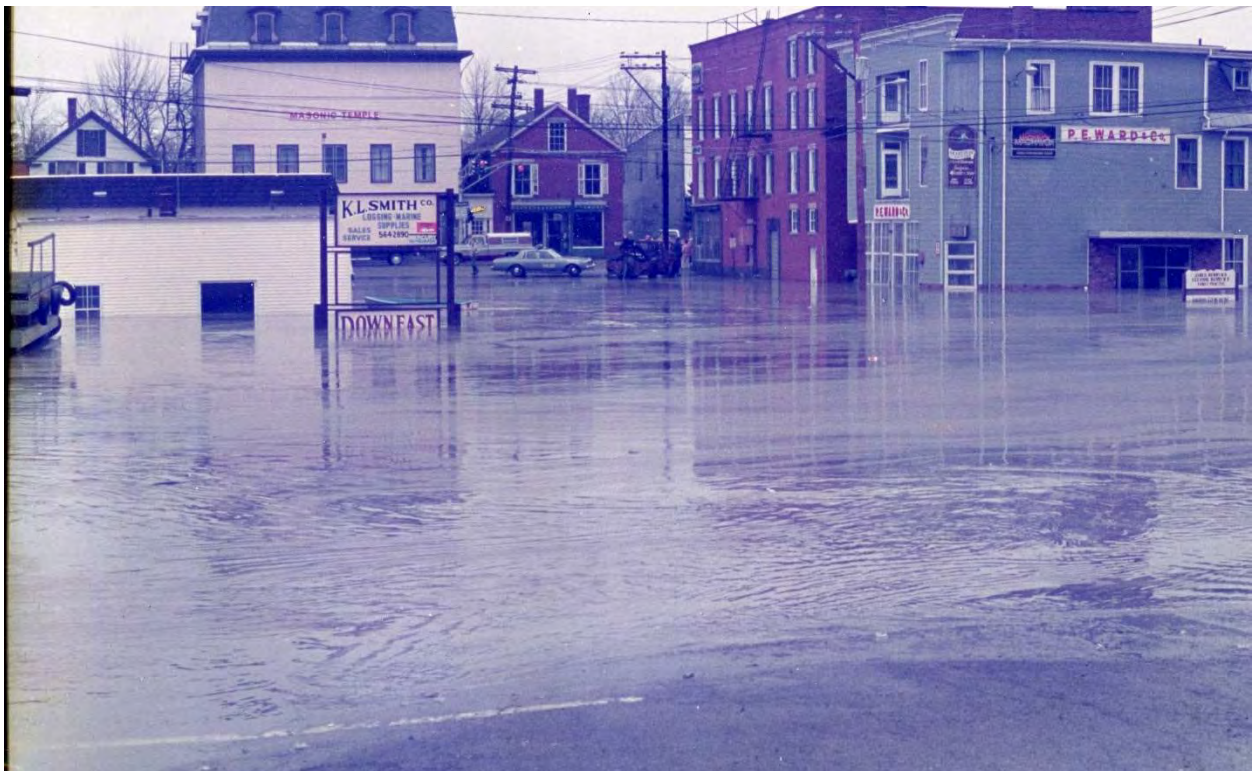
Figure 59. Flood conditions along South Street during the 1987 flood, an approximate 200-year peak flood event. Photo courtesy of Dover-Foxcroft Historical Society.

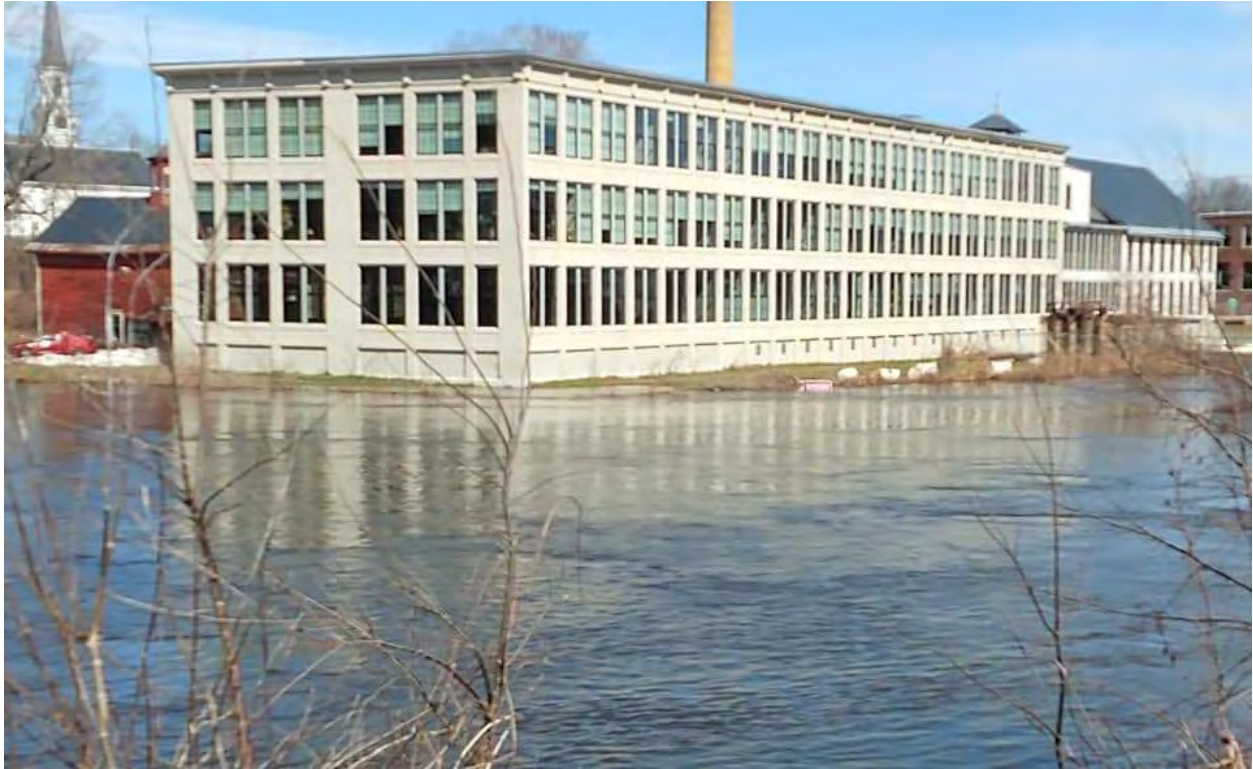
Figure 60. Flood conditions April 14, 2020, estimated as an approximate 3-year peak flood event. Photo courtesy Piscataquis County Emergency Management Agency.

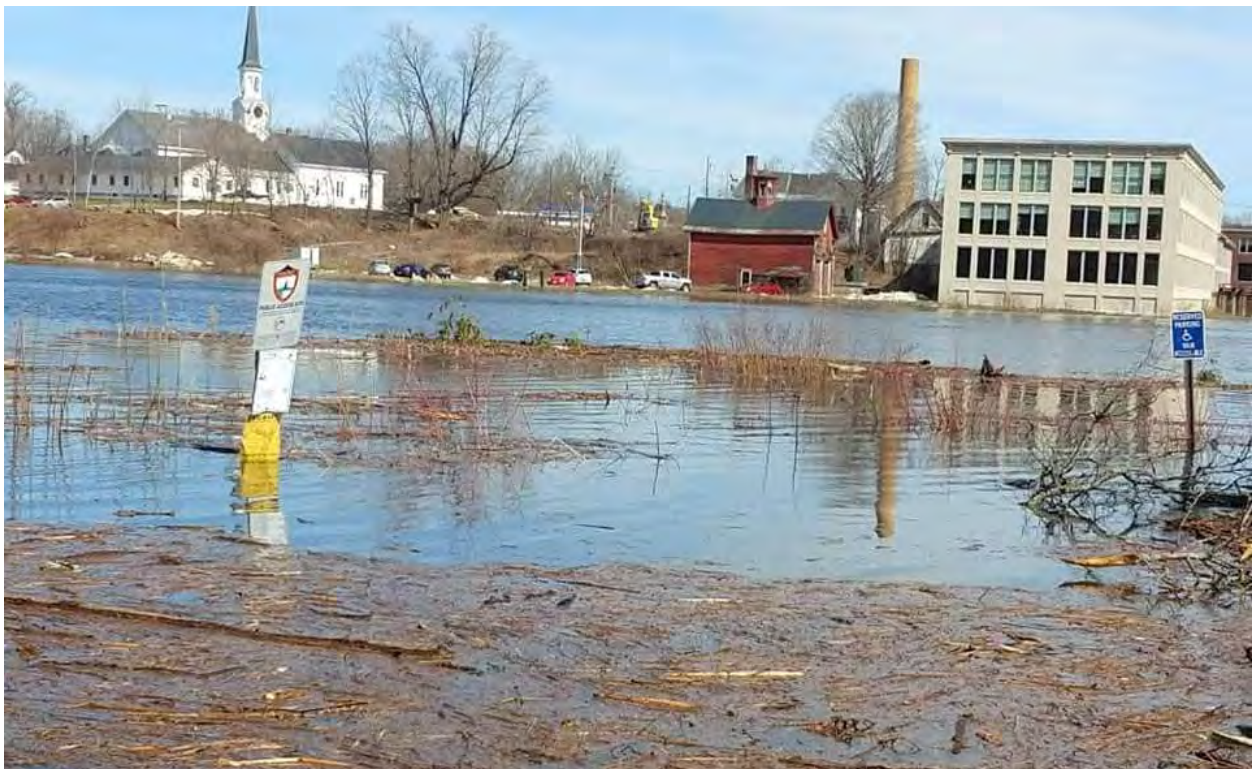
Figure 61. Flood conditions April 14, 2020, estimated as an approximate 3-year peak flood event. Photo courtesy Piscataquis County Emergency Management Agency.

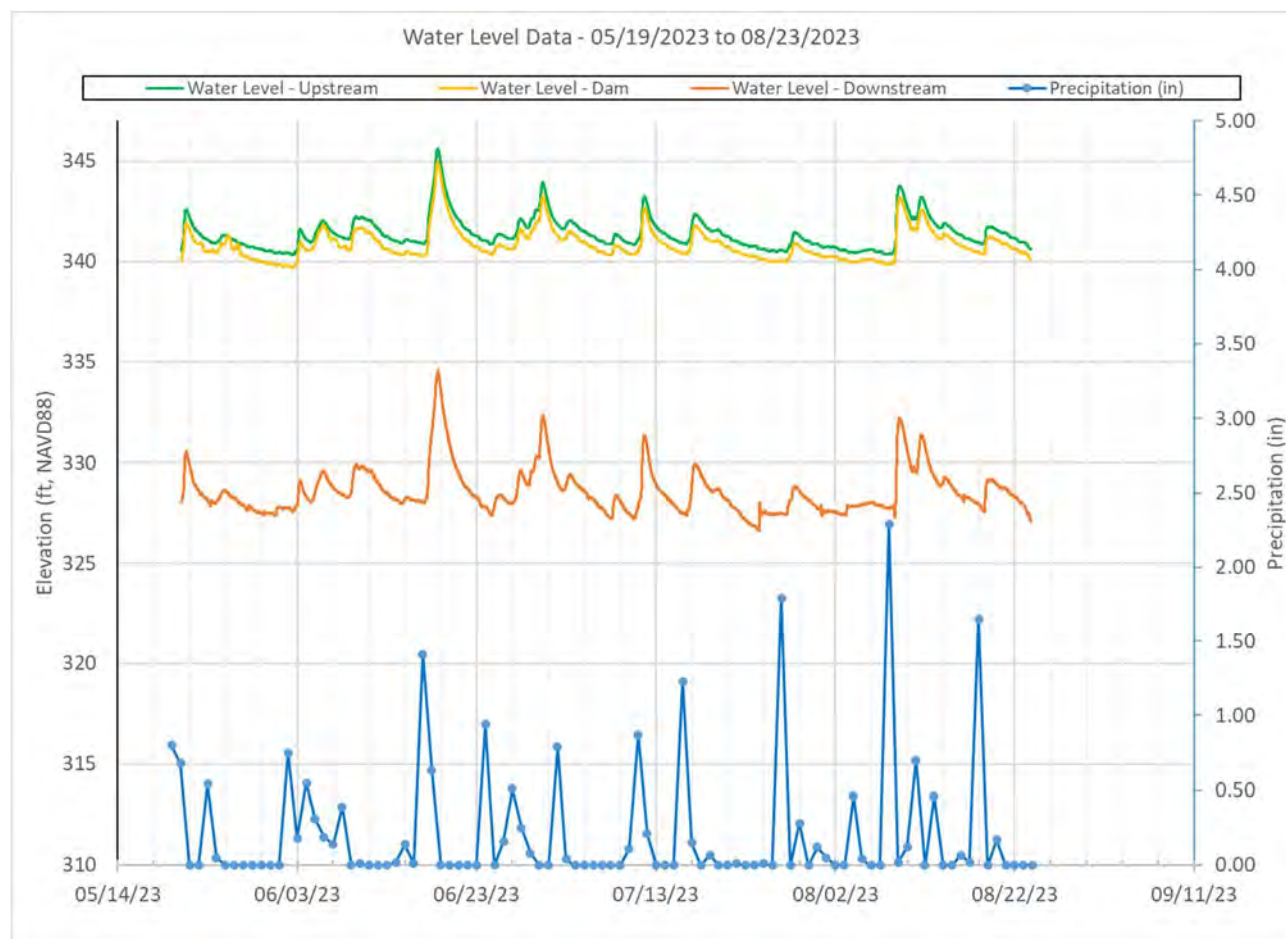
Figure 64. Water level monitoring data collected from May 15, 2023 to August 23, 2023 at three locations along the Piscataquis River. Precipitation data for Dover-Foxcroft was obtained from wunderground.com on 9/20/2023 (weather station ID: KMEDOVER 14).

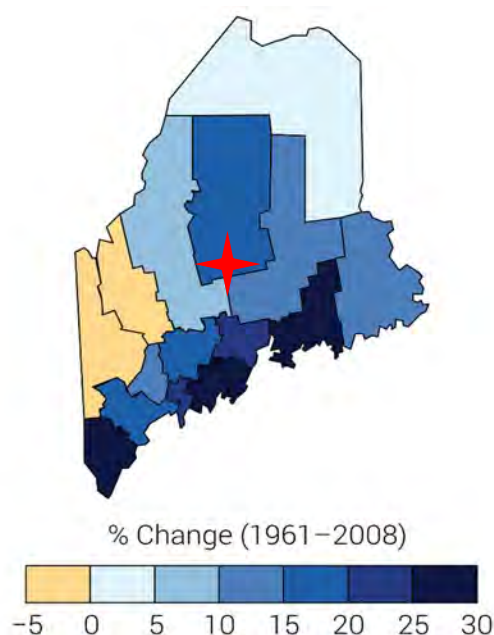
Figure 70. Change in the magnitude of the 24-hr, 100-yr precipitation event by county in Maine. Reprint from Runkle et al. 2017. Red star indicates location of Dover-Foxcroft.

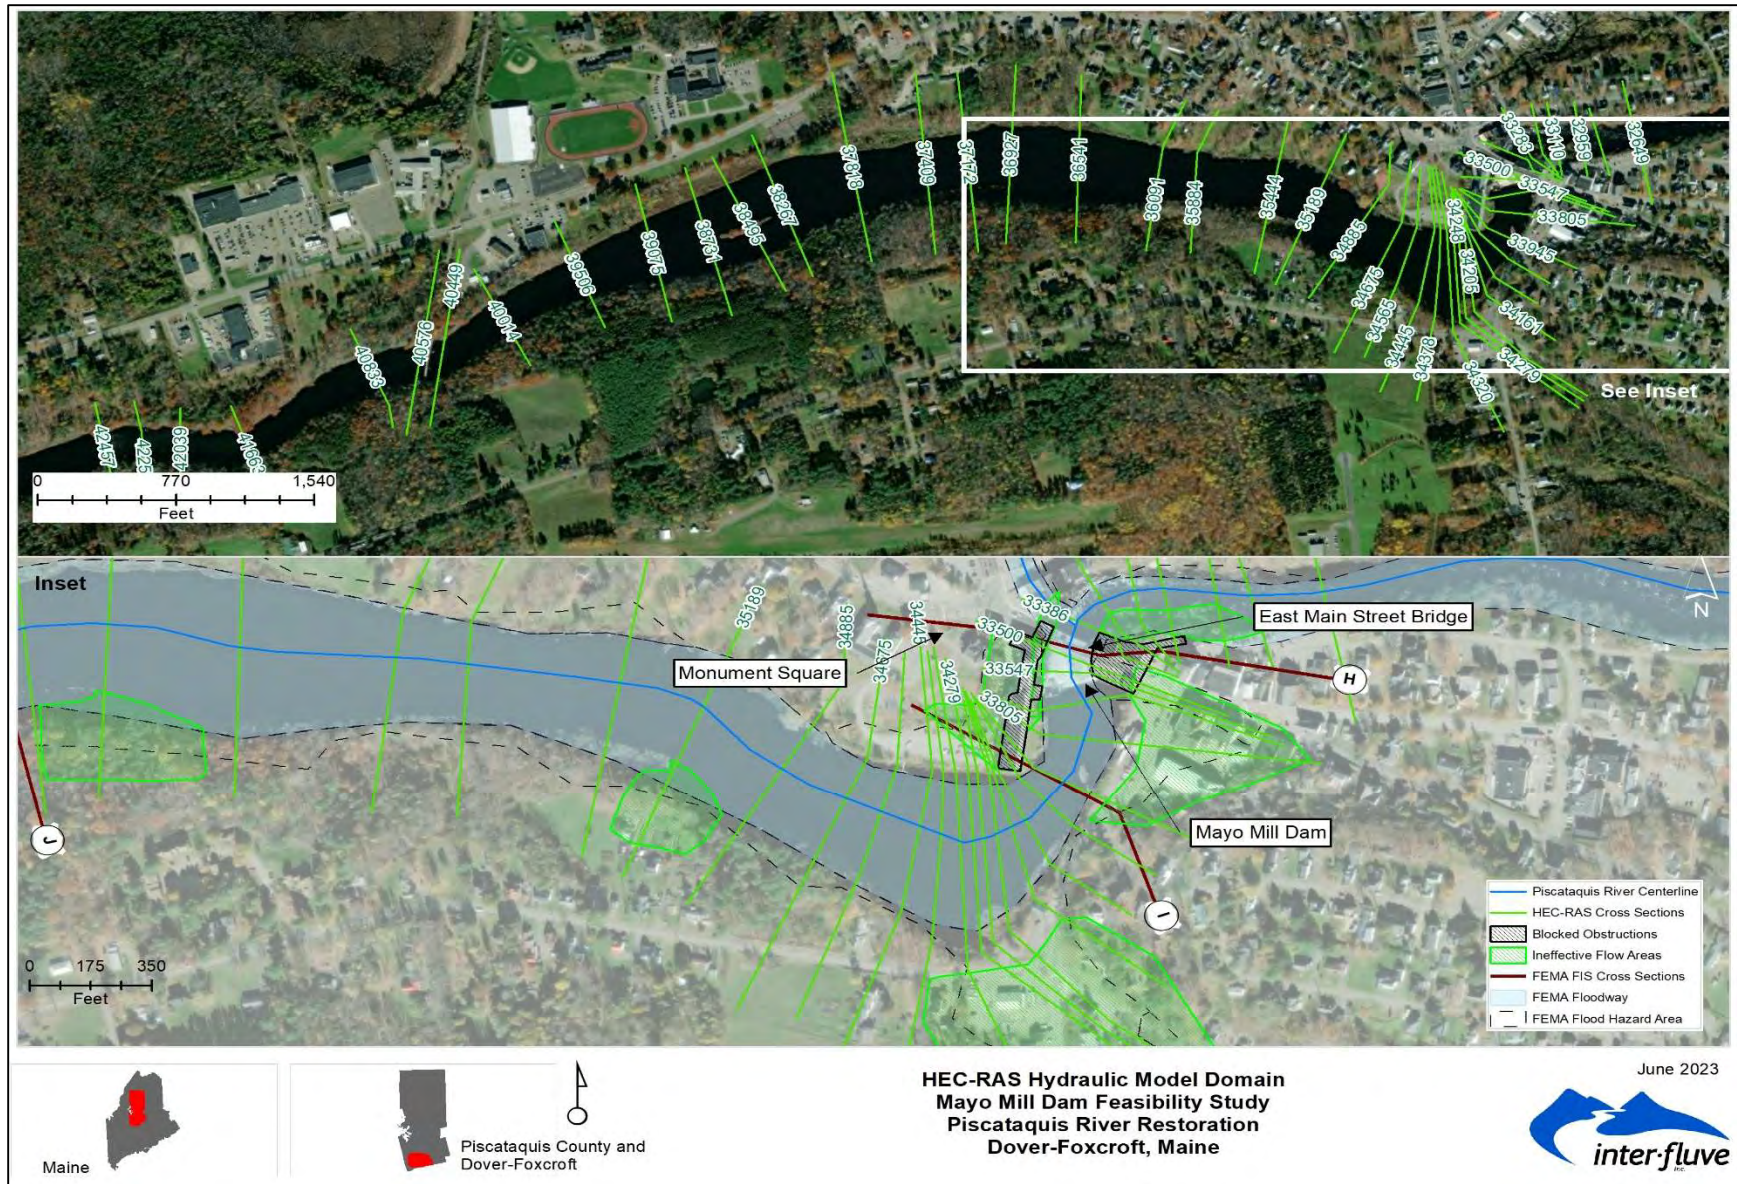
Figure 71. HEC-RAS Model Domain.

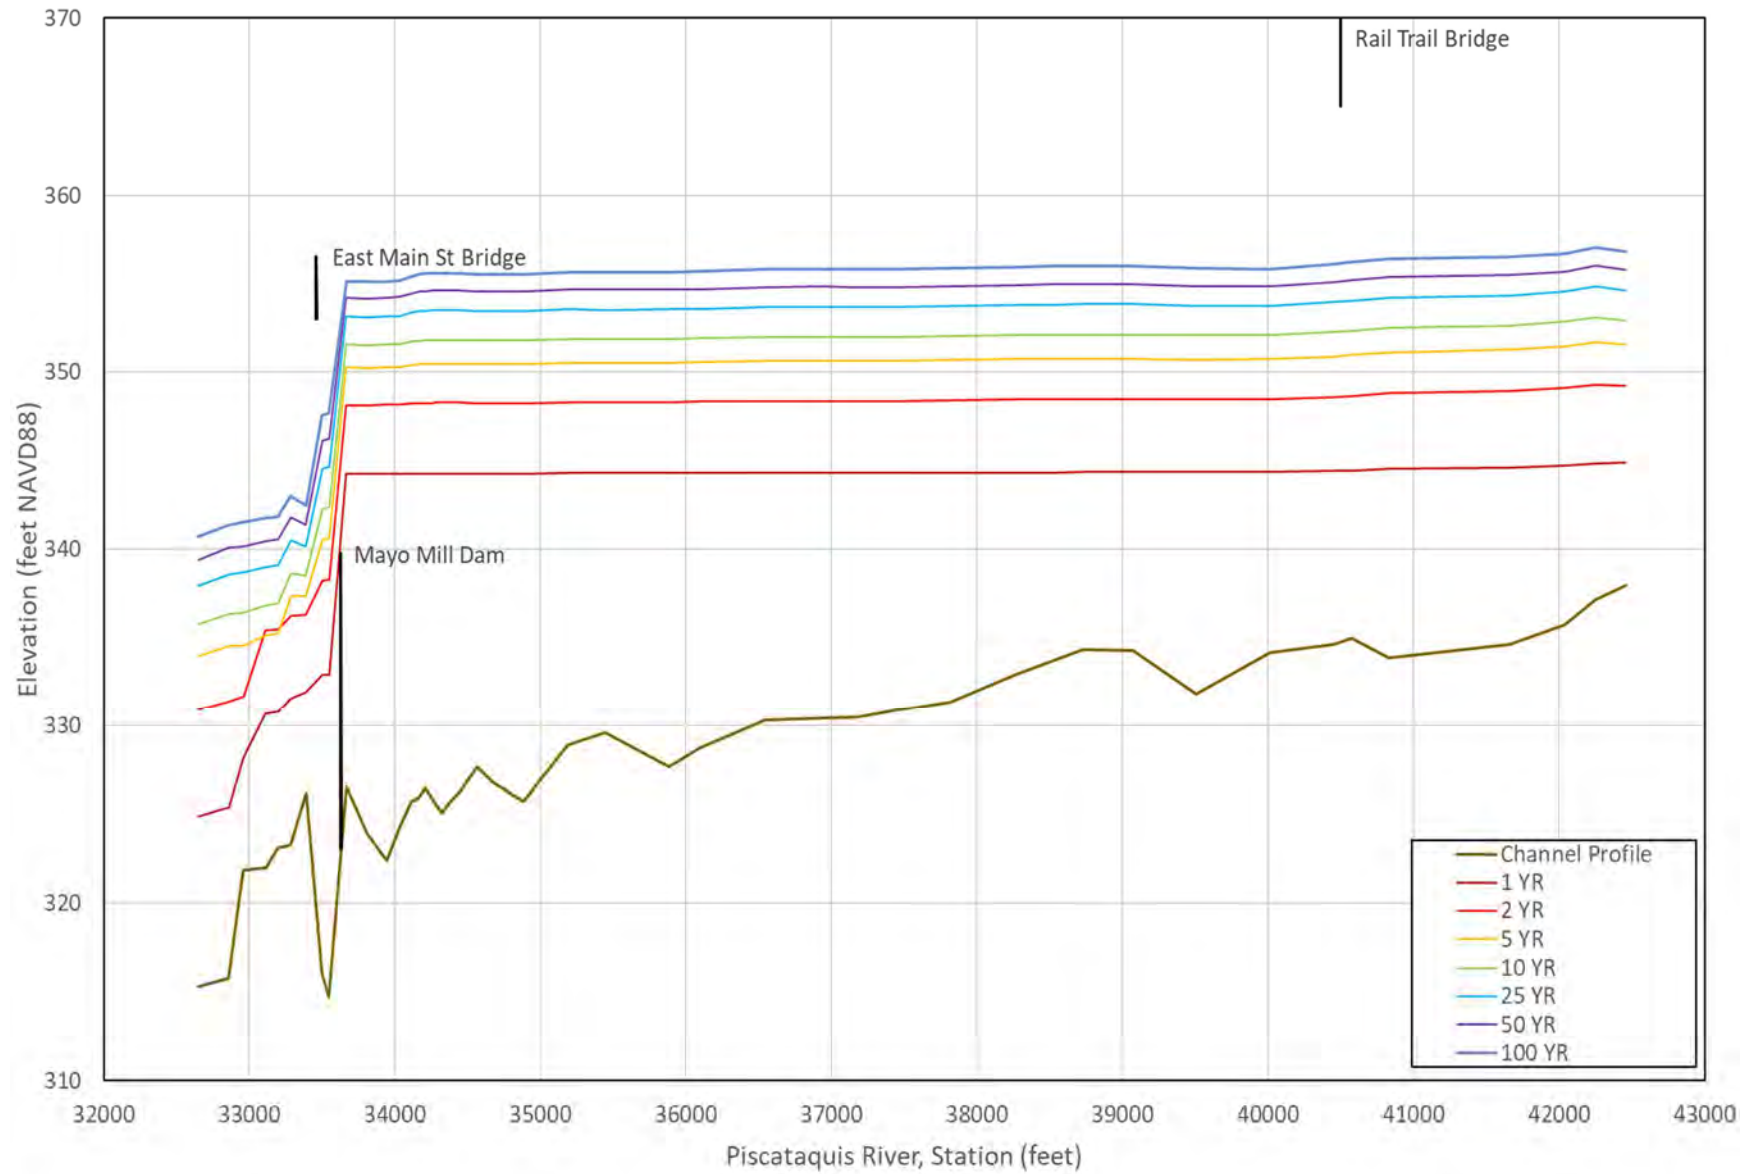
Figure 72. Existing Condition Hydraulic Model Results. Flood Profiles.

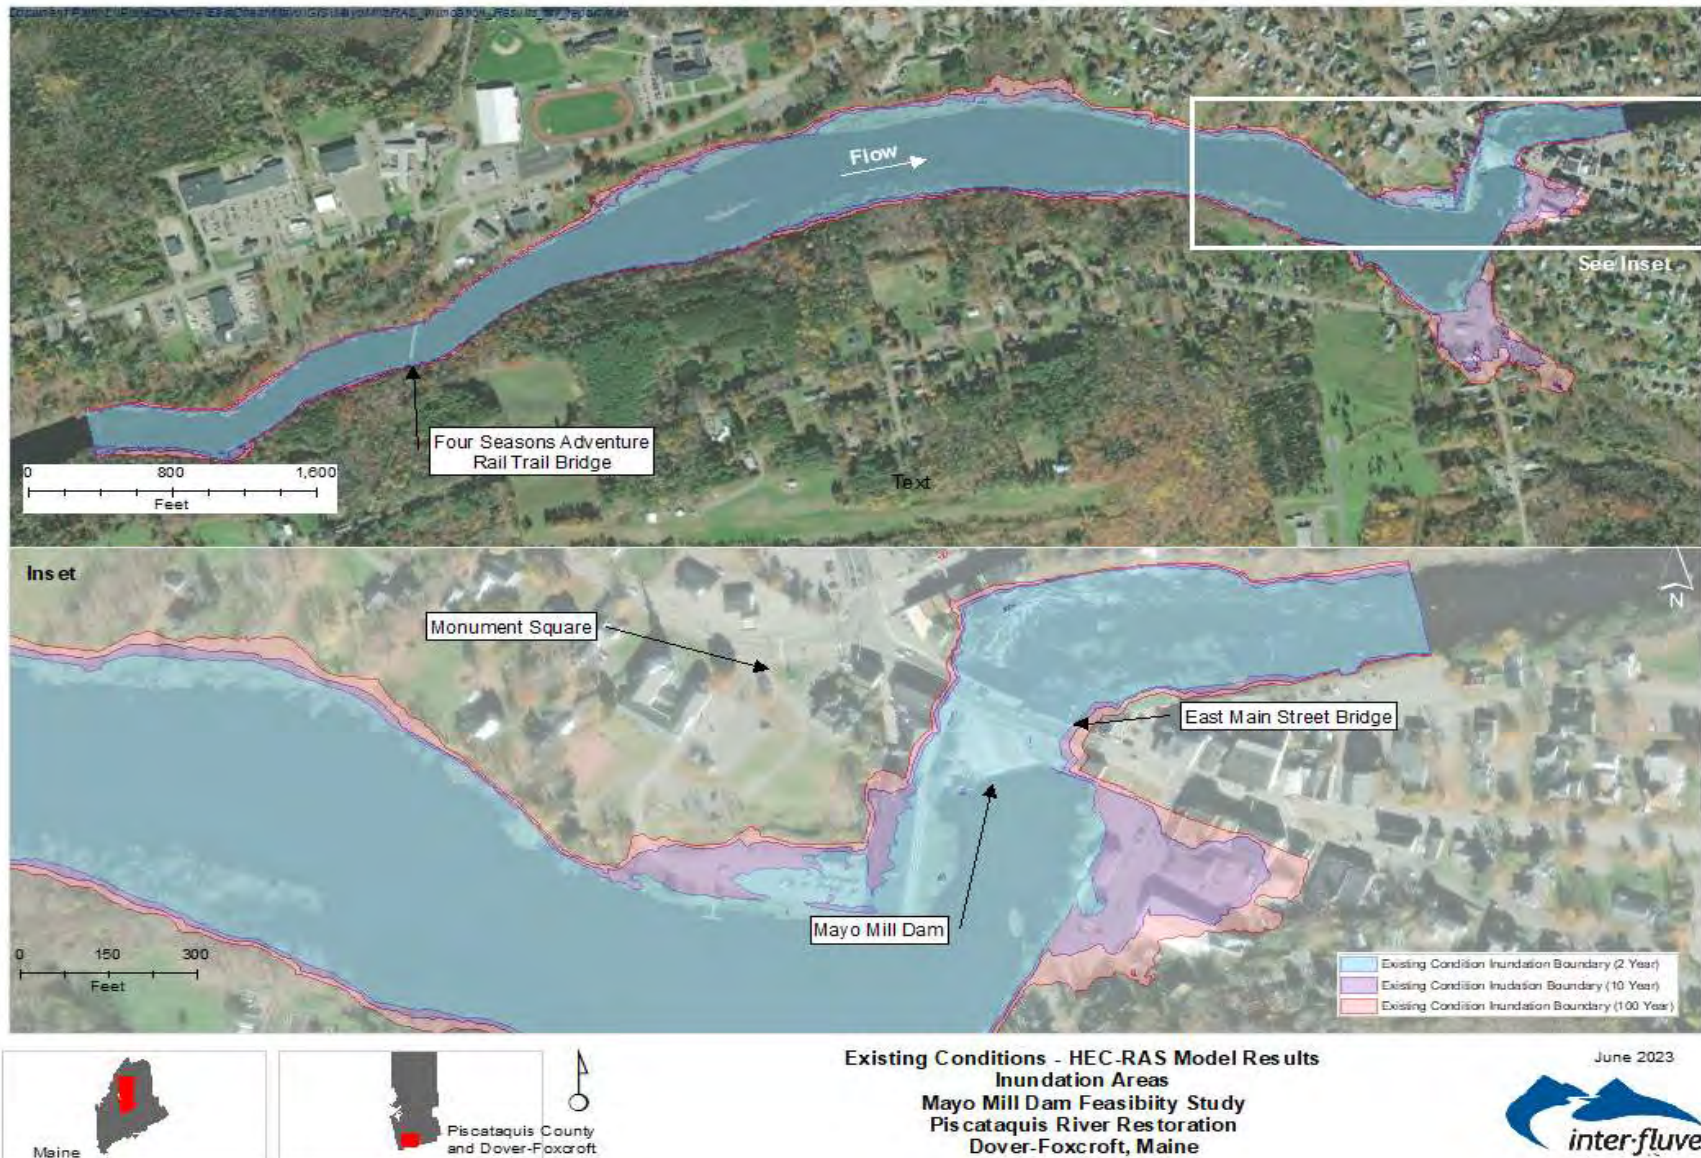
Figure 73. Simulated Two-, Ten-, and 100-Year Event Inundation Footprints.

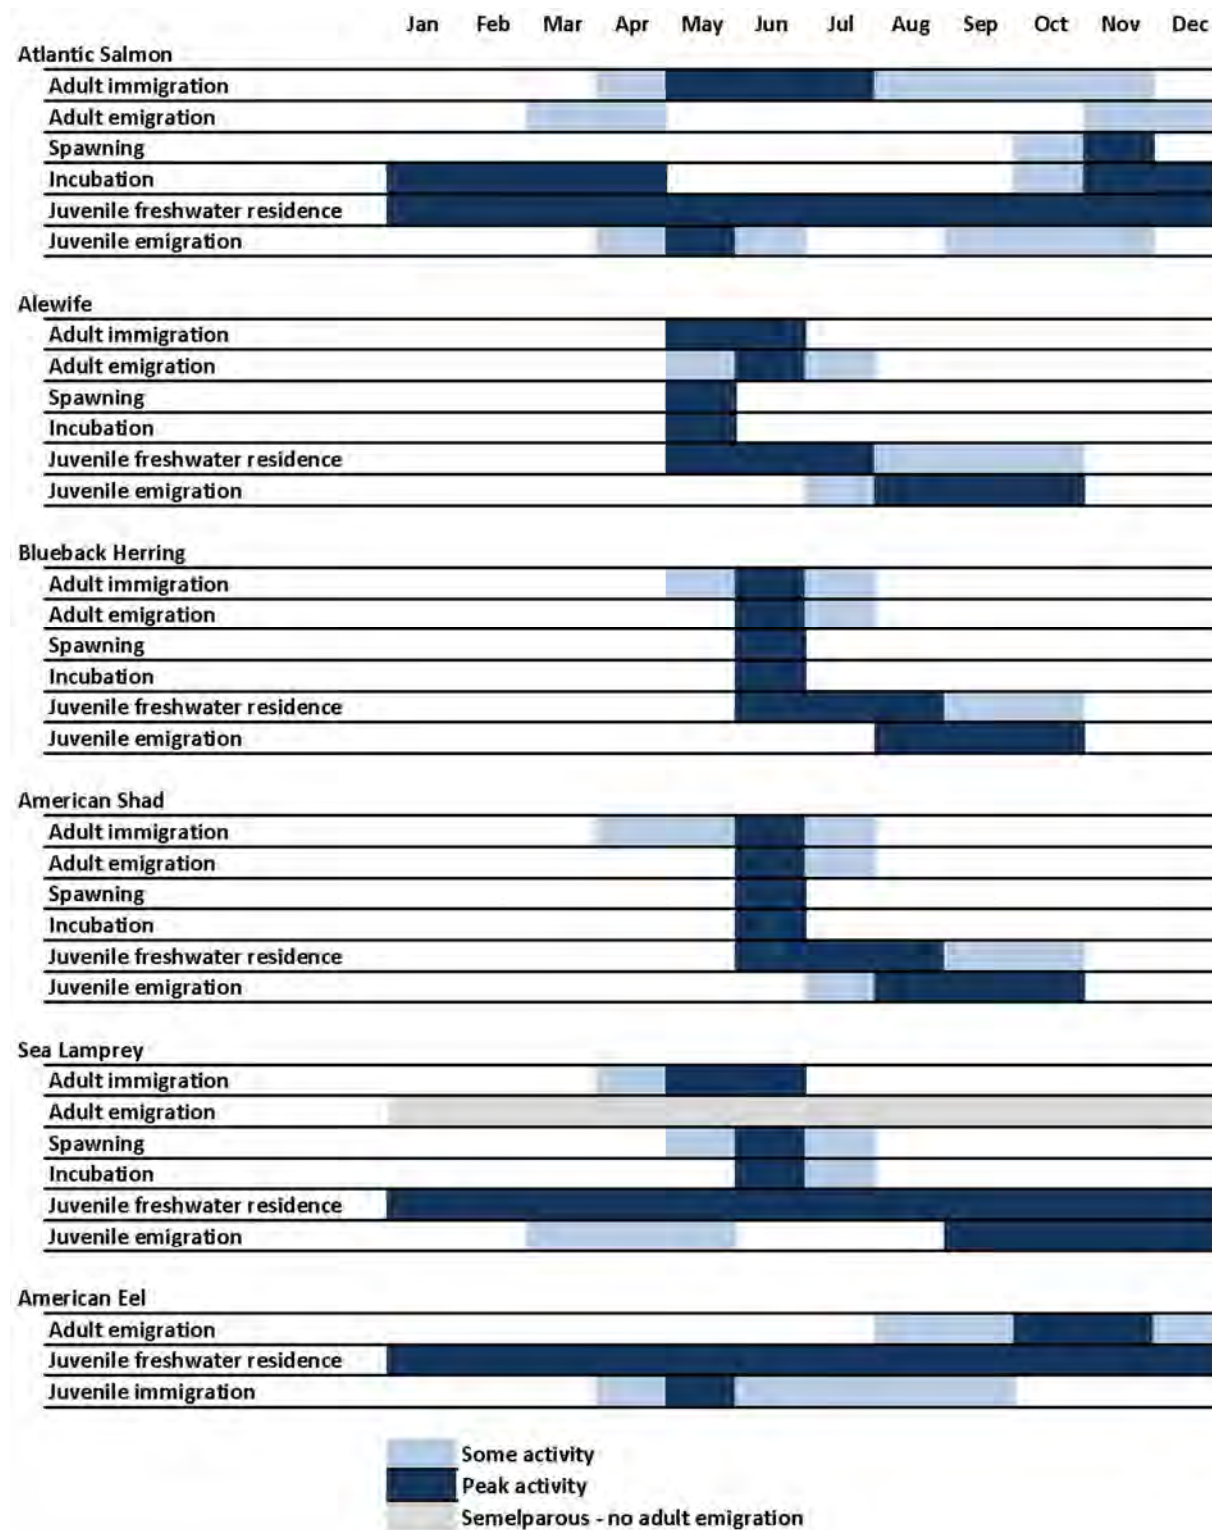
Figure 74. Generalized life history of diadromous fish in the Piscataquis River, Maine, adapted from Saunders et al. (2006), NOAA Fisheries (2023), and MDMR (2023).
