Mayo Mill Dam Feasibility Study Baseline Conditions Report Piscataquis River Dover-Foxcroft, ME

October 2023

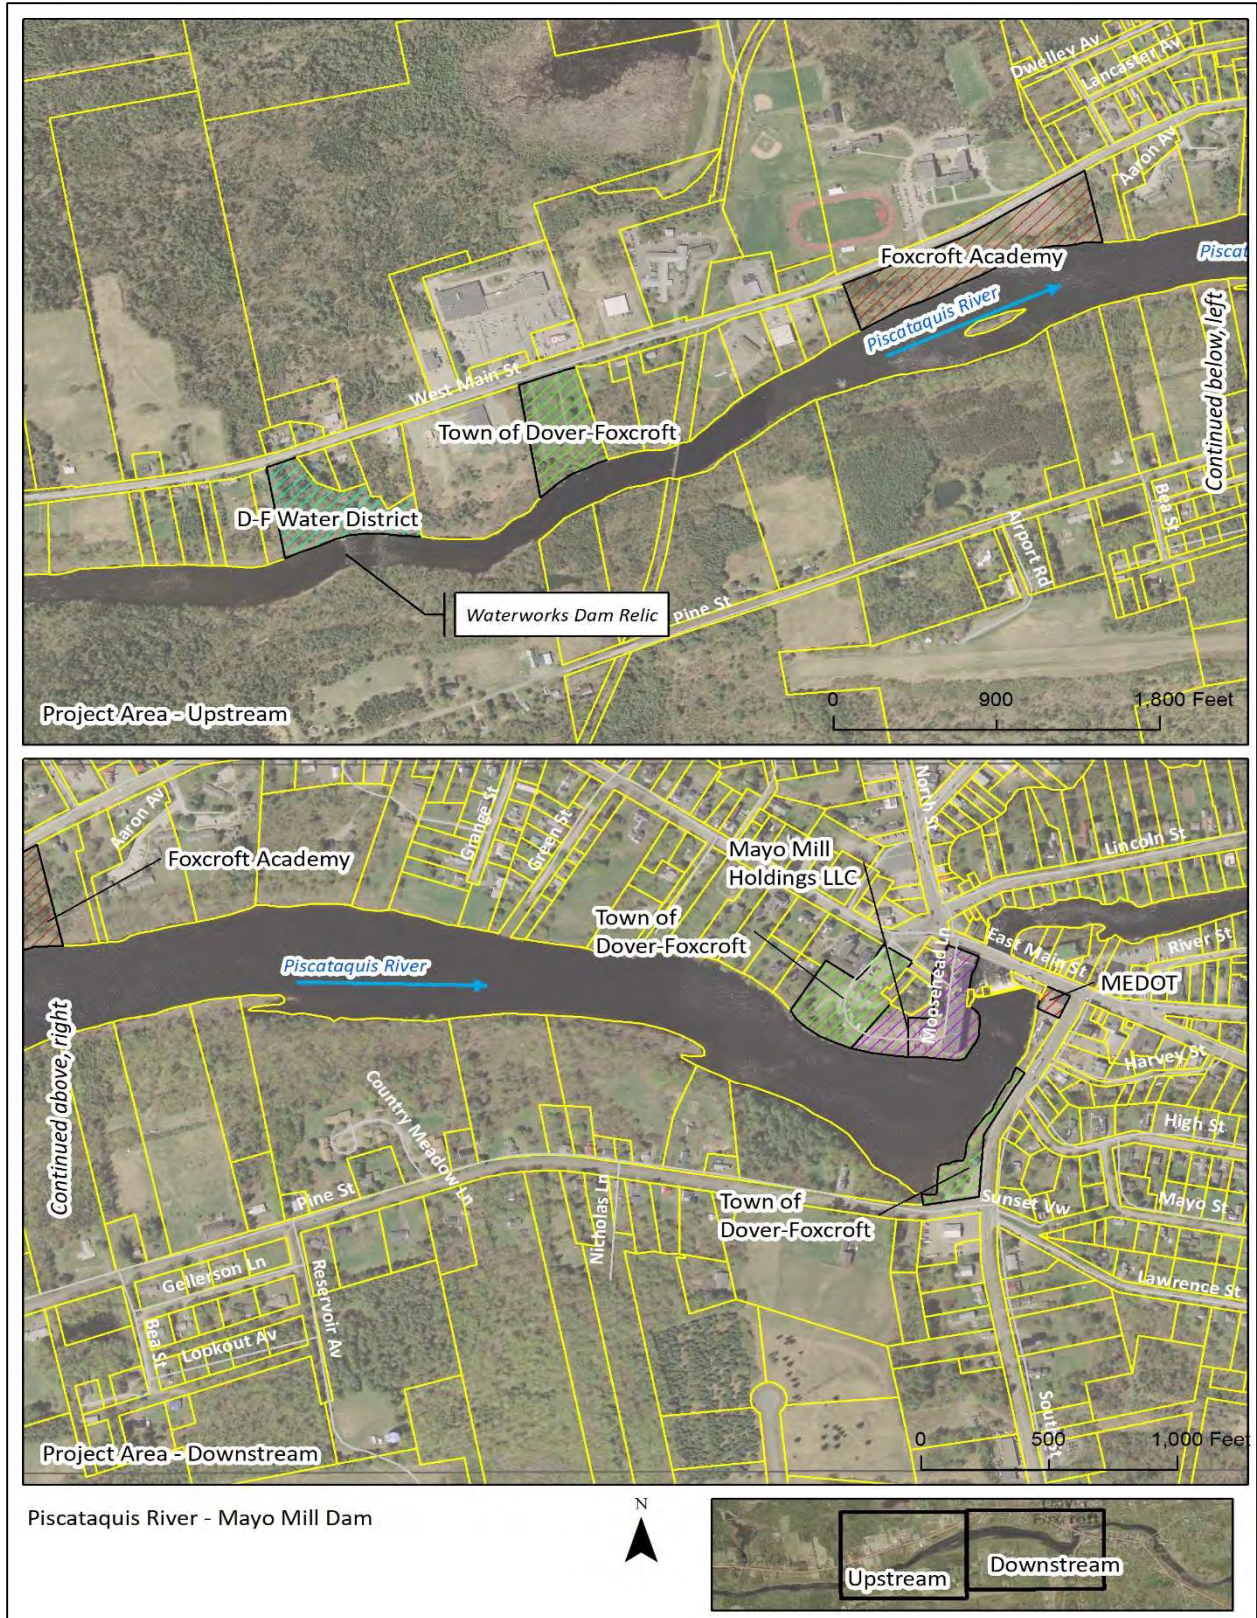
Figure 78. Parcels along the impoundment, with select property owners noted.

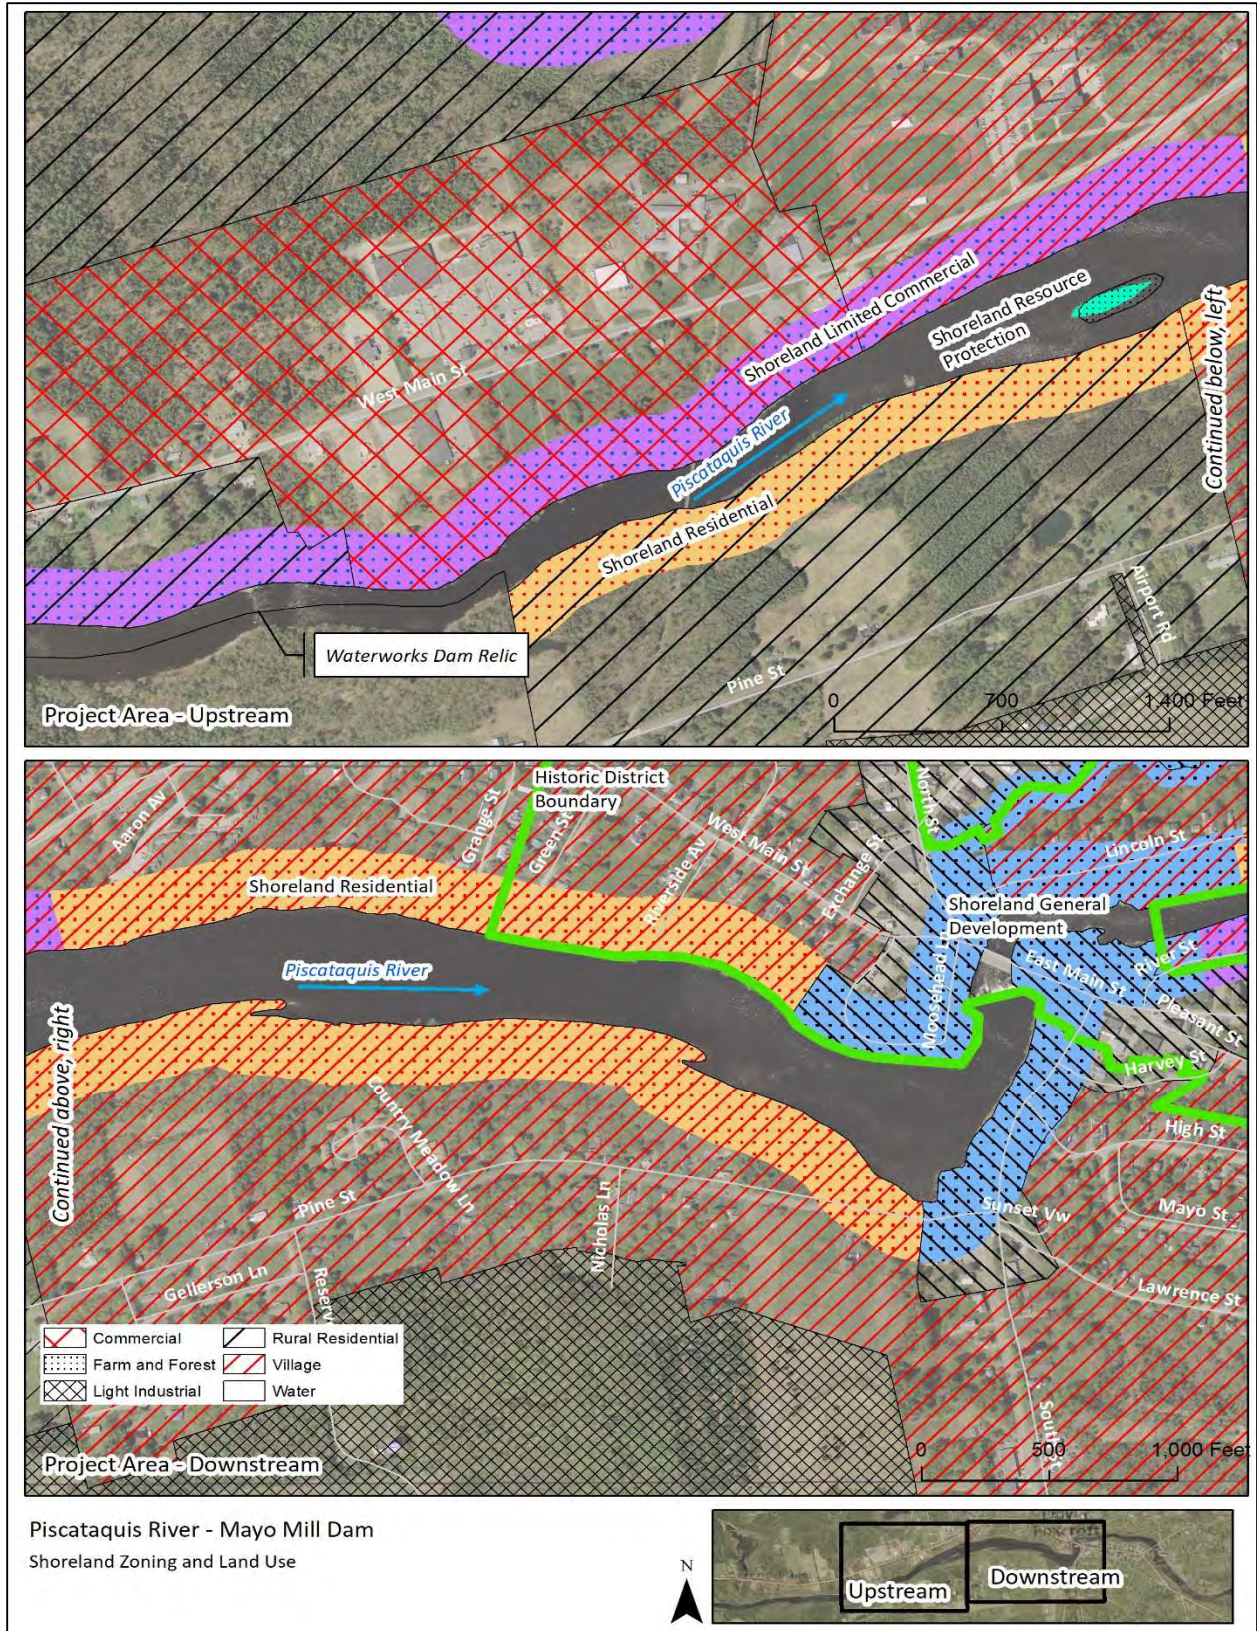
Figure 79. Land Use and Shoreland Zone districts. The Historic District overlay is shown with the heavy green boundary.

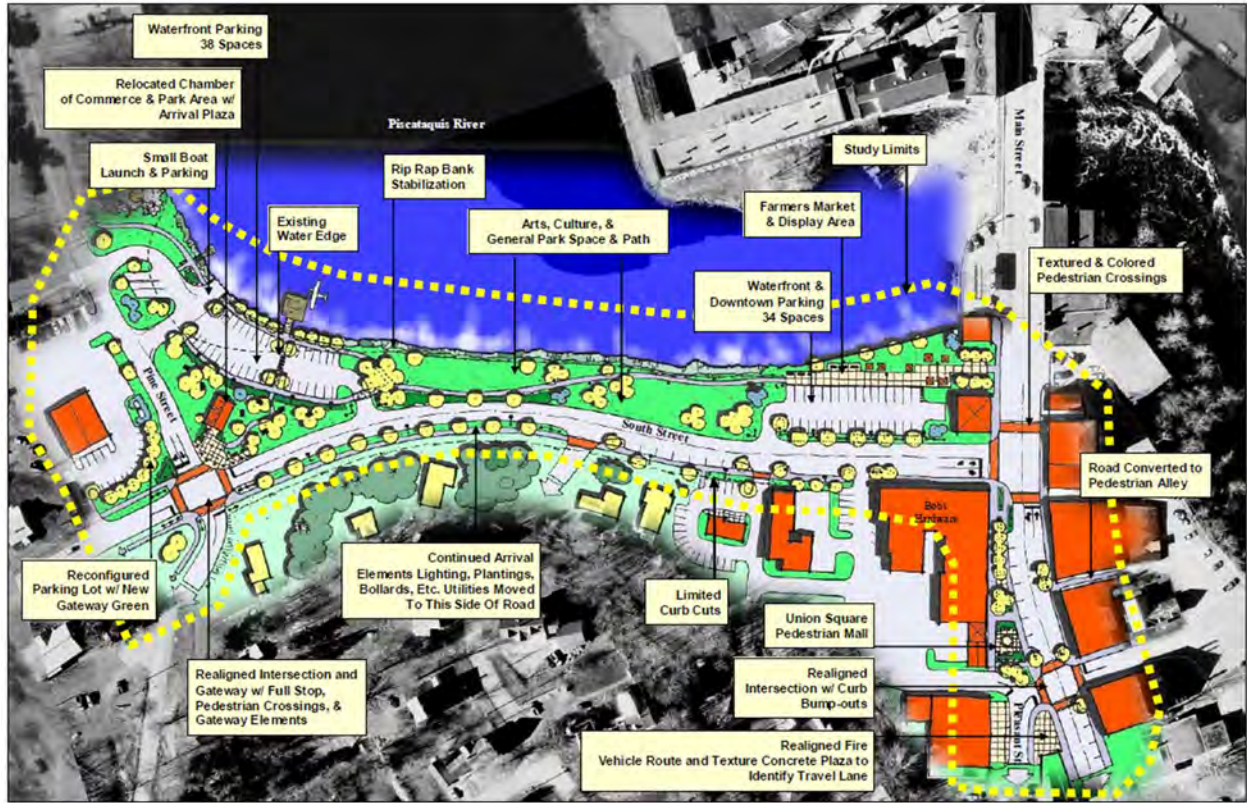
Figure 80. 2003 Dover-Foxcroft Downtown Revitalization Phase I Master Plan (WBRC 2003).

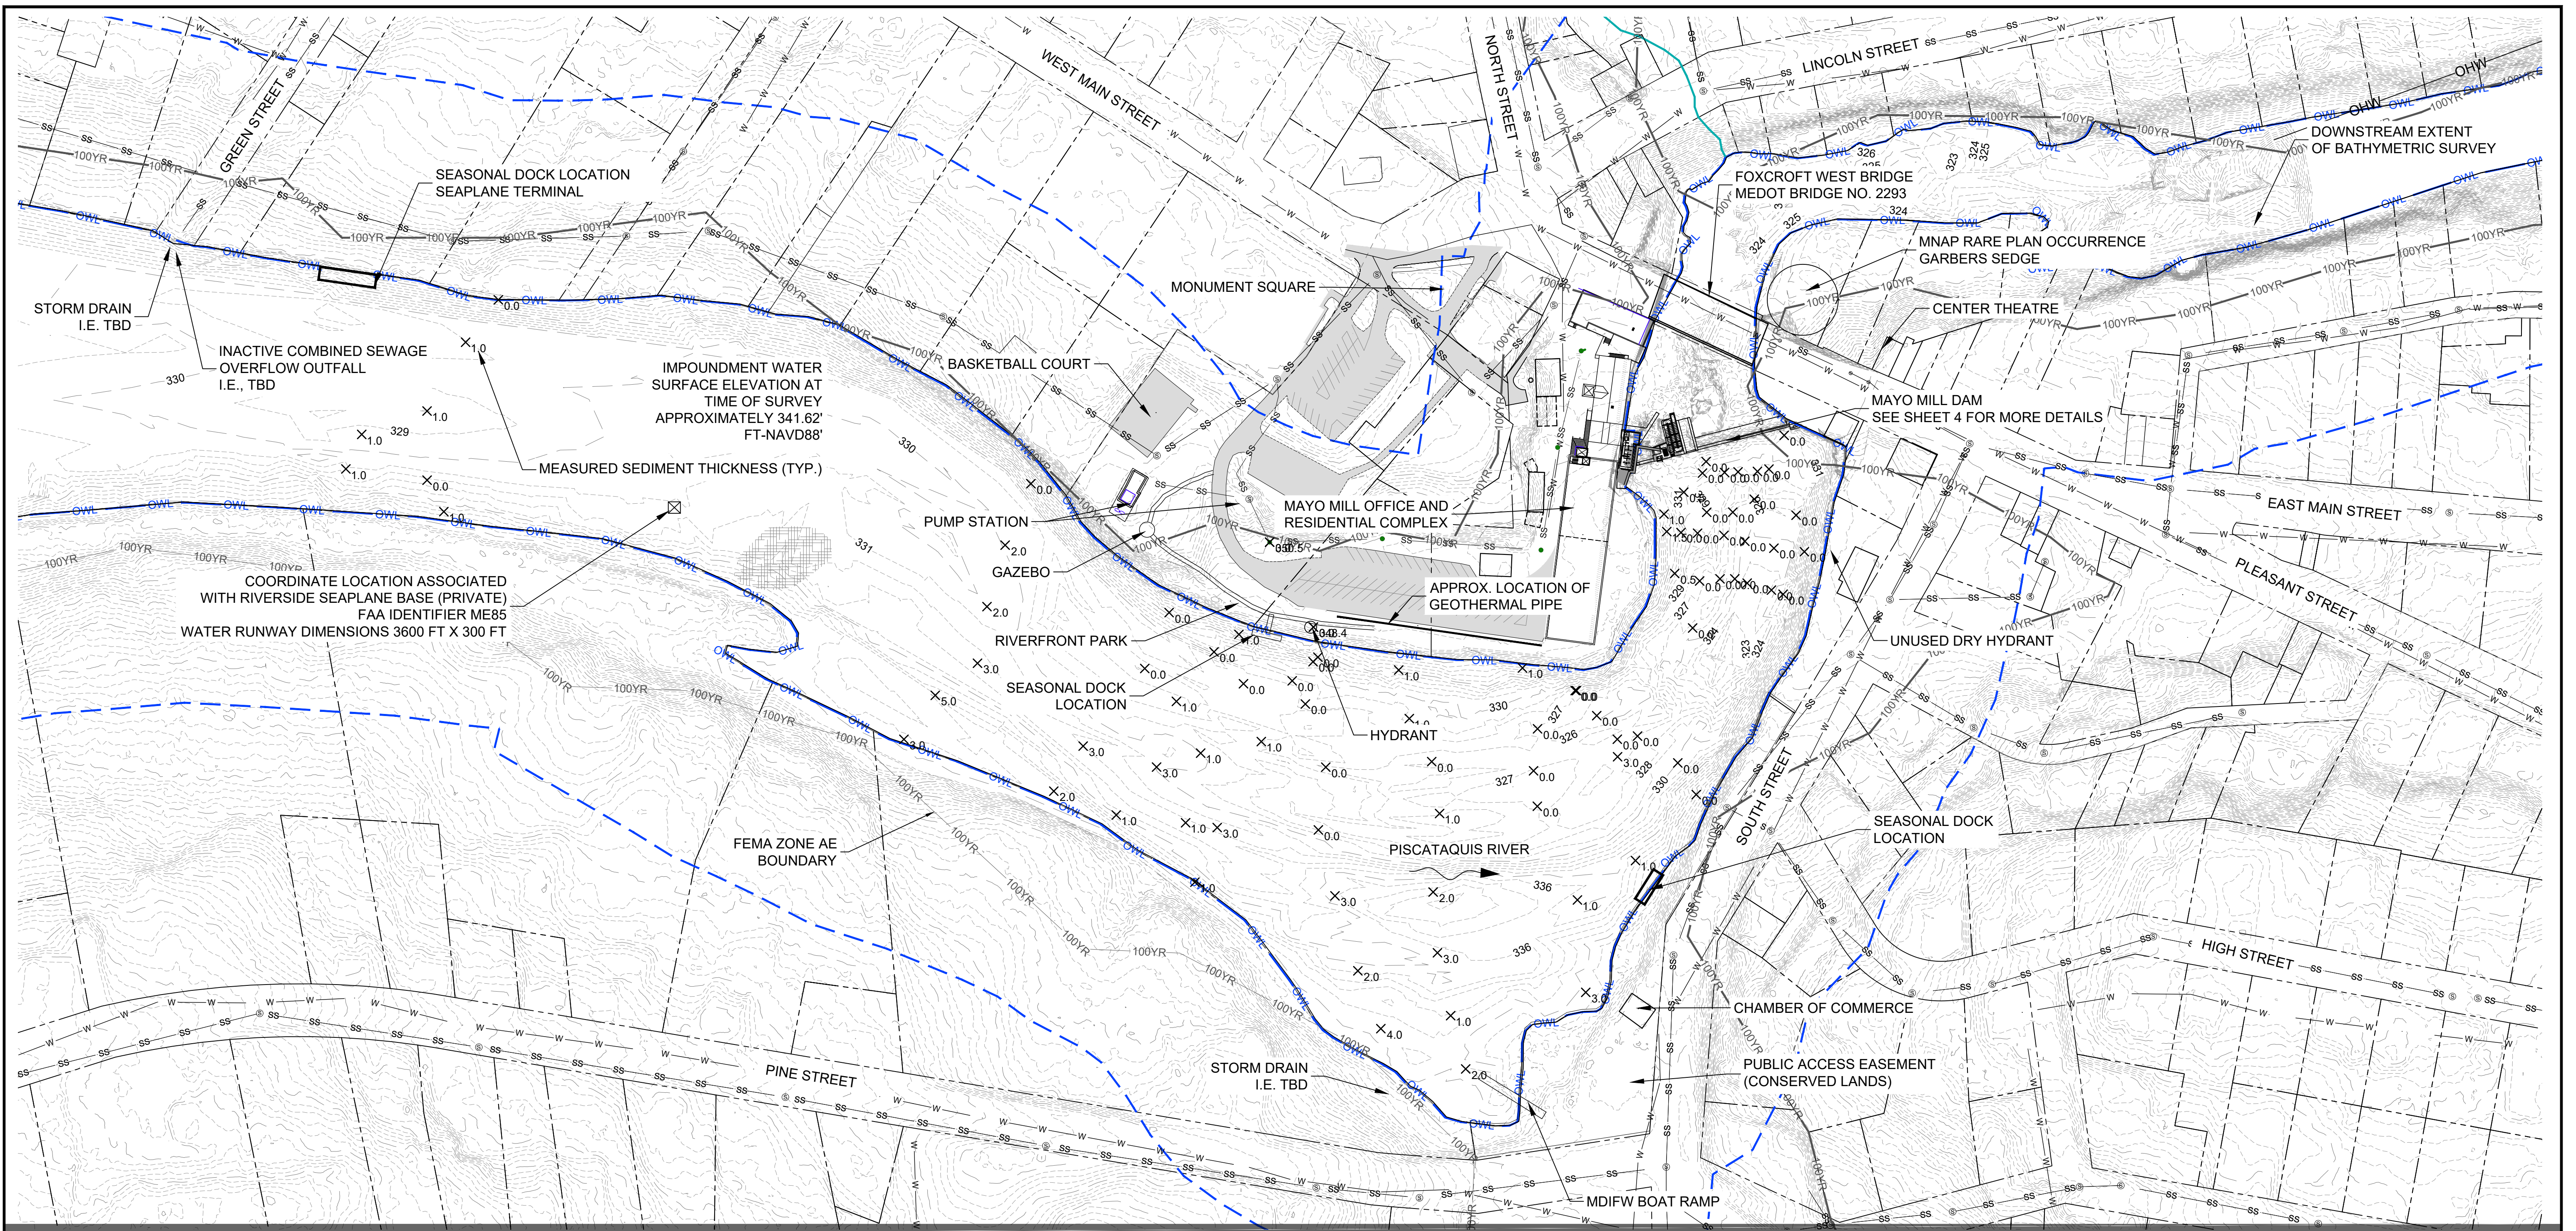
Appendix A - Project Basemap

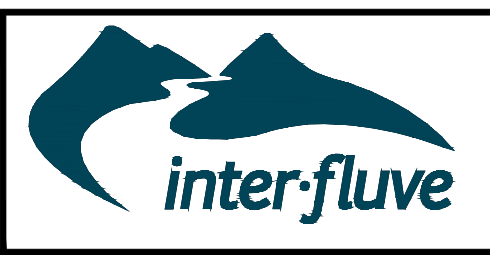
265 Main Street, Suite 2 B
 PO Box 236
 Damariscotta, ME 04543
 207.315.7014
 www.interfluve.com

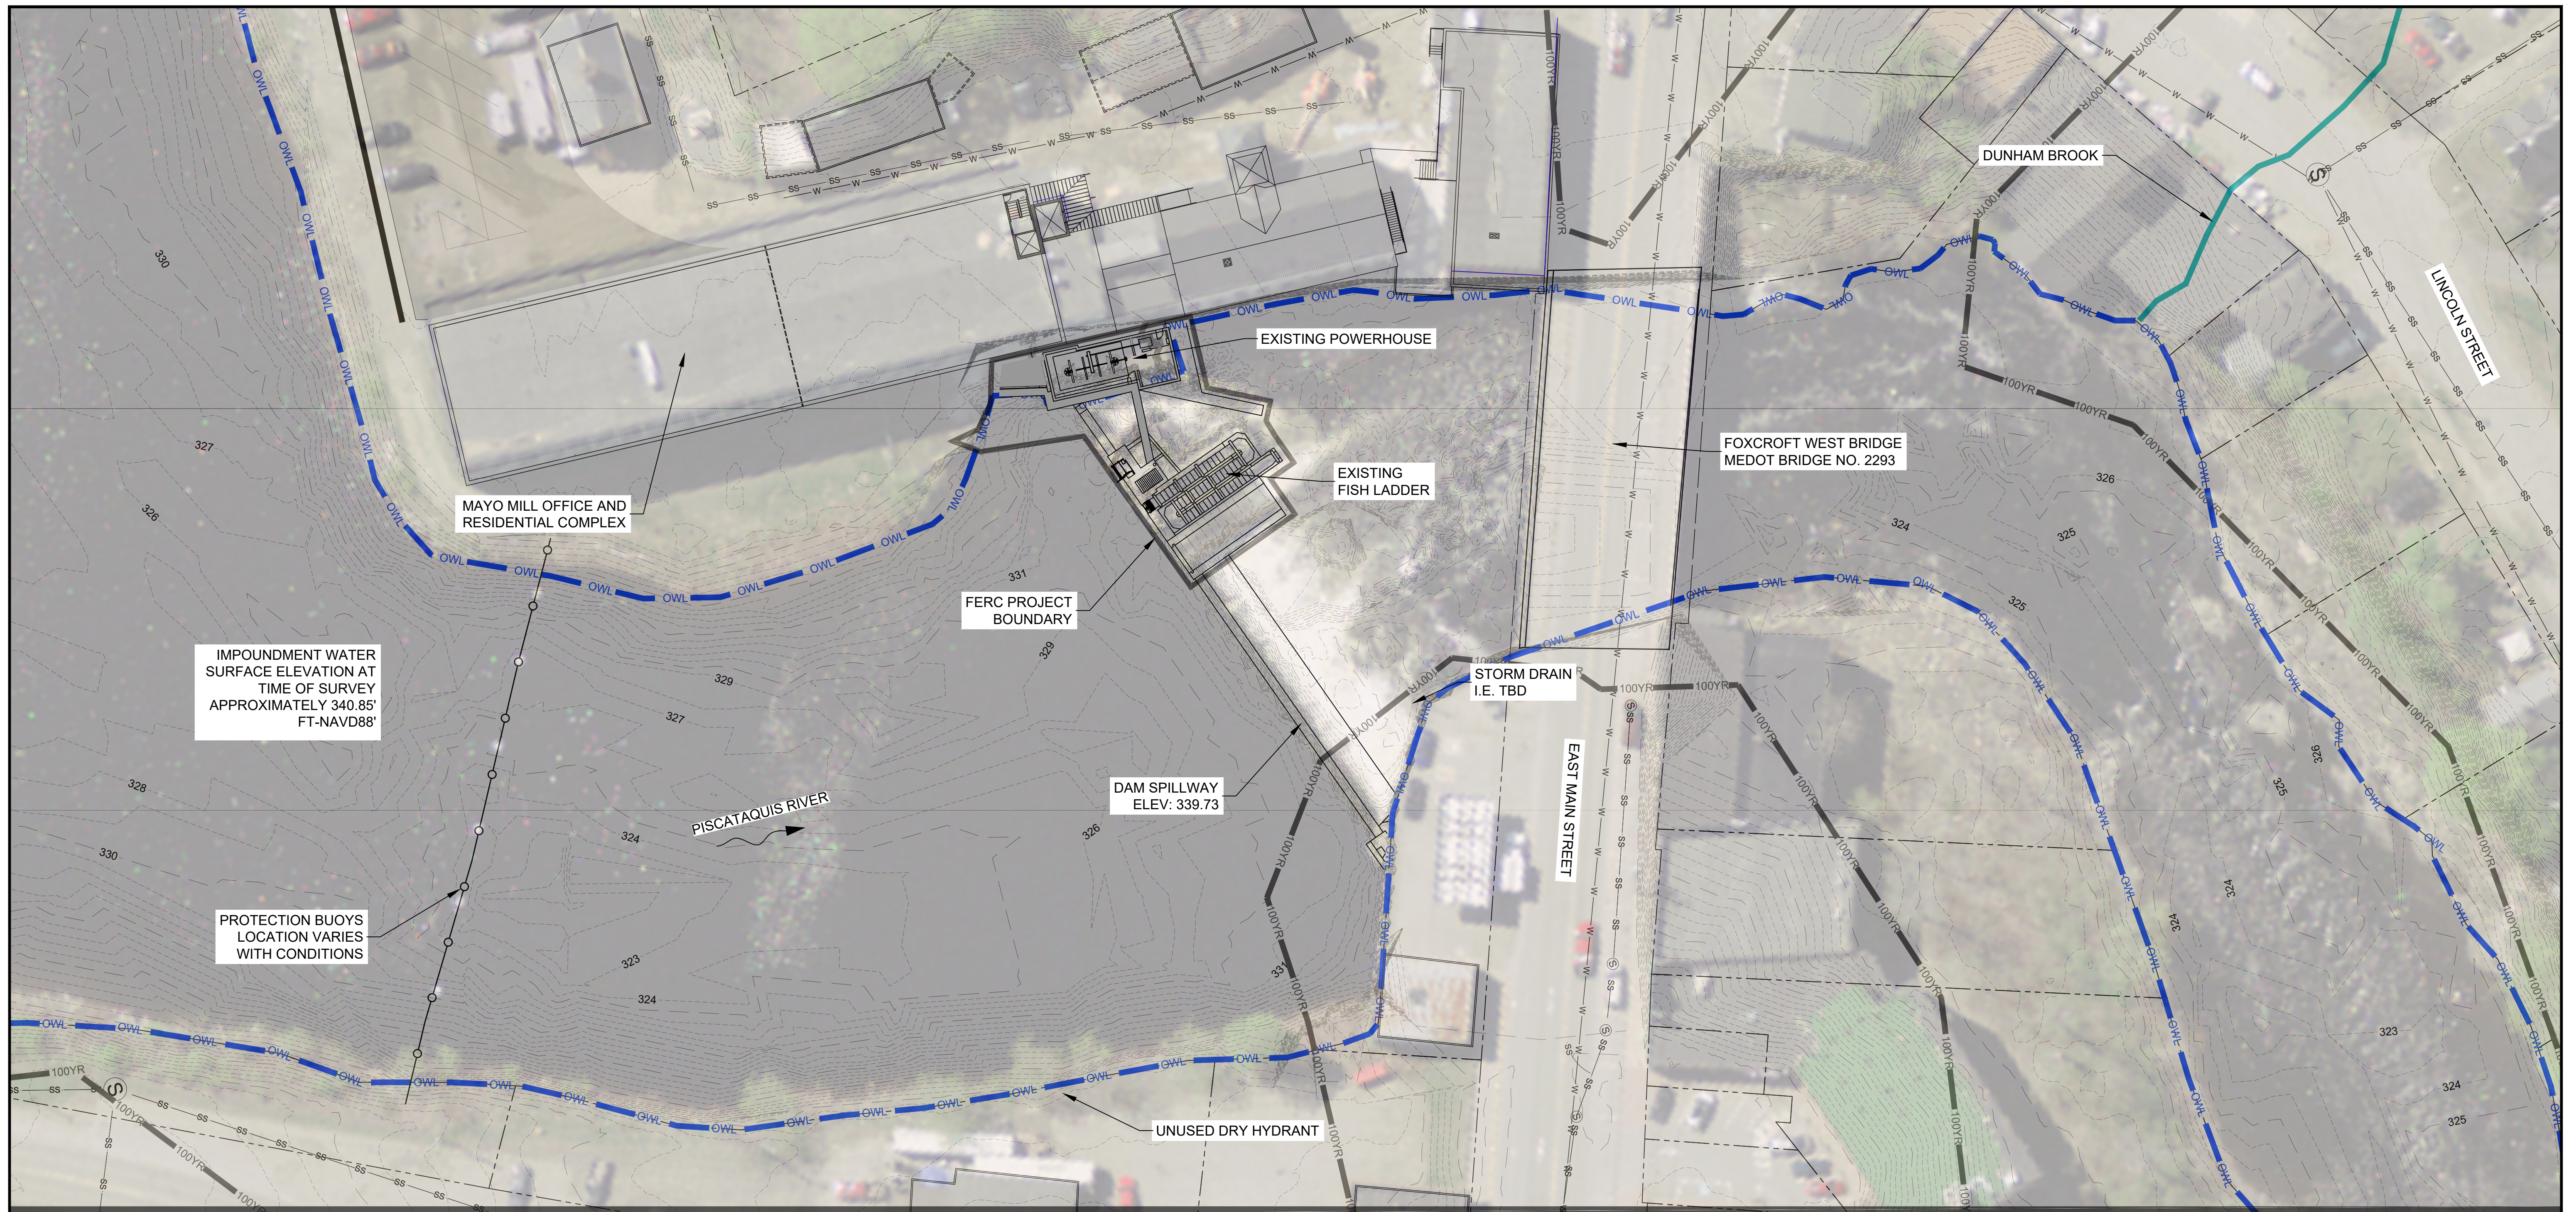
IMPOUNDMENT WATER SURFACE ELEVATION AT TIME OF SURVEY APPROXIMATELY 340.85' FT-NAVD88'

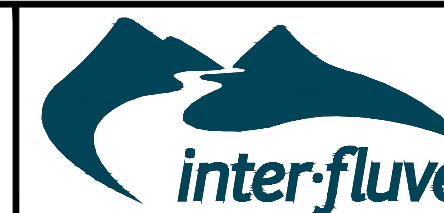
265 Main Street, Suite 2 B
PO Box 236
Damariscotta, ME 04543
207.315.7014
www.interfluve.com

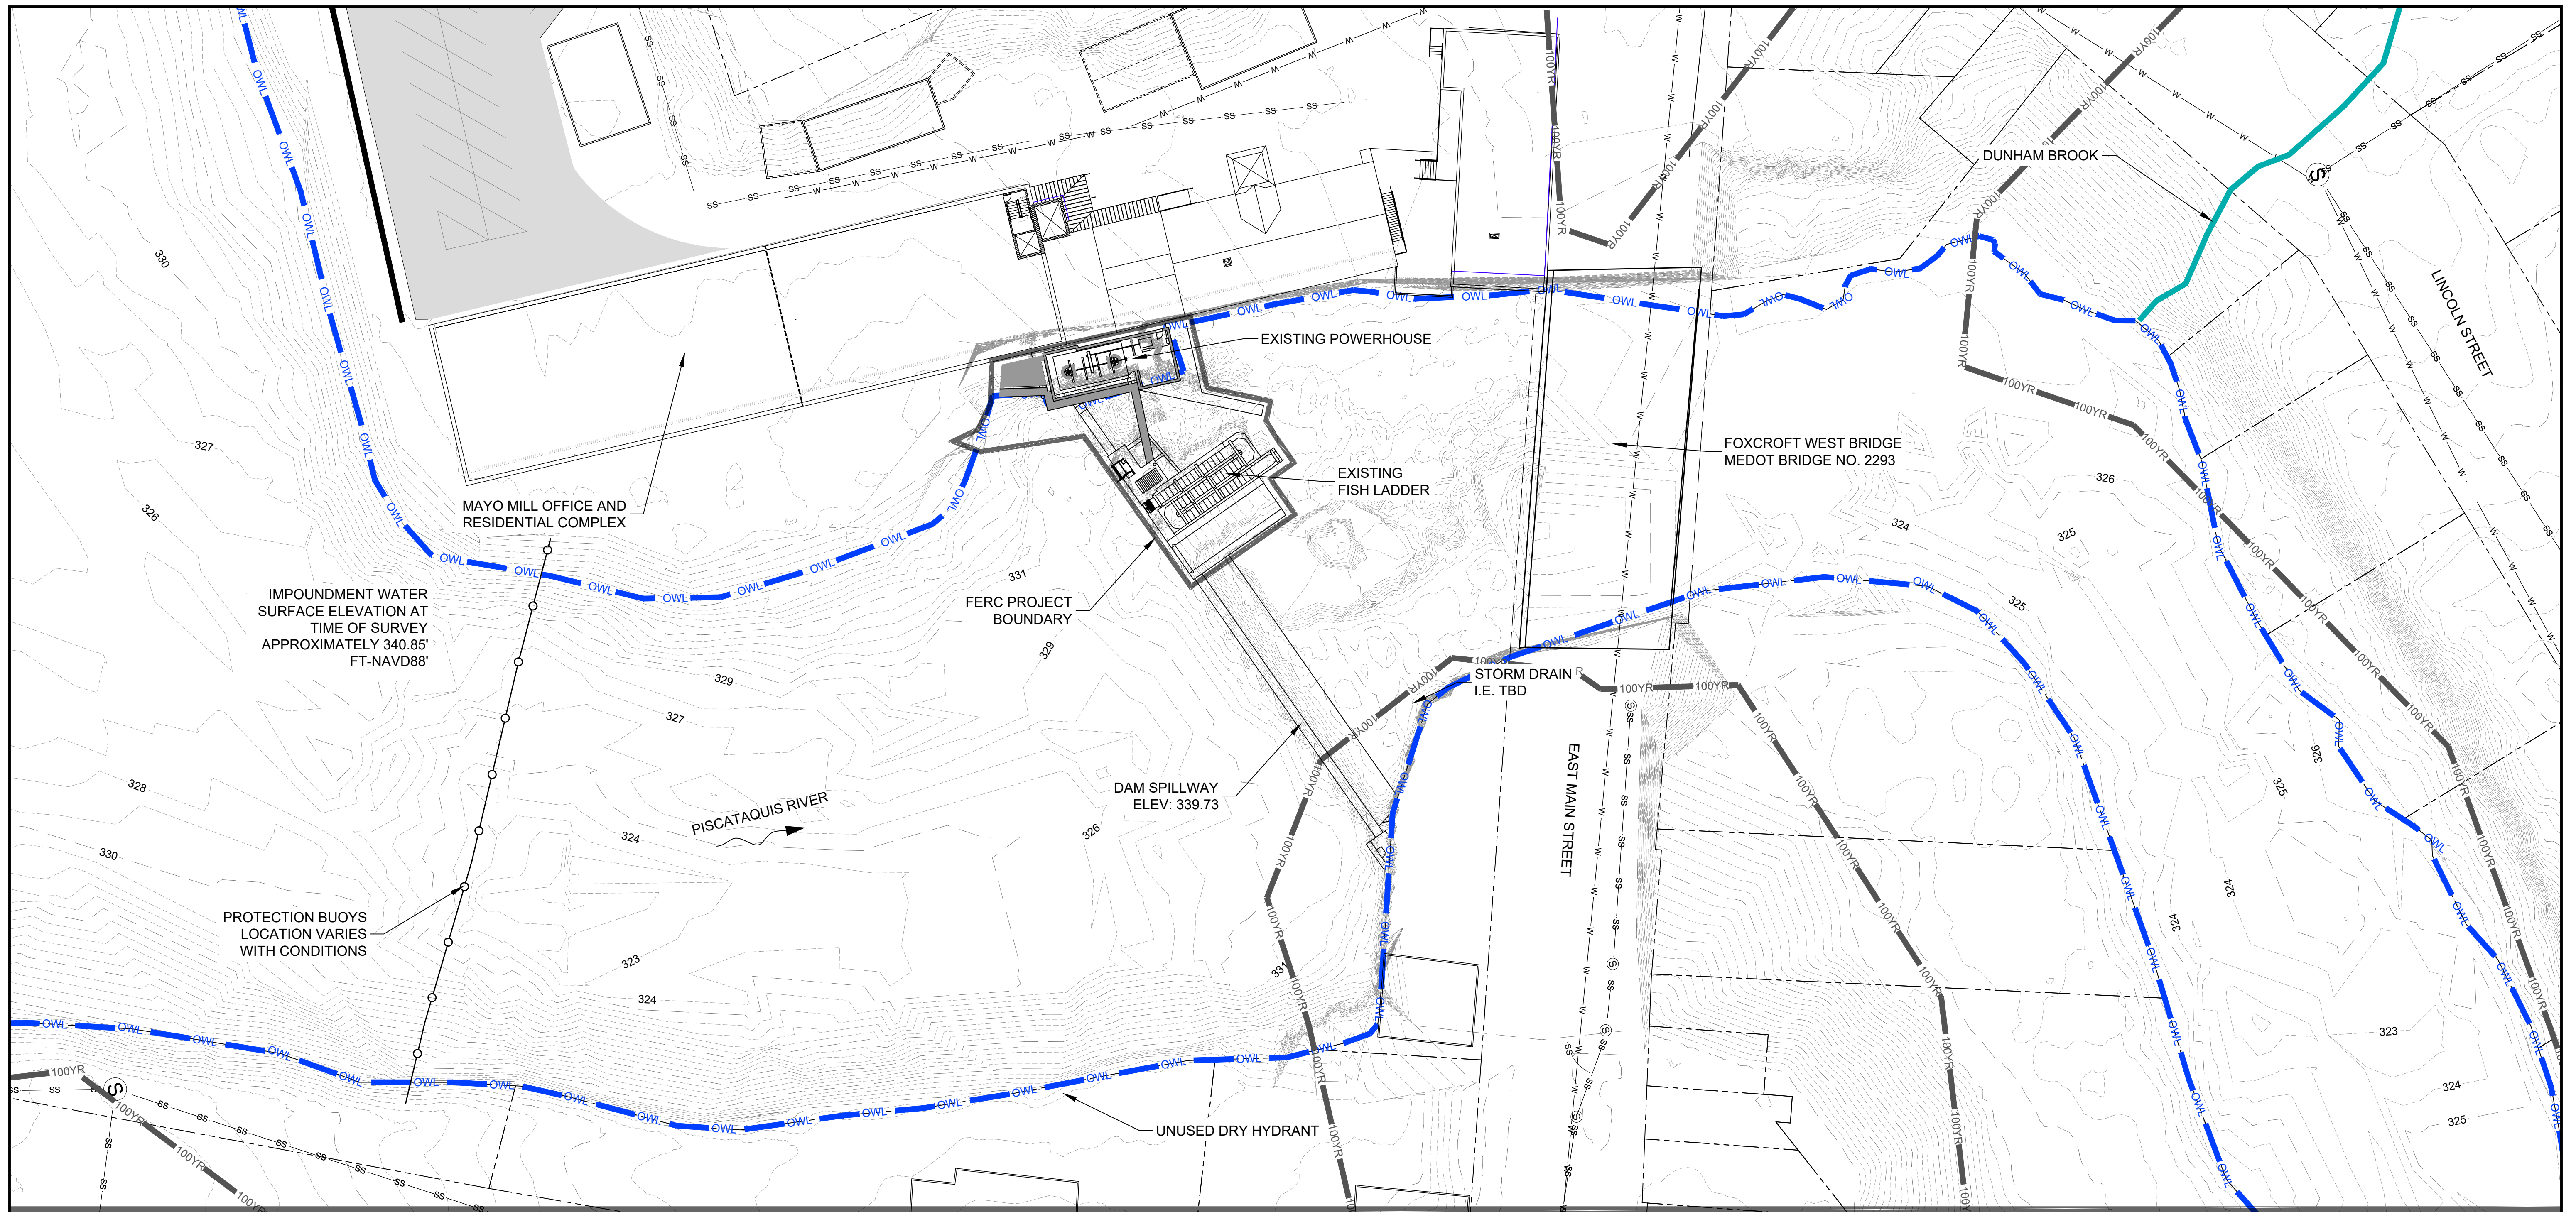
IMPONDMENT WATER SURFACE ELEVATION AT TIME OF SURVEY APPROXIMATELY 340.85' FT-NAVD88'

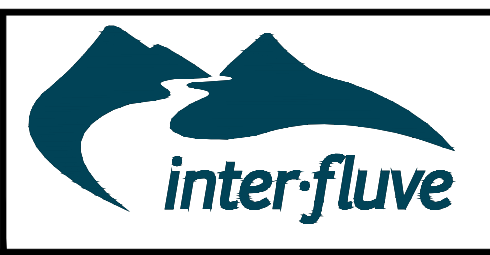
265 Main Street, Suite 2 B
 PO Box 236
 Damariscotta, ME 04543
 207.315.7014
 www.interfluve.com

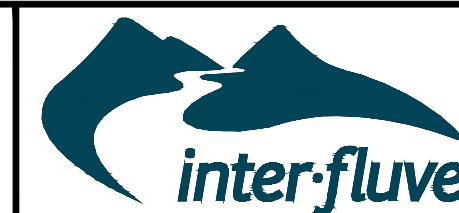
265 Main Street, Suite 2 B
PO Box 236
Damariscotta, ME 04543
207.315.7014
www.interfluve.com

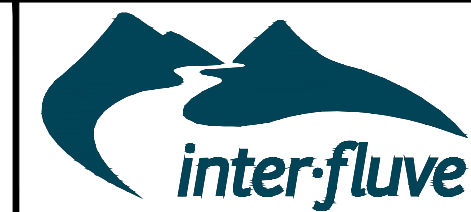
265 Main Street, Suite 2 B
PO Box 236
Damariscotta, ME 04543
207.315.7014
www.interfluve.com

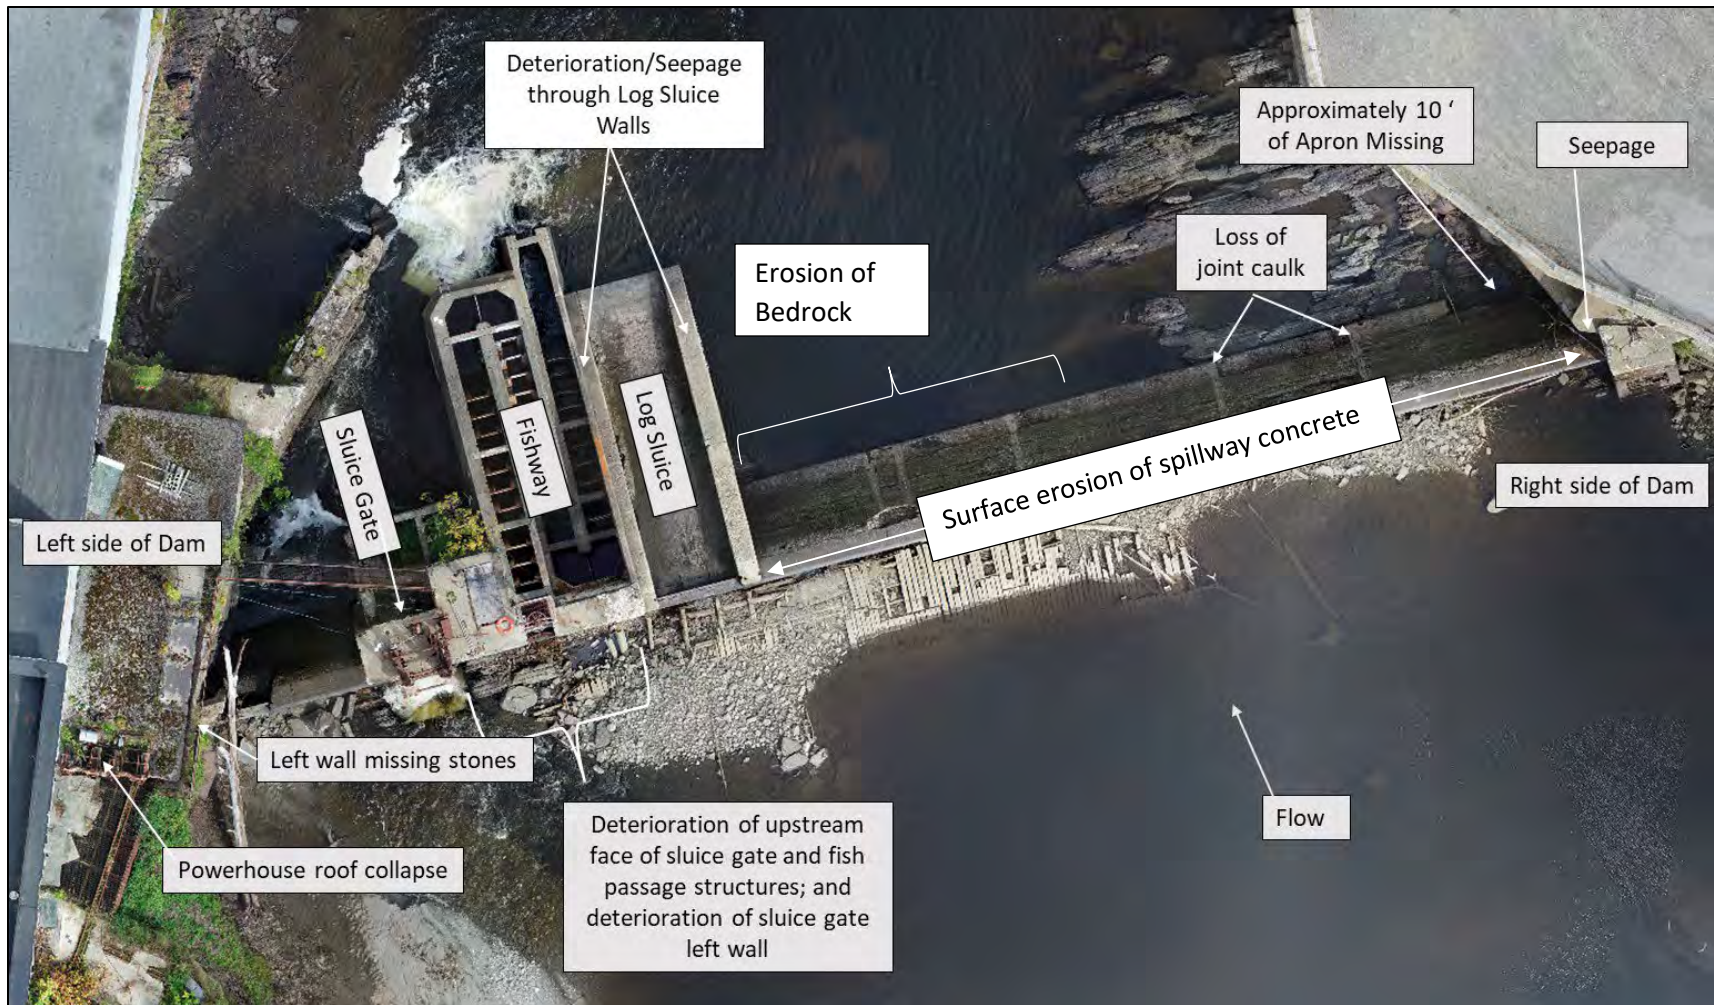
Figure 2.1-1. Aerial Image of Dam with Structural Deficiencies Labeled
