Mayo Mill Dam  
Riparian and Wetland Habitat Assessment

Piscataquis River  
Town of Dover-Foxcroft, Piscataquis County, ME

Prepared by Alan Haberstock, PWS

Inter-Fluve

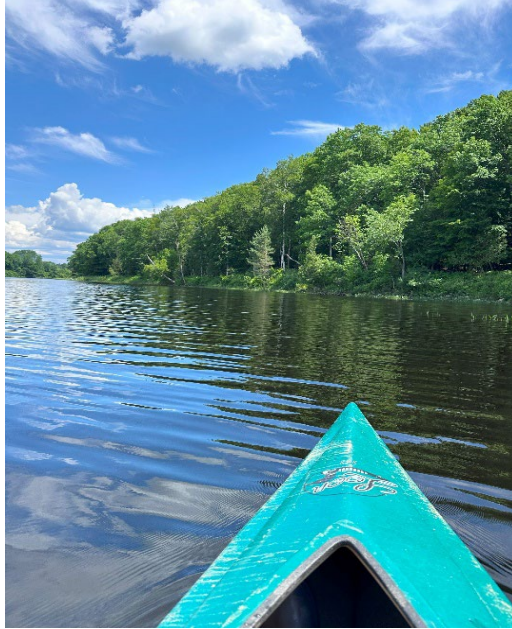
Photo 1. Shoreline wetlands are uncommon in the impoundment due to the relatively abrupt slopes at the impoundment edge. This portion of the impoundment typically transitions from PUB to upland forest abruptly. There is a relatively unfragmented upland riparian forest along most of the southern shoreline (pictured), but the northern shoreline is mostly fragmented with residential and commercial development.

topography adjacent to the impoundment shoreline (photo 1). There is a lack of broad, flat areas above the ordinary high water mark for larger floodplain wetlands to develop.

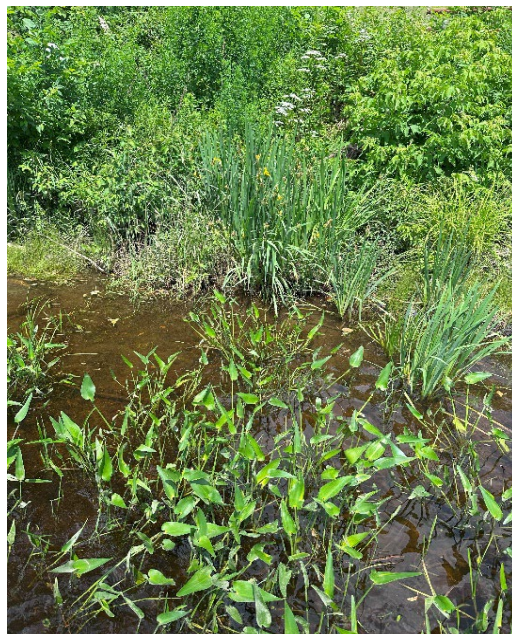
Photo 2. This photo shows a typical narrow strip of PEM wetland along the northern shoreline. Pickerelweed dominates the lower portion of the photo. Yellow iris (invasive) and a native wildflower, water parsnip (white flower) are visible in the upper part of the photo. These wetlands are not extensive but do form long, continuous narrow bands along portions of the shoreline, especially the northern shoreline (river left) in the lower half of the impoundment.

The PEM wetlands (see photo 2 for typical PEM) occur primarily as relatively narrow bands along the immediate shoreline where there are shelves of alluvium and organic matter that are shallowly inundated at typical impoundment levels. Dominant and representative species in shallowly inundated marsh areas along the immediate shoreline include pickerelweed (*Pontederia cordata*), arrowhead (*Sagittaria latifolia*), cattail (*Typha latifolia*), three-way sedge (*Dulichium arundinaceum*), bulrushes (*Schoenoplectus*, spp), spikerush species (*Eleocharis*, spp), smartweeds (*Polygonum*, spp), and American bur-reed (*Sparganium americanum*). This marsh community typically transitioned to a diverse wet meadow with occasional shrubs. Representative species in this less-frequently inundated wet meadow PEM community included nodding sedge (*Carex gynandra*), fringed sedge (*Carex crinita*), water parsnip (*Sium suave*), Joe pyeweed (*Eupatorium maculatum*), blue-flag iris (*Iris versicolor*), sweet flag (*Acorus calamus*), Canada rush (*Juncus canadensis*), northern long sedge (*Carex folliculate*), tussock sedge

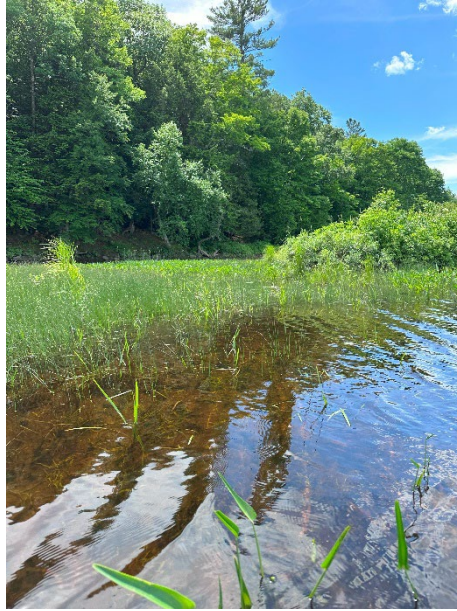
Photo 5. River right about 0.2 miles downstream of Academy Island. The PEM is dominated by pickerelweed, arrowhead, burreed, marsh purslane, three-way sedge and smartweeds. Elderberry, willows and silky dogwood dominate the PSS. The emergent zone was exposed in August and inundated in July.

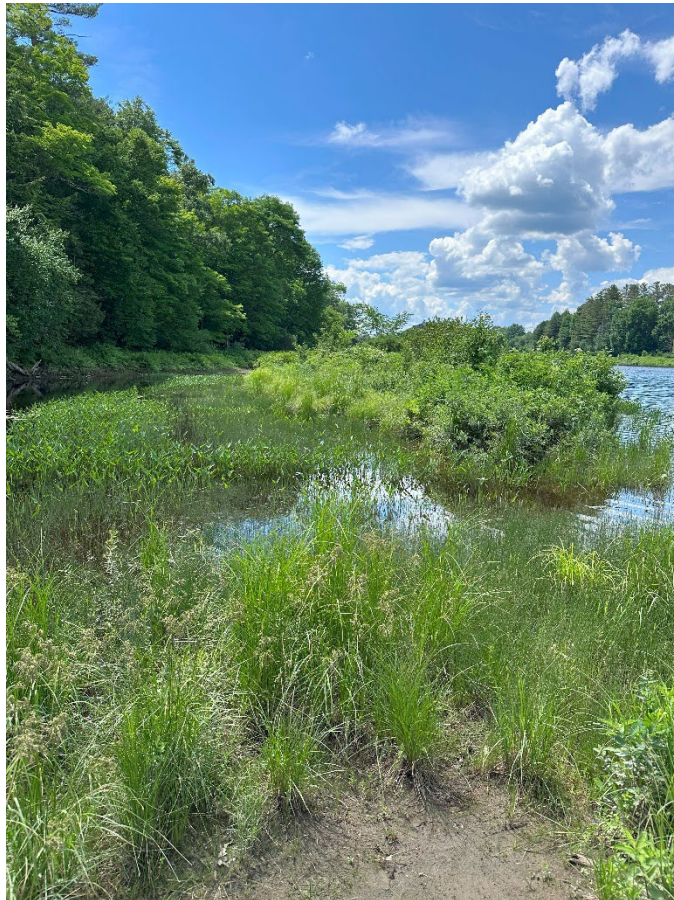
Photo 7. This is a small PSS located about 0.2 miles upstream from the public boat launch on river right in the lower portion of the impoundment.

The PSS wetlands (see photo 7 for typical PSS) occurred in the wetland habitat zone between the PEM and riparian upland forest or intermingled with PEM. Representative species were willows, sweetgale (*Myrica gale*), winterberry (*Ilex verticillate*), speckled alder (*Alnus incana*), arrowwood (*Viburnum dentatum*), withe-rod (*Viburnum nudum*), elderberry, silky dogwood, red osier dogwood, dewberry (*Rubus hispidus*), meadowsweet (*Spiraea latifolia*), and stepplebush (*Spiraea tomentosa*). Dominant herbs included Joe pyeweed and the invasive reed canarygrass. Vines thrived in this habitat zone including balsam apple or wild cucumber (*Echinocystis lobata*), groundnut (*Apios americana*), arrow-leaved tearthumb, virgin's bower (*Clematis virginiana*), and riverbank grape (*Vitis riparia*). Vines frequently covered the shrub canopy in a tangle, to the point where the habitat was nearly impenetrable. Soils in the PSS habitats were largely Fluvaquents or alluvial soils with an aquic moisture regime dominated by fine sand and silt.

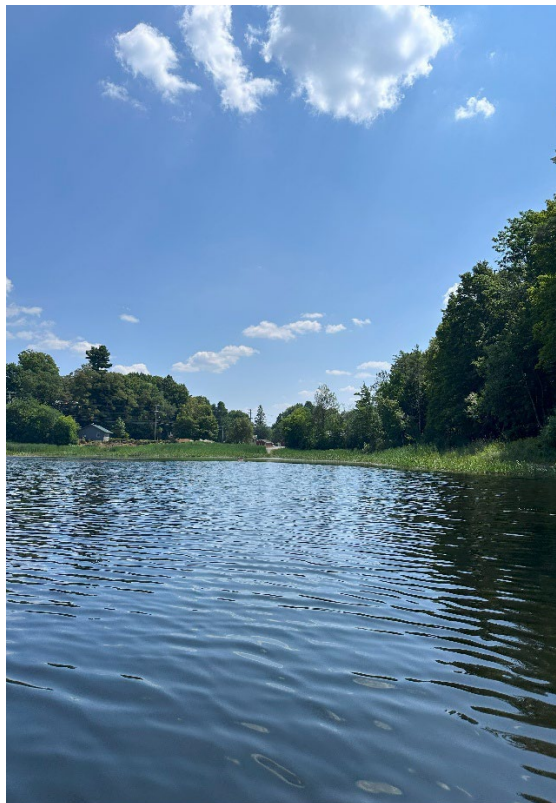
Photo 8. PEM surrounding the public boat launch on river right a few hundred feet upstream from Route 7. Pickerelweed, broad-leaved cattail and burreed were dominant species. Much of this cove will likely transition to palustrine wetlands with the dam out.

Photo 9. Facing upstream in the lower portion of the impoundment showing the typical shoreline condition (abrupt transition to upland forest). Most of the PUB (impoundment) lacks aquatic or wetland vegetation. In a few protected, shallows, aquatic vegetation like pondweeds (*Potamogeton, spp*) were observed.

The RUB (photo 9) is primarily ponded, unvegetated habitat with a mixture of soft (silt, organic matter) and sandy substrates. Coarser substrate (boulder/cobble/gravel/sand) occurs at the impoundment head and up into riverine habitat upstream of the impoundment and below the dam. Small pockets of aquatic bed are intermingled with the PUB in the impoundment, primarily in more protected, shallow-water areas. Typical species of these areas included pipewort (*Eriocaulon aquaticum*), white water-lily (*Nymphaea odorata*), spatterdock (*Nuphar lutea*), pondweeds (*Potamogeton, spp*), and water shield (*Brasenia schreberi*).

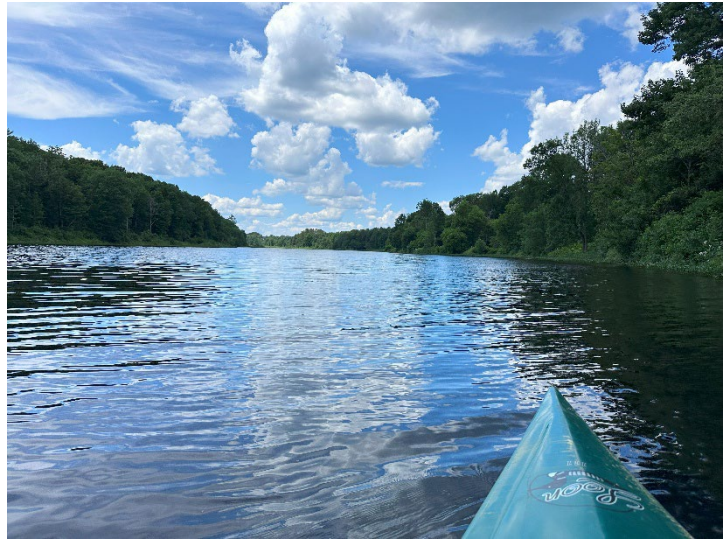
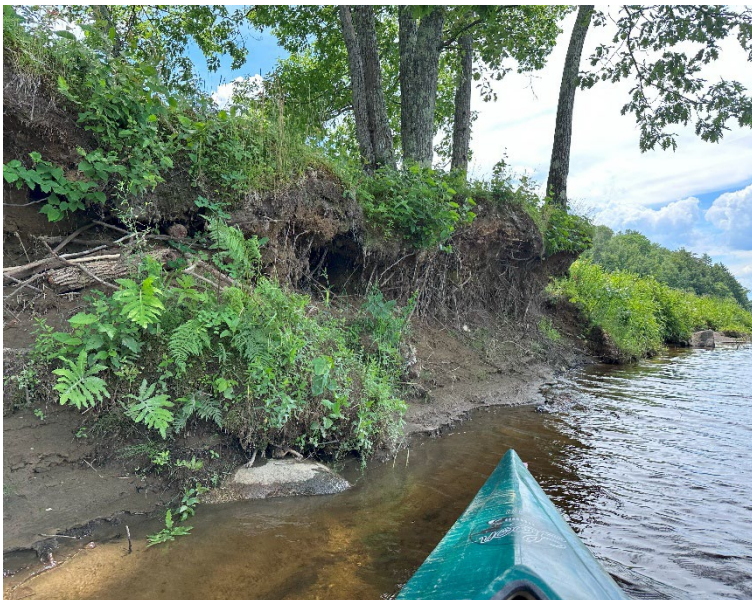
Photo 10. Shoreline erosion was commonly observed along the impoundment shorelines. This is the northern shore of Academy Island. Exposed small roots indicate that this section of the island likely experienced erosion during a recent winter flood event. Visible in the photo are several slumped sections with wetland vegetation such as sensitive fern. The alluvial soils on this island are non-cohesive and easily erode.

Shoreline stabilization is another principal function served by the subject wetlands. Areas of erosion (photos 10-12) were observed along some sections of the shoreline, especially where steeper slopes resulted in an abrupt transition from the PUB habitat to upland forest. A combination of wind, waves and overbank flows apply erosive energies onto the shoreline.

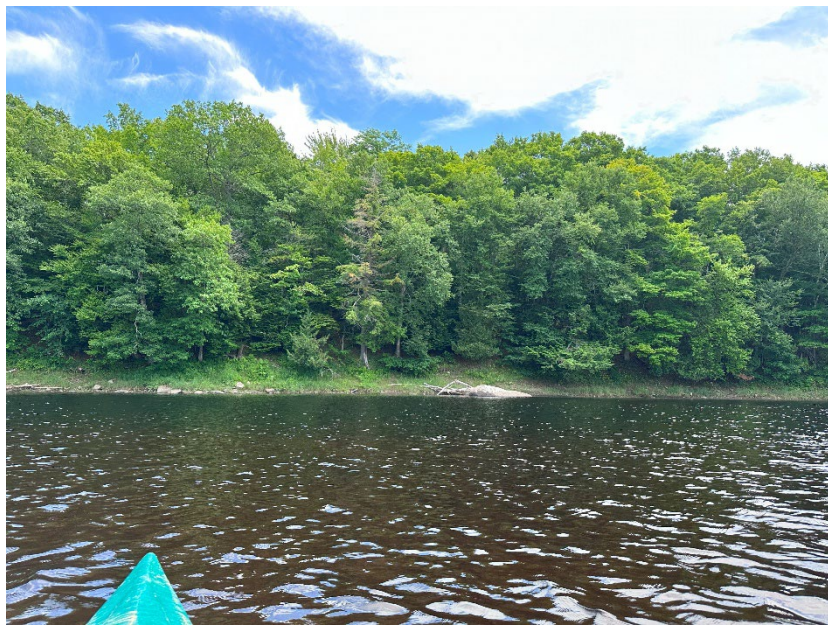
Photo 12. Several-hundred feet of shoreline is visible in this photo taken along river right upstream of Academy Island on August 11 (lower water levels). Below the tree-line, the fines have been eroded from the shoreline by wind waves, ice and flood flows leaving behind coarser material.

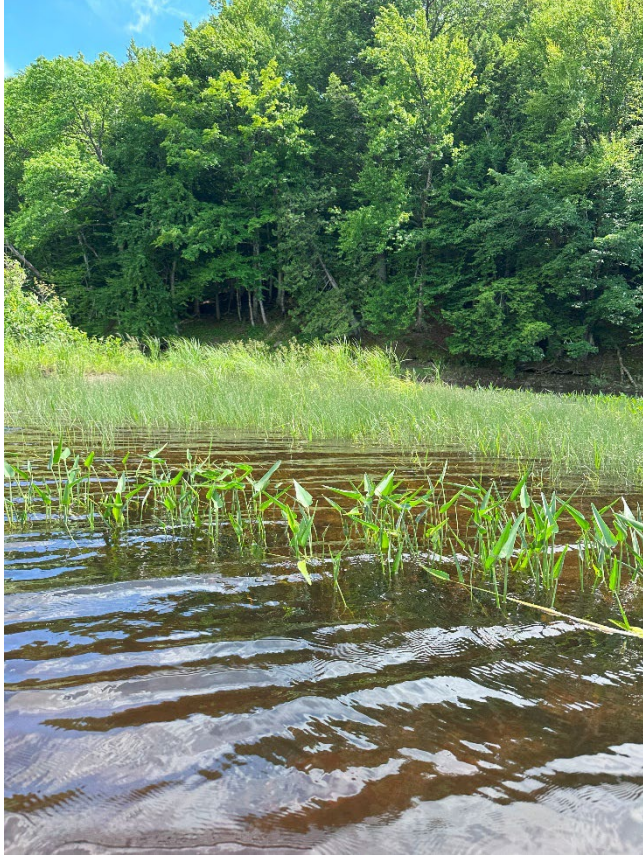
Photo 13. On July 2<sup>nd</sup>, this wetland located on river right between the public boat launch and Academy Island was inundated. Black duck (hidden by bulrush and pickerelweed in this photo), were observed foraging/hiding in the emergent vegetation.

The emergent wetlands along the shoreline border the Piscataquis River, which is an optimal habitat juxtaposition for waterfowl and wading birds (photos 6 and 13). This habitat is ideal for many species of wading birds and waterfowl, aquatic furbearers and songbirds. The diversity of berry-producing shrubs (e.g., dogwoods and viburnums) and nutritious emergent marsh plants (e.g., pickerelweed and arrowhead) also contribute to the high-quality wildlife habitat function. The diverse native wetland plant community adjacent to the stream is productive and, in addition to providing important habitat features in the existing condition, is an important source of the seedbank that will help colonize the exposed impoundment following dam removal.

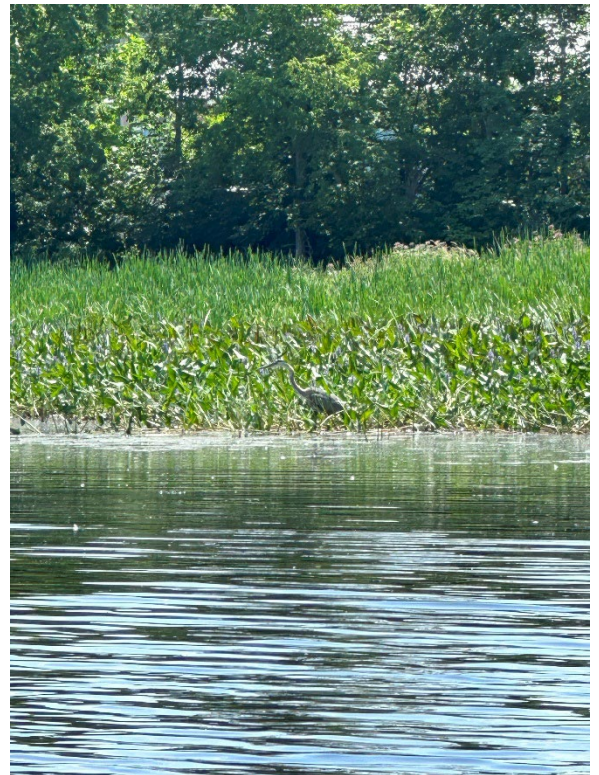
Photo. 14. Mature great blue heron hiding in the pickerelweed near the public boat launch. This water level is low (August drought).

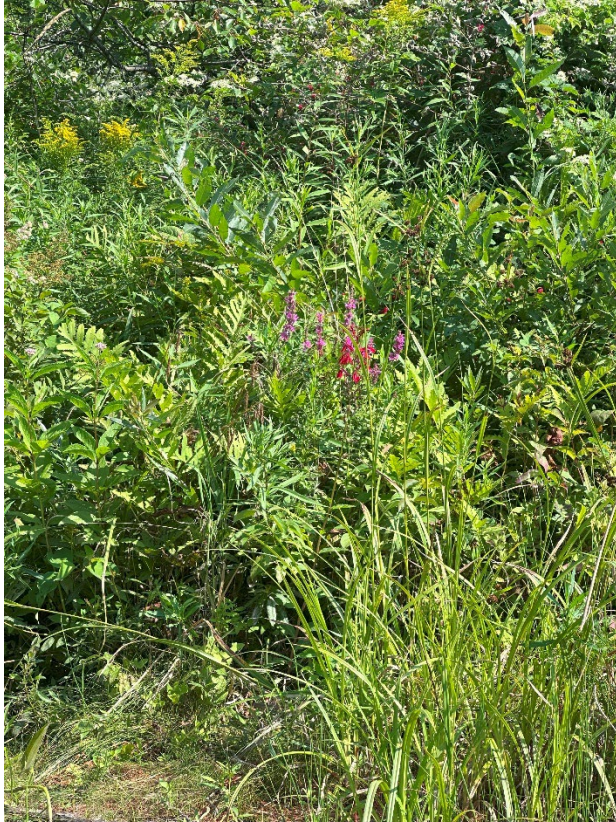
Photo 19. Cardinal flower was fairly common above the impoundment where it was more riverine. In this photo, it is battling with the invasive purple loosestrife.

Reed canarygrass is, by far, the most abundant invasive in the existing wetlands. In places this species represents as much as 15-20% of the estimated cover (photo 19). Purple loosestrife was also observed within the PEM and PSS habitats, however this species was rarely seen as more than a small clump or individual stem. Purple loosestrife was estimated to comprise no more than 3% of the overall cover.

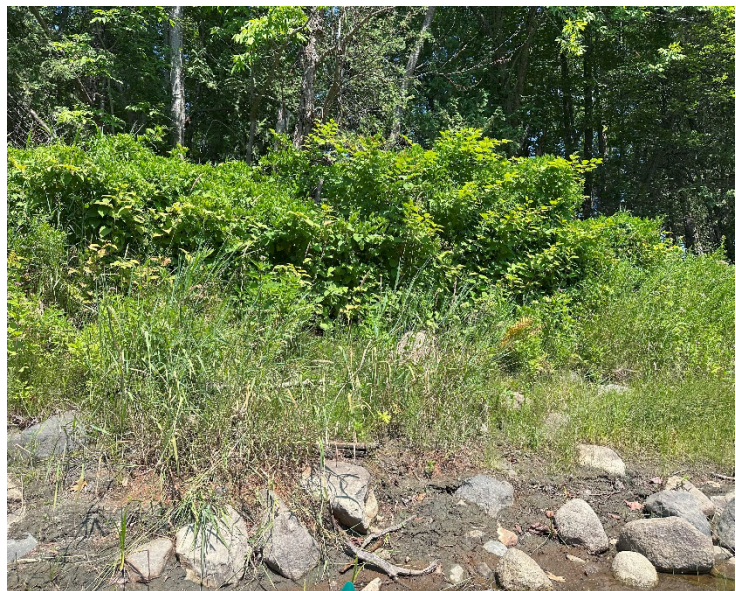
Photo 20. Japanese knotweed (riparian invasive) on river left just downstream from the historic trestle (current recreational trail).

Japanese knotweed (*Falopia japonica*) was observed in several places. The largest stands were on the northern shoreline (river left) immediately downstream of the railroad trestle/recreational trail and immediately below the dam on river left (photos 20 and 21). These locations are included in the wetland maps in Appendix B. Japanese knotweed is not a wetland species but it can form spreading monocultures along upland portions of the shoreline and along wetland margins. Yellow iris tends to occur in small patches along the PEM wetlands on the shoreline.

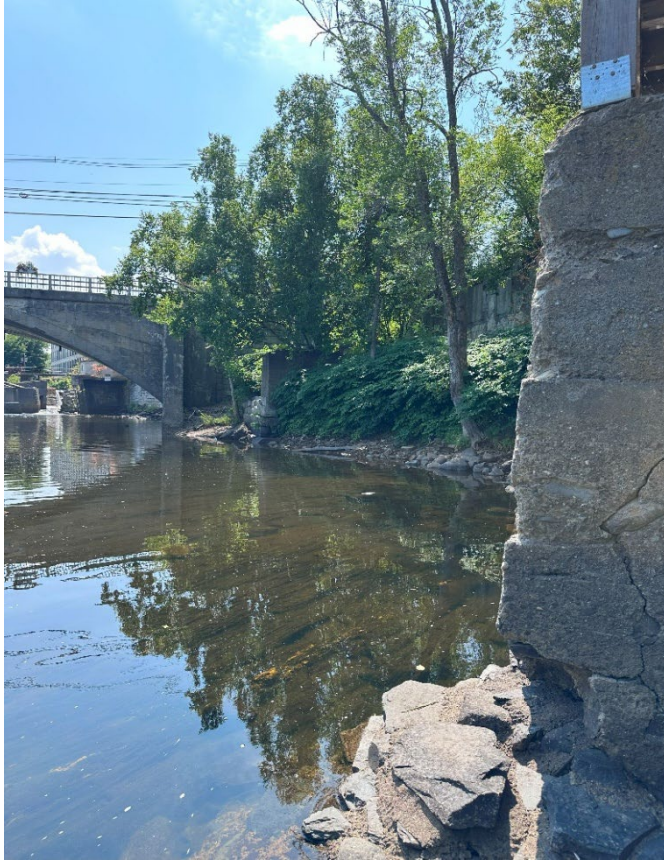
Photo 21. Japanese knotweed growing in the tailrace, river left, in downtown Dover-Foxcroft, just below Main Street. The Japanese knotweed occupies the entire area from the ordinary high water mark to the retaining wall.

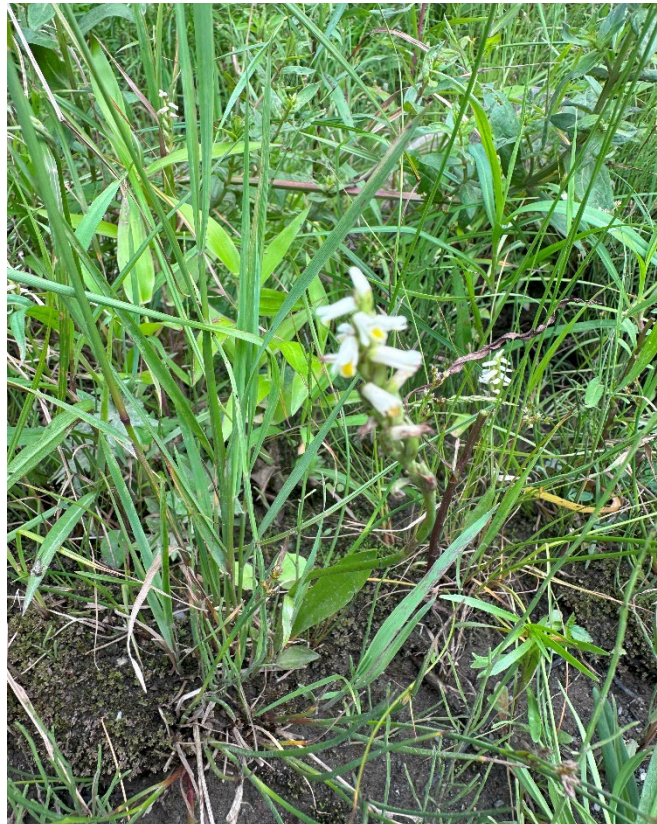
Photo 22. Shining ladie's tress in flower. Two characteristics that make this Maine-Threatened orchid fairly straightforward to identify are the yellow blotch on the protruding flower lip and phenology (this is the only *Spiranthes* in Maine that flowers in late June and first week of July). This population was likely surveyed at least 1-2 weeks after the onset of flowering. Note the spent flowers along the lower portion of the floral spike. There is another shining ladie's tress in the upper left of the photo where all the flowers are going to seed (15 or so other individuals in the population were past peak flowering).

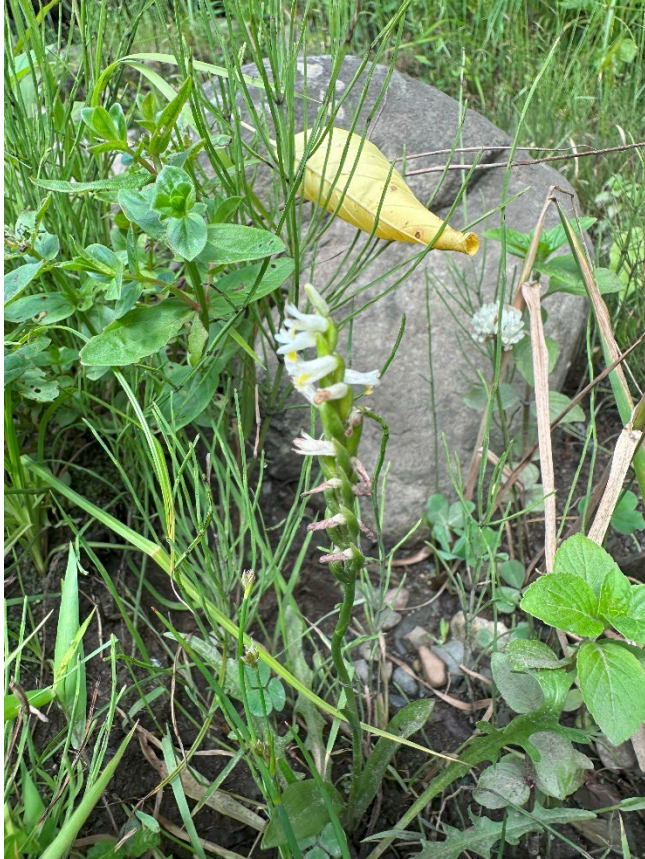
Photo 23. Another example of a shining ladies' tress where the top half of the floral spike is still in flower. Note the purple loosestrife plants in this community. Some of them were pulled. This plant community was growing on wet alluvium.

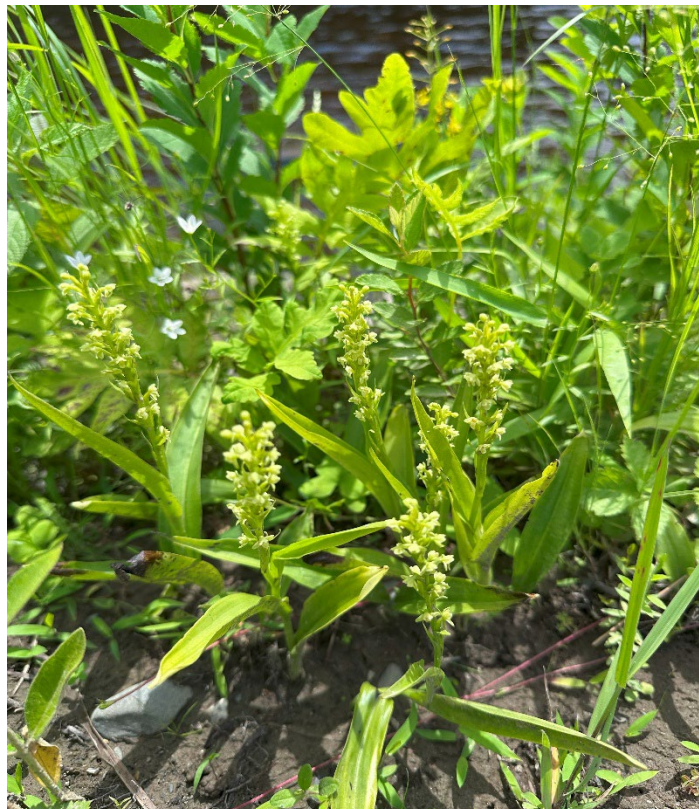
Photo 24. A patch of several pale green orchises growing in wet alluvium. Marsh bellflower, swamp candles, sensitive fern and deer-tongue grass were found in this community.

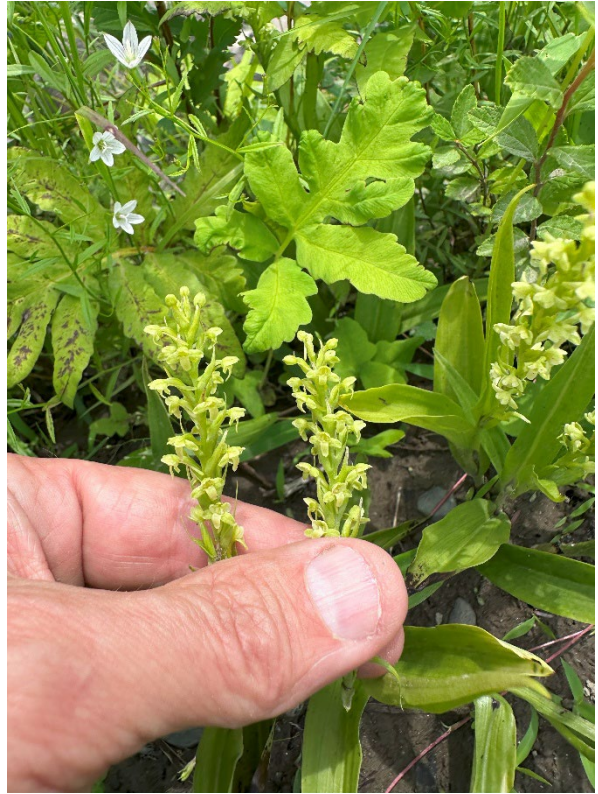
Photo 25. Close-up showing the large, modified, lower petals (spurs) that distinguish this rare orchid.

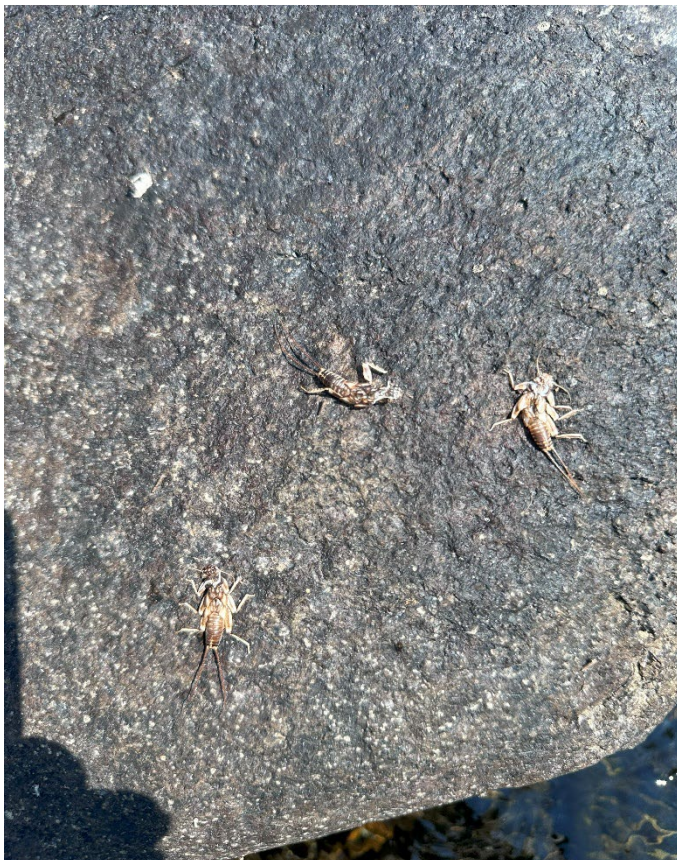
Photo 26. Stonefly exoskeletons found in the free-flowing river upstream from the impoundment. Stoneflies are indicators of good water quality and in the long-term would be expected to benefit from dam removal.

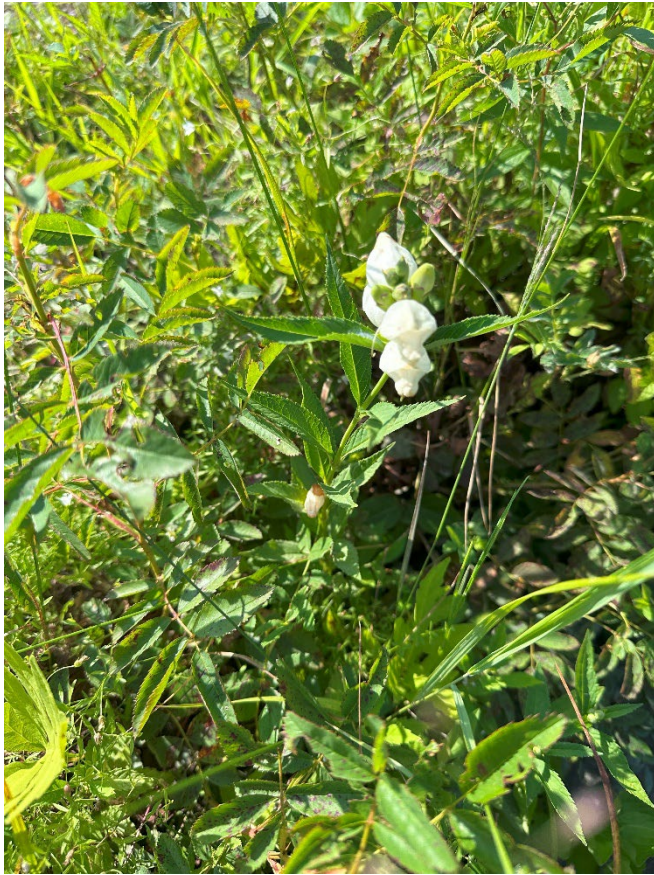
Photo 27. Turtlehead is a welcome native wildflower that occurs along the shoreline of the river above the impoundment.

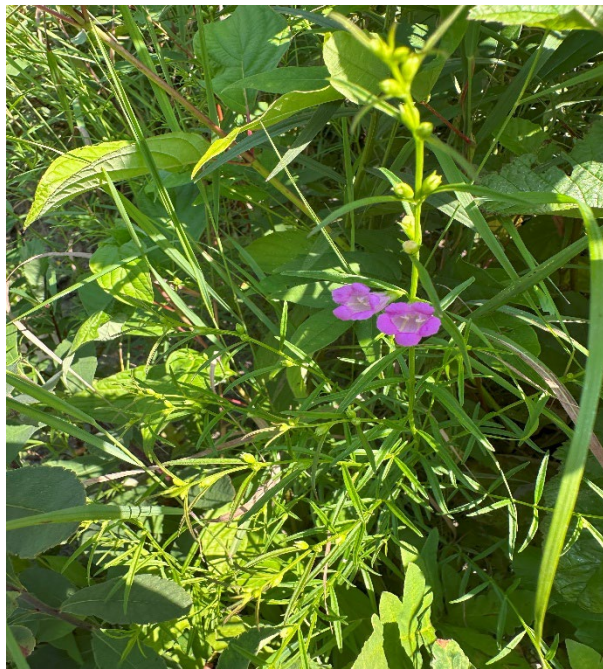
Photo 28. Small-flowered gerardia is common on the shores of Admiral Island. This native wildflower likes to grow in alluvial parent material.

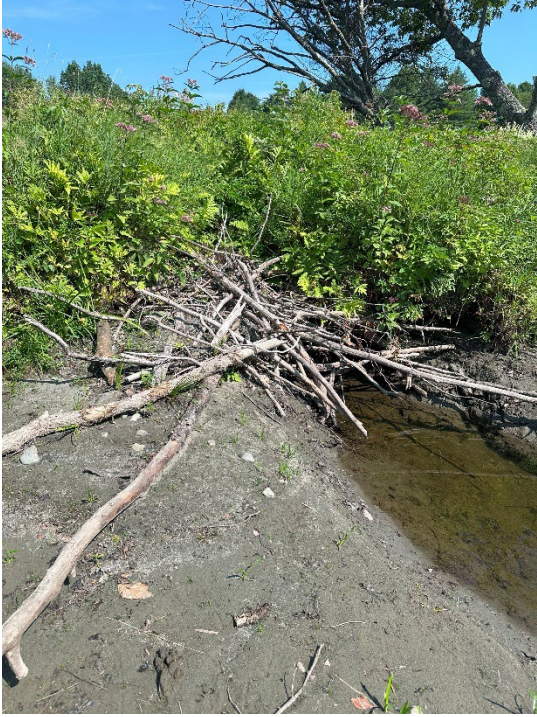
Photo 29. Bank beaver use the non-cohesive alluvial material (easy to dig into) on the south side of Academy Island to build winter homes into the bank.

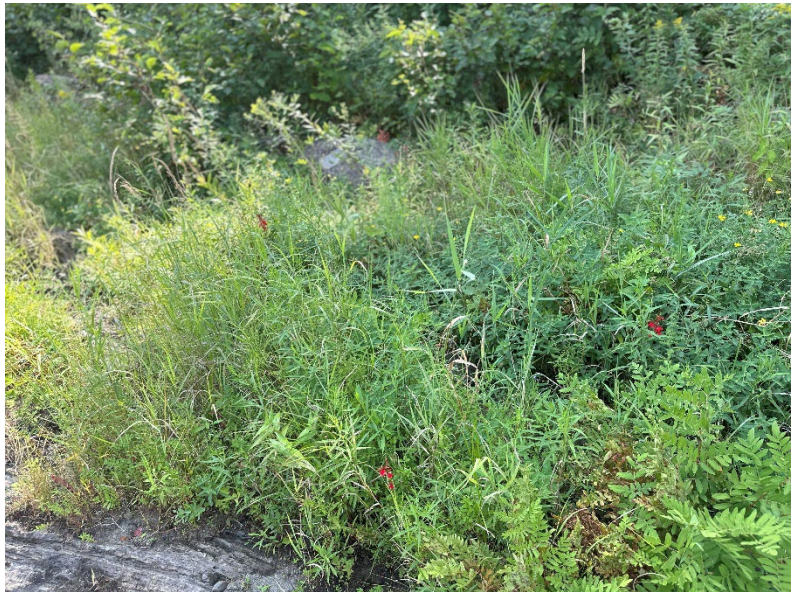
Photo 30. Cardinal flower and royal fern against a patch of reed canarygrass river right in the upper impoundment.

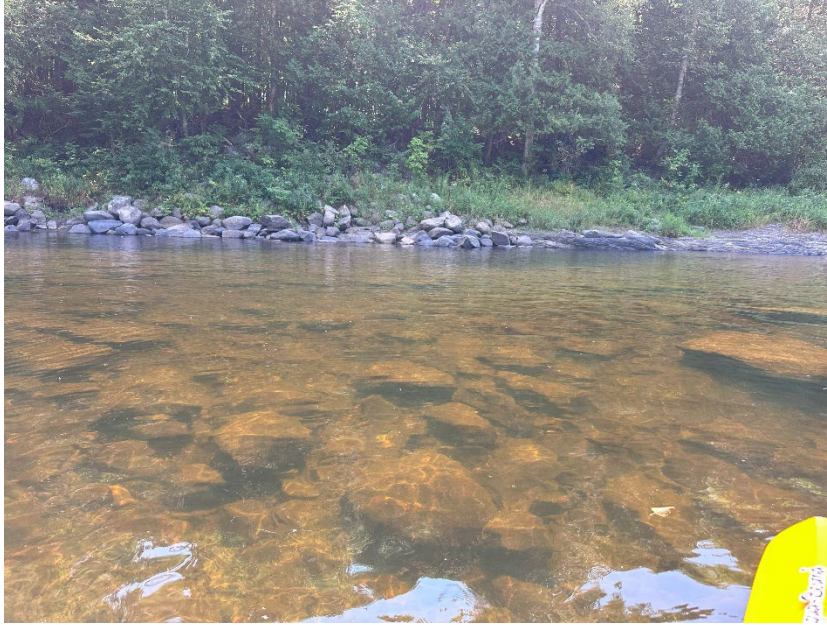
Photo 31. The upper portion of the impoundment (above Academy Island) has a much rockier substrate in the river as well as bedrock outcrops and larger rocks on the shoreline.

Bedrock was observed at the site of the dam, along the shorelines for several hundred feet below the dam, and also in the upper impoundment, above Academy Island. The impoundment substrate is more coarse from Academy Island upstream.

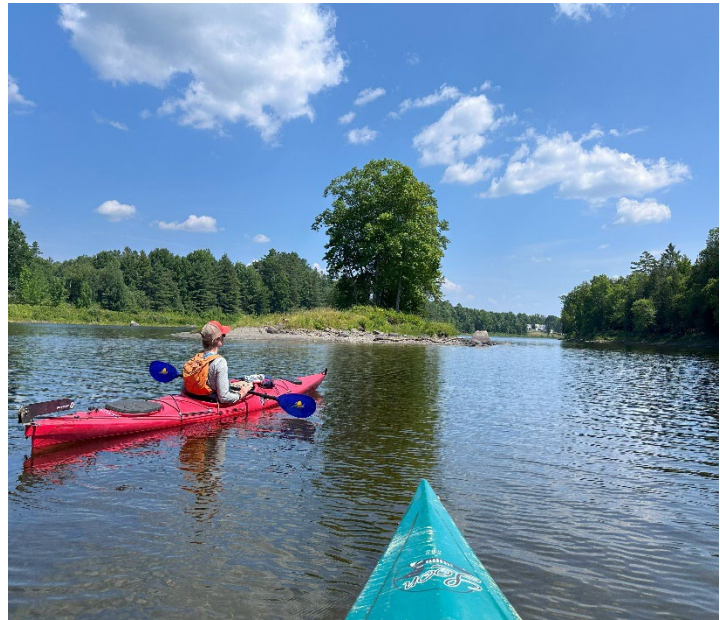
Photo 32. View of the upstream end of Academy Island looking downstream. This photo was taken in August when water levels were down as a result of the drought. Many of the wetland plants on the sandy alluvium on the upstream end of this island were desiccating or senesced early.

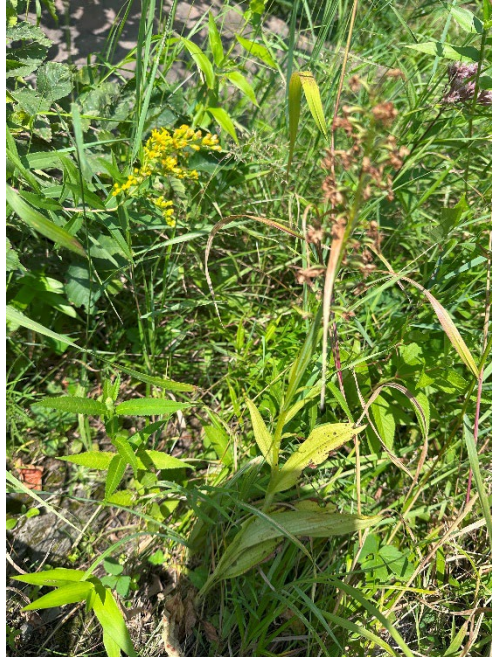
Photo 33. Photo of an orchid that is senescing in August (likely early due to drought). It appears to be a small purple-fringed orchid. It is growing on the shoreline below the dam in wet alluvial material.

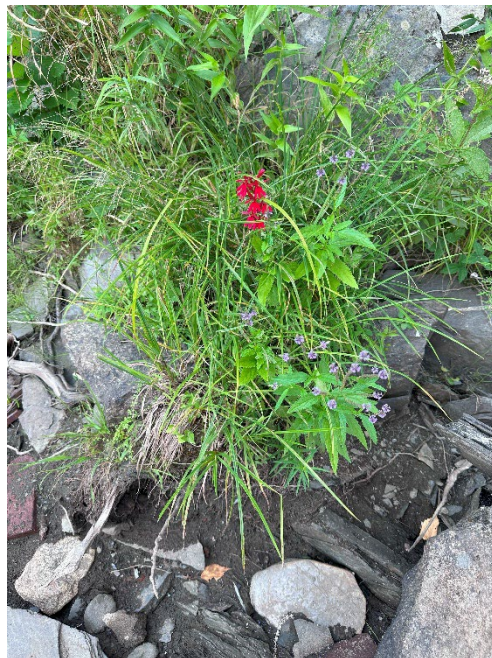
Photo 34. Cardinal flower growing with stunted blue vervain. Possibly, a wet May followed by a drought stressed some of the shoreline plant community.
